PARTS & SERVICE NEWS

REF NO.	A910163
DATE	Oct. 18, 1991

SUBJECT: REINFORCEMENT OF FRONT FRAME BOOM MOUNTING PLATES ON WA700-1

APPLICATION: WA700-1 Wheel Loaders, Serial Nos. 10001 thru 10082 (except 10077)

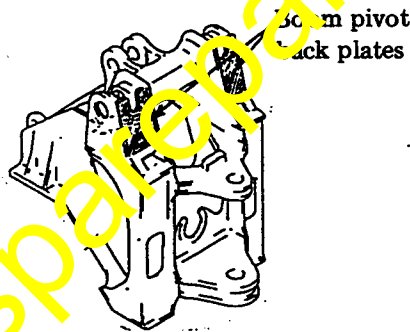
If cracks are caused to the boom mounting plates (or boom pivot back plates) on the front frame on Wheel Loader Model WA700-1, repair to reinforce the plates as described in this PARTS & SERVICE NEWS.
