PARTS & SERVICE NEWS

REF NO. A950048B

SUBJECT: IMPROVEMENT OF TRANSMISSION OIL FILTER CLOG SENSOR

APPLICATION: 558 Wheel Loader, S/N 006001 and up
568 Wheel Loader, S/N 007001 and up
WA500-1 Wheel Loader, S/N 10001 thru 21096 and A20001 thru A20266
WA500-1L Wheel Loader, S/N A20267 and up
WA500-1LC Wheel Loader, S/N A60001 and up
WA600-1 Wheel Loader, S/N A10001 thru A10139
WA600-1L Wheel Loader, S/N A10140 and up
WA600-1LC Wheel Loader, S/N A50001 and up

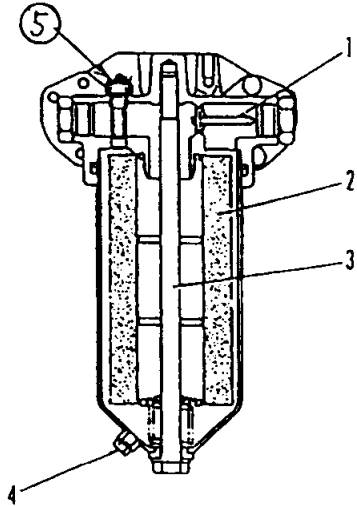
Section of transmission oil filter

The caution of the clogging of transmission oil filter may be while the latter is not clogged actually. (A probable cause of trouble is dust in the hydraulic oil which can enter and trouble the sensor) If this trouble occurs, repair it according to the following procedure as outlined in this **Parts & Service News**.

- 1. Relief valve
- 2. Element
- 3. Center bolt
- 4. Drain plug
- 5. Clogging sensor

A 150-mesh strainer is added to the high-pressure port of the transmission oil filter clogging sensor to prevent dust from entering the contact area in the sensor and the cylinder.
