PARTS & SERVICE NEWS

REF NO.	A960022A
DATE	April 15, 2004

SUBJECT: REPAIR OF BELLCRANK FOR HIGH LIFT BOOM

PURPOSE: To introduce modification procedures to prevent occurrence of interruption between the high lift boom and bell crank on high lift boom specifications on wheel loaders

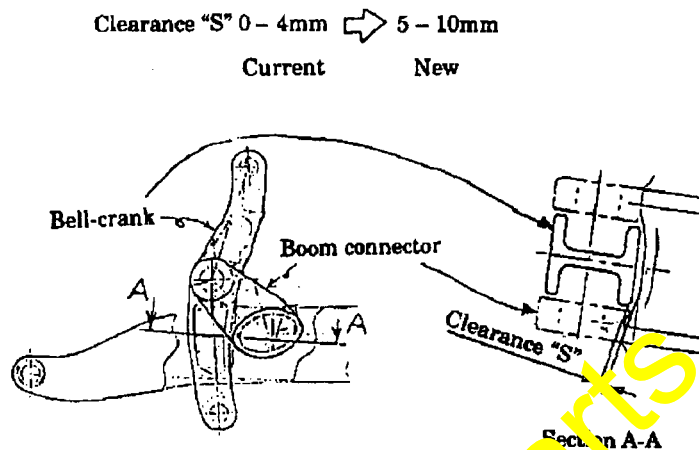
3-1. Already shipped vehicles

With high lift boom specification, interference may occur between the bell-crank and the boom connector when the bucket is tilted back to its stroke end, causing cracks in the bell crank structure. It is therefore necessary to execute a modification to prevent occurrence of this trouble following the procedures outlined in this **Parts & Service News**.

An additional plate is being added to the bucket tilt stopper to prevent occurrence of the interference between the bell-crank and boom connector.

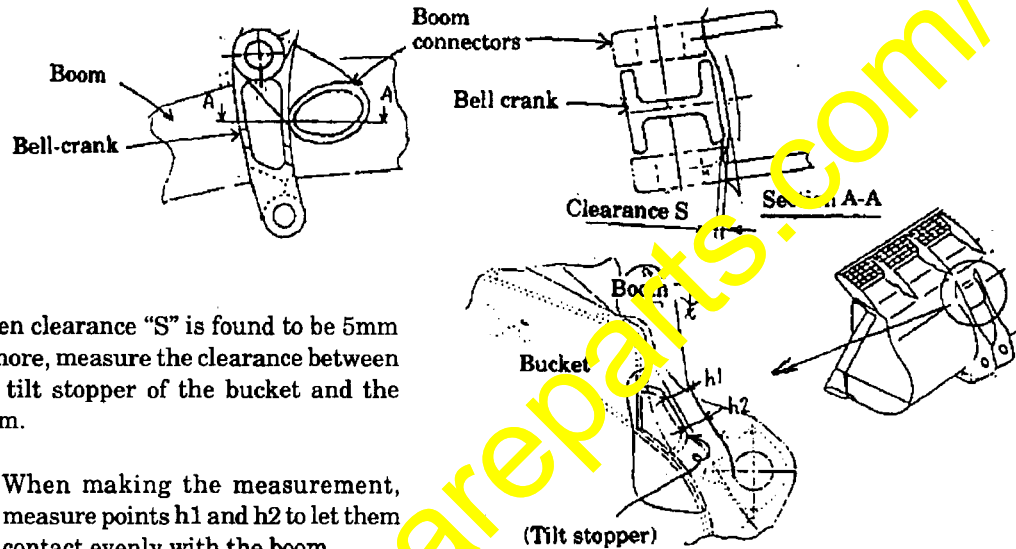
[Note]: If clearance "S" between the boom connector and the bell-crank remains 5mm or more when the bucket is tilted back to its stroke end, this modification is not necessary.

- 4-1. Land the bucket, tilt back the bucket as shown at right before adjusting the bucket control lever so that clearance "S" between the boom connector and the bell-crank becomes 5mm or more.
