PARTS & SERVICE NEWS

REF NO.	AA00091
DATE	09, June 2000

SUBJECT: Door Window Assemblies

APPLICATION: 530M, 730E, 830E, and 930E trucks equipped with J-Dak window assembly

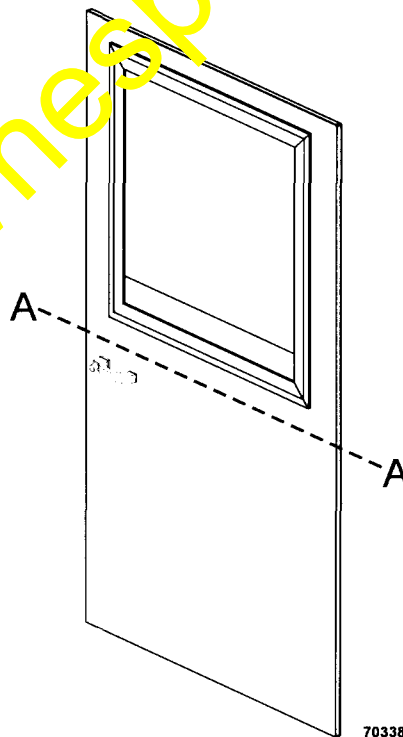
Figure 1. Door Panel Structure

When manufactured, the heat from the welding of the stiffeners may cause the door to bow and push outward. The bowing of the door causes the window channels to turn inward putting pressure on the glass by pushing it against the inside window seal hard enough that the window will not operate.

When the new door window assembly is installed, the seal asserts more pressure on the outside of the glass. This causes the window to be pressed against the inside seal hard enough that some windows may not be able to go up or down under motor power properly.

1. Assure that the door structure is relatively flat as shown (Line A-A, Figure 1). To remove the bow from the door, lower the window and apply a smooth, even pulling force from inside the cab until door structure is flat..
2. Remove the inside seal (2, Figure 2) from the armrest portion of the door structure to allow enough clearance between the door glass (1, Figure 2) and the armrest (3, Figure 2). **NOTE: REMOVING THE INSIDE SEAL MAY ALLOW DIRT AND MOISTURE TO ENTER THE CAB DURING OPERATION BUT ONLY FROM INSIDE THE CAB UNLESS THE WINDOW IS DOWN.**
