# PARTS & SERVICE NEWS

REF NO. AA00104

**SUBJECT:** STEERING WHEEL NUT TIGHTENING PROCEDURE

**PURPOSE:** To introduce the proper procedure for tightening the steering wheel nut to prevent steering valve damage

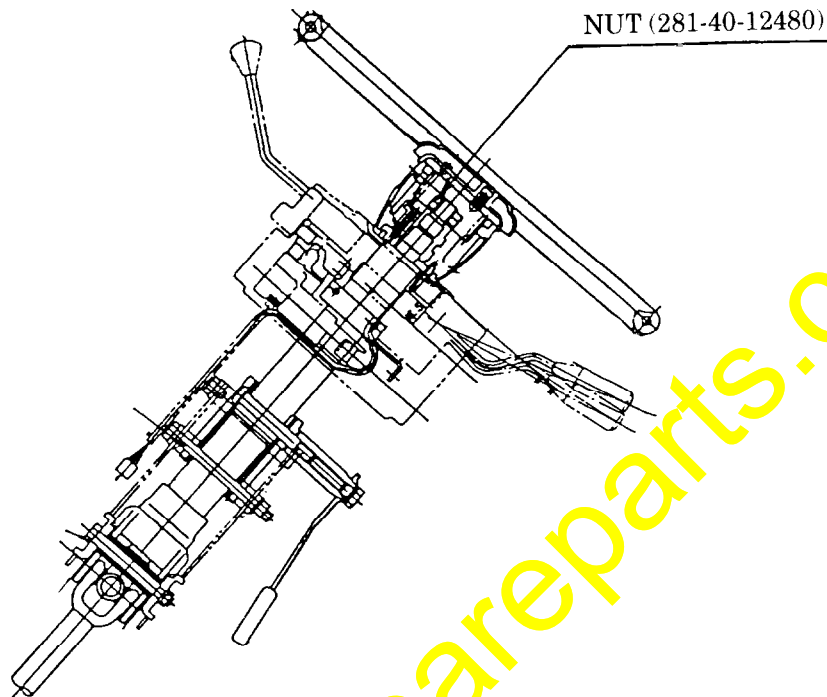
If the steering wheel nut is over-tightened, the steering valve input shaft may be damaged. The nut should be tightened according to the procedure described in this **PARTS & SERVICE NEWS**.

- (1) When installing the steering wheel, fix the steering wheel firmly so as not to allow the wheel to turn and tighten the nut (281-40-12480) into the following torque,

N · m 34.3 to 44.1 N.m (3.5 to 4.5 kg.m)

**A** Do not use an impact wrench for tightening a nut.

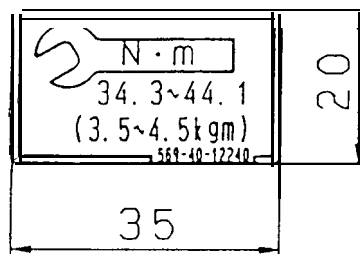
Part No.569-40-12240

- (1) A caution plate is not available for preventing trouble due to the excessively large torque to tighten the steering wheel securing nut.

The caution plate should be stuck into place as described in PAR.4-(2).
