# PARTS & SERVICE NEWS

REF NO. AA00141

**SUBJECT:** TROUBLESHOOTING OF CAB HARNESS

**APPLICATION:** HD785-3 Dump Trucks, S/N 2001 thru 2224  
HD785-5 Dump Trucks, S/N A10228 and up  
330M Dump Trucks, S/N Cf24120 and up

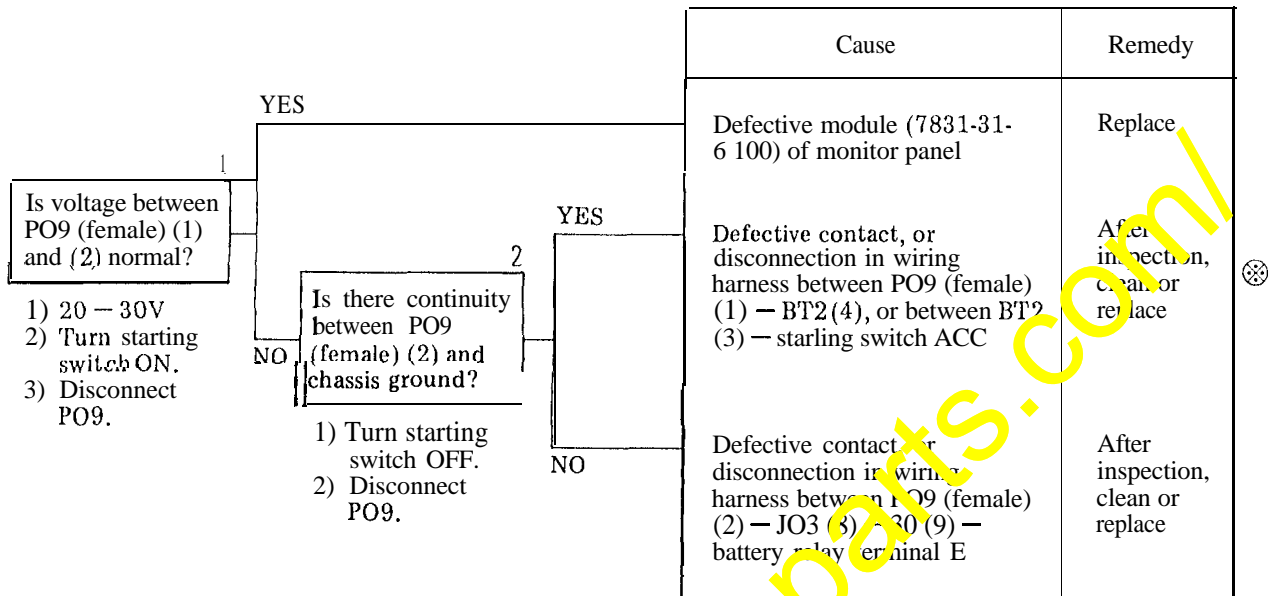
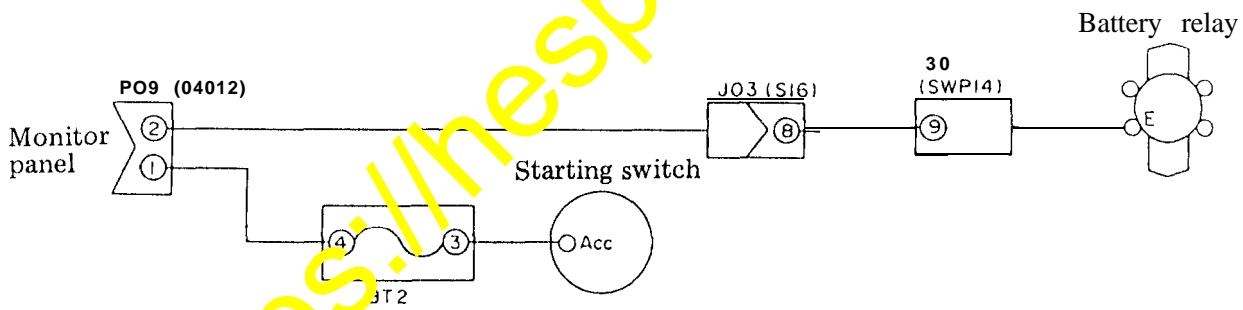
When monitor panel is totally inoperative, check the places of discontinuity by troubleshooting.

When the check resulted in ⊗, verify the discontinuity between PO9 ① and battery ④ using a tester.

By this check, estimate the discontinuity of wiring harness (561-06-63314) (For domestic) and wiring harness (561-87-61310) (For overseas).

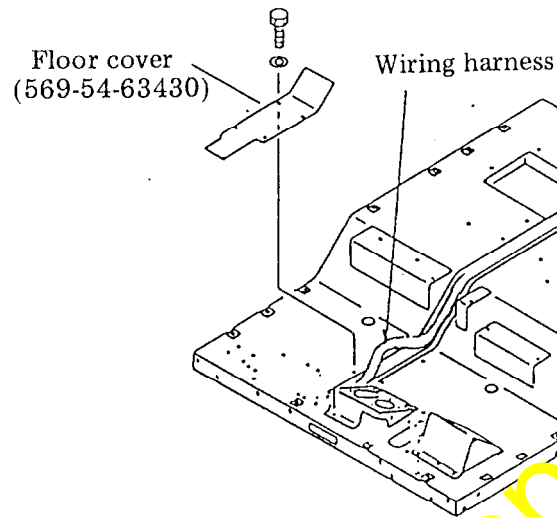
Fig. 1 Floor cover

Remove floor cover (569-54-63430) of cab platform to pull out wiring harness. (Fig. 1)

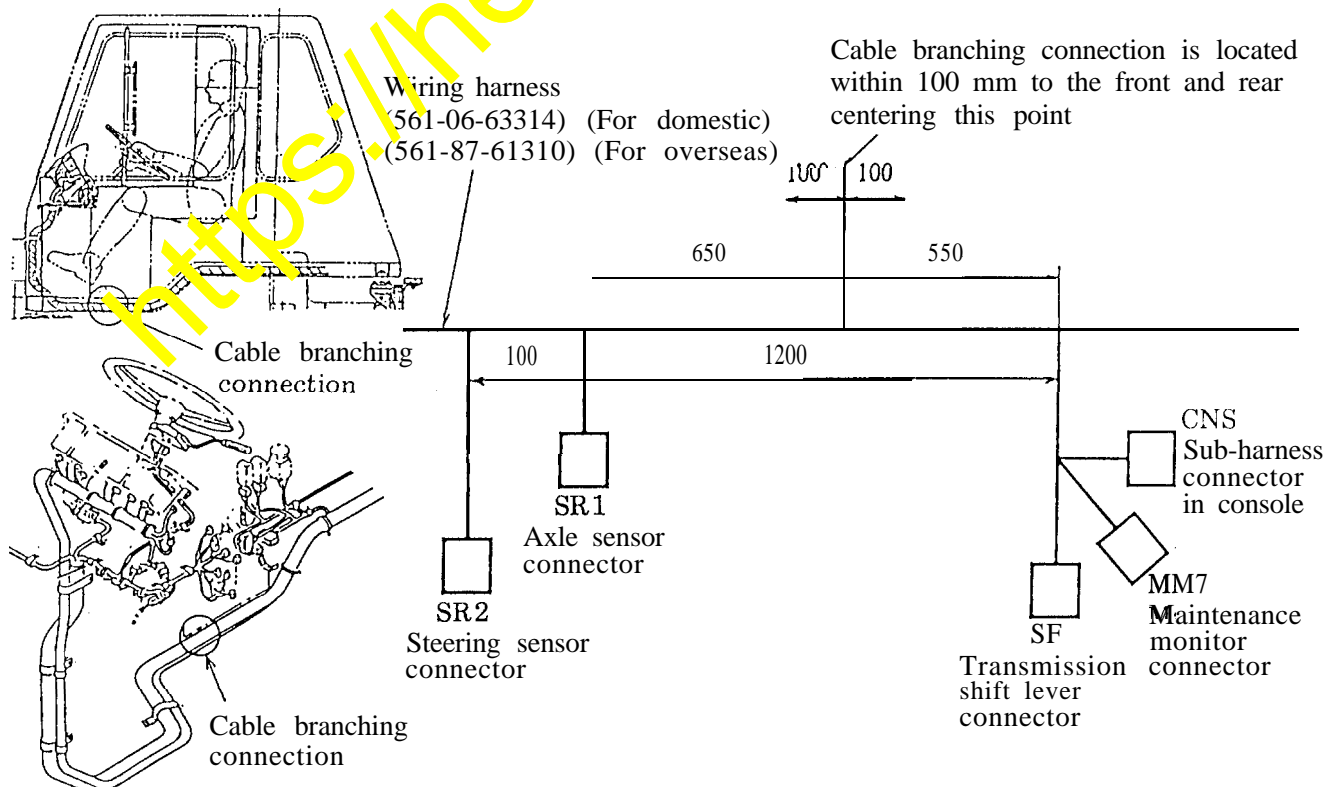
Fig. 2 Location of cable branching connection

(2) The cable branching connection of the applicable circuit is located at the middle of axle sensor harness and transmission lever harness, approx. 450 mm — 650 mm to the front of transmission lever harness.

Open harness conduit to pull out cable branching connection. (Fig. 2)
