PARTS & SERVICE NEWS

REF NO.	AA00172
DATE	July 27, 2000

SUBJECT: REPAIR PROCEDURE OF HOSE CLAMP ON TURBOCHARGER

PURPOSE: To introduce modification procedures to eliminate the breakage of hose clamps used on air supply hoses for turbochargers of twin turbo engines

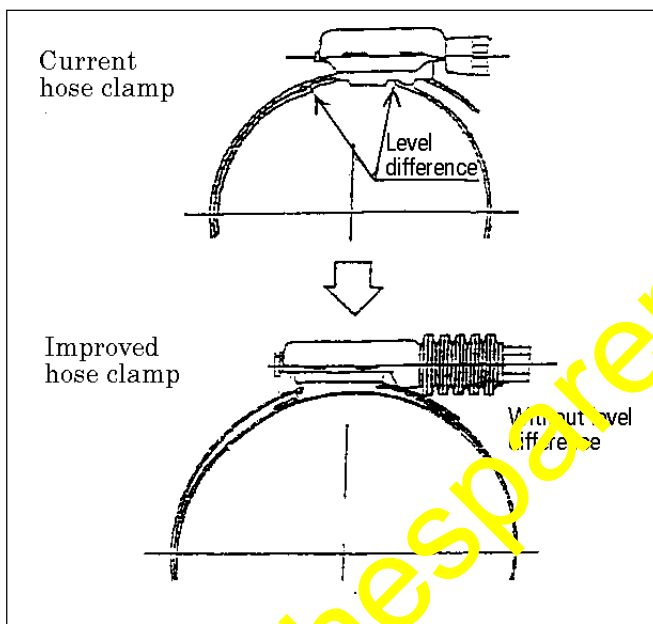
1) Modification with the hose clamp

The level difference thus existing in the clamp band has been eliminated to increase the strength.

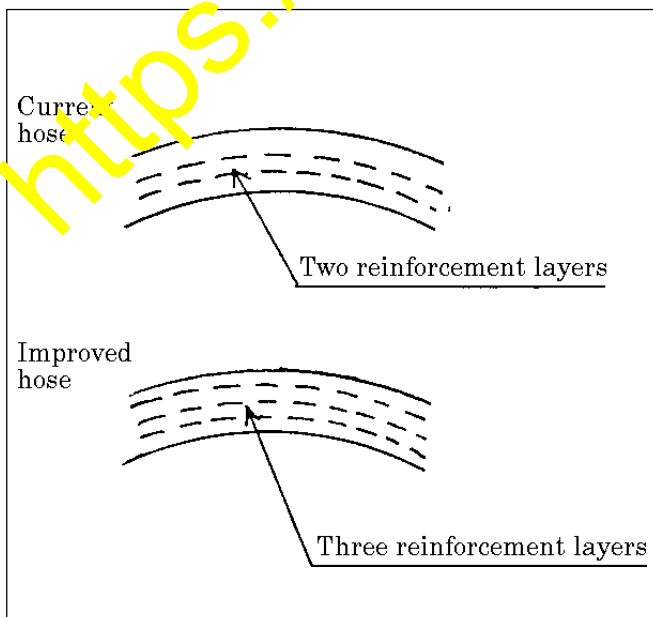
2) Modification with the hose

The number of reinforcement layers has been increased to prevent the hose from swelling due to air supply pressure, thus preventing cracking even if the hose material is deteriorated after prolonged operation.
