PARTS & SERVICE NEWS

REF NO. AA00225A

SUBJECT: IMPROVEMENT OF HYDRAULIC OIL COOLER SYSTEM

PURPOSE: To introduce a modification procedure to prevent hydraulic oil cooler failures.

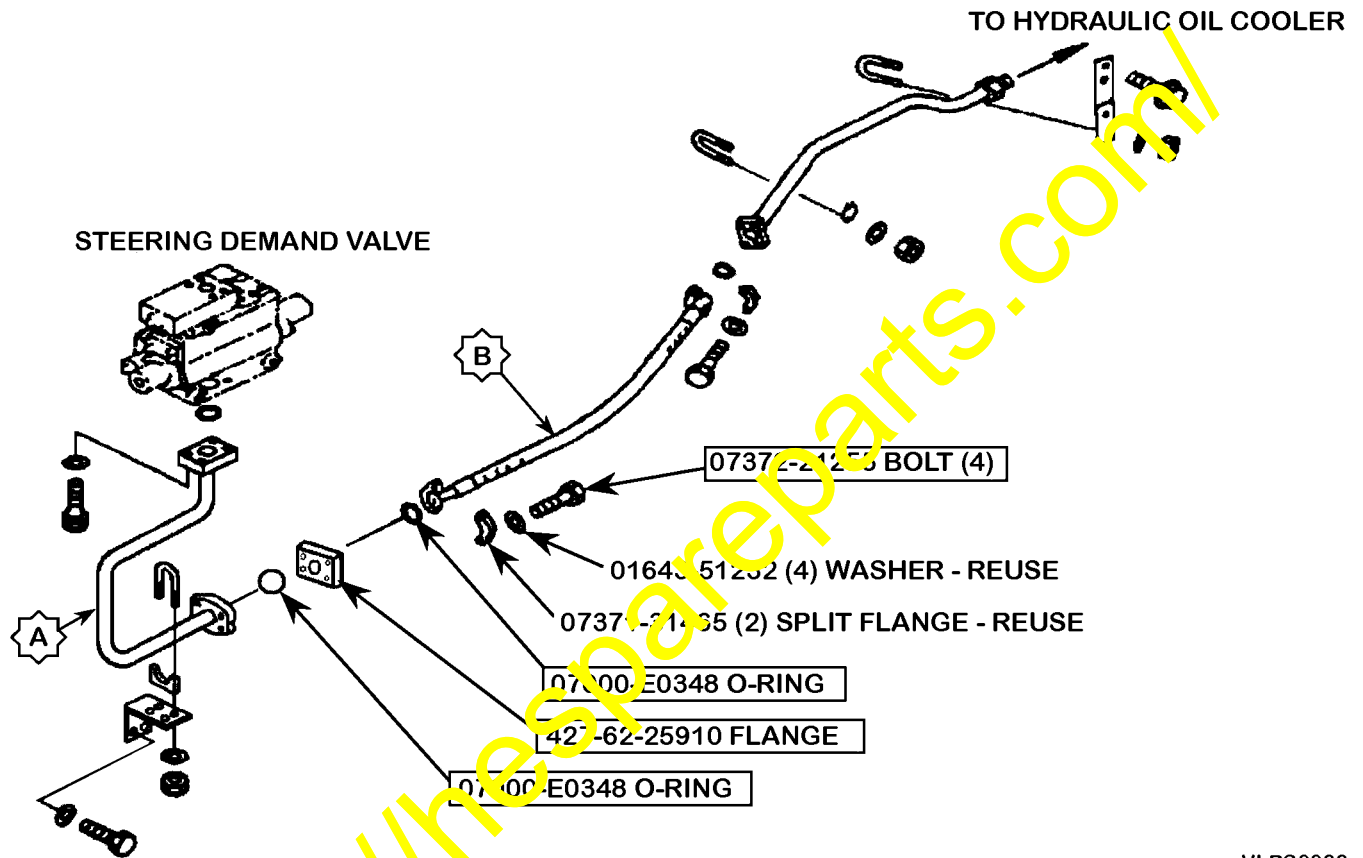
VLPS0066

A. Add the flange into the return line of the steering valve piping.

- a. Disconnect hose B from tube A.
- b. Install the new o-ring on the flange, install flange then reassemble hose B to tube A.
Reuse existing split flanges and washers with new bolts for hose installation.

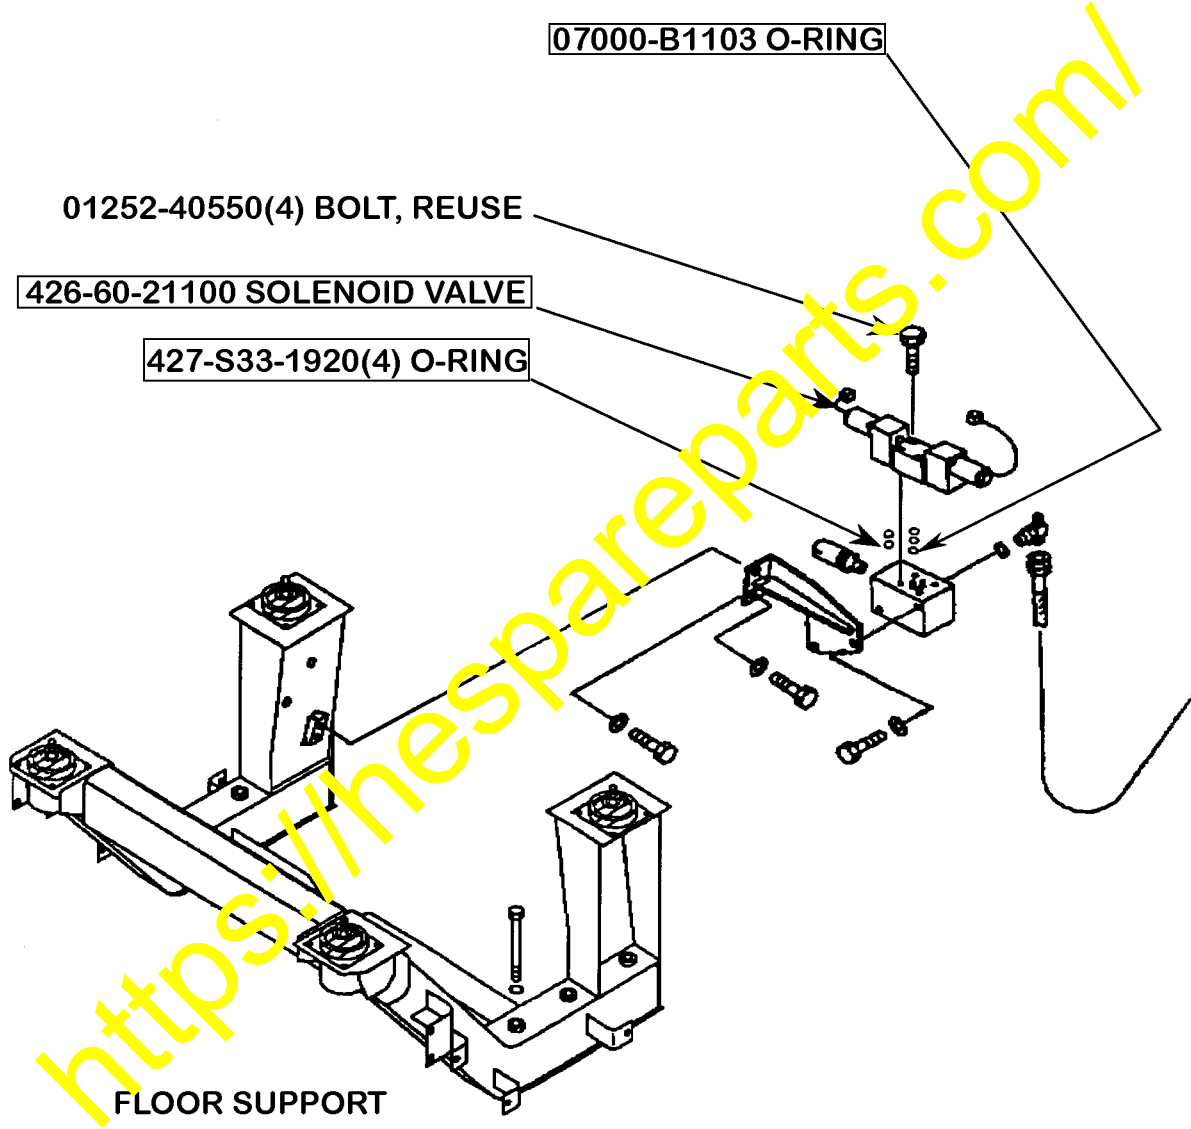
VLPS0092

THE FOLLOWING ILLUSTRATION IS FOR THE WA800-2, WA800-2L, WA800-2LC, WA900-1, WA900-1L, and WA900-1LC.

- a. Disassemble and remove the existing solenoid valve assembly (427-S33-1911).
- b. Install new solenoid valve (426-60-21100) using o-rings (427-S33-1920 and 07000-B1103) and bolts (01252-40550).

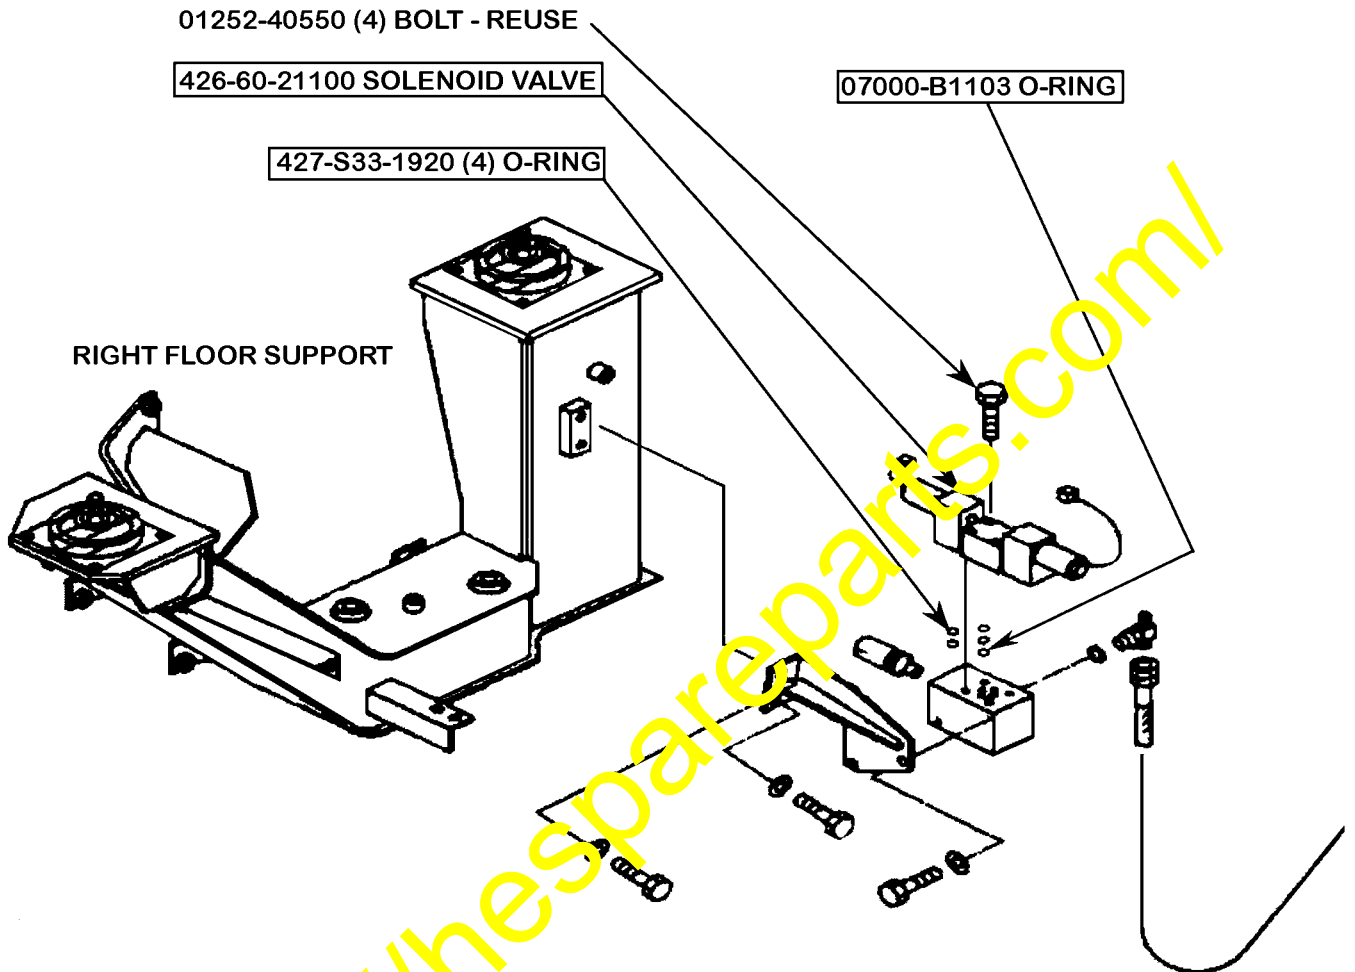
VLPS0067

THE FOLLOWING ILLUSTRATION IS FOR THE WA800-3, WA800-3LC, WA900-3, and WA900-3LC.

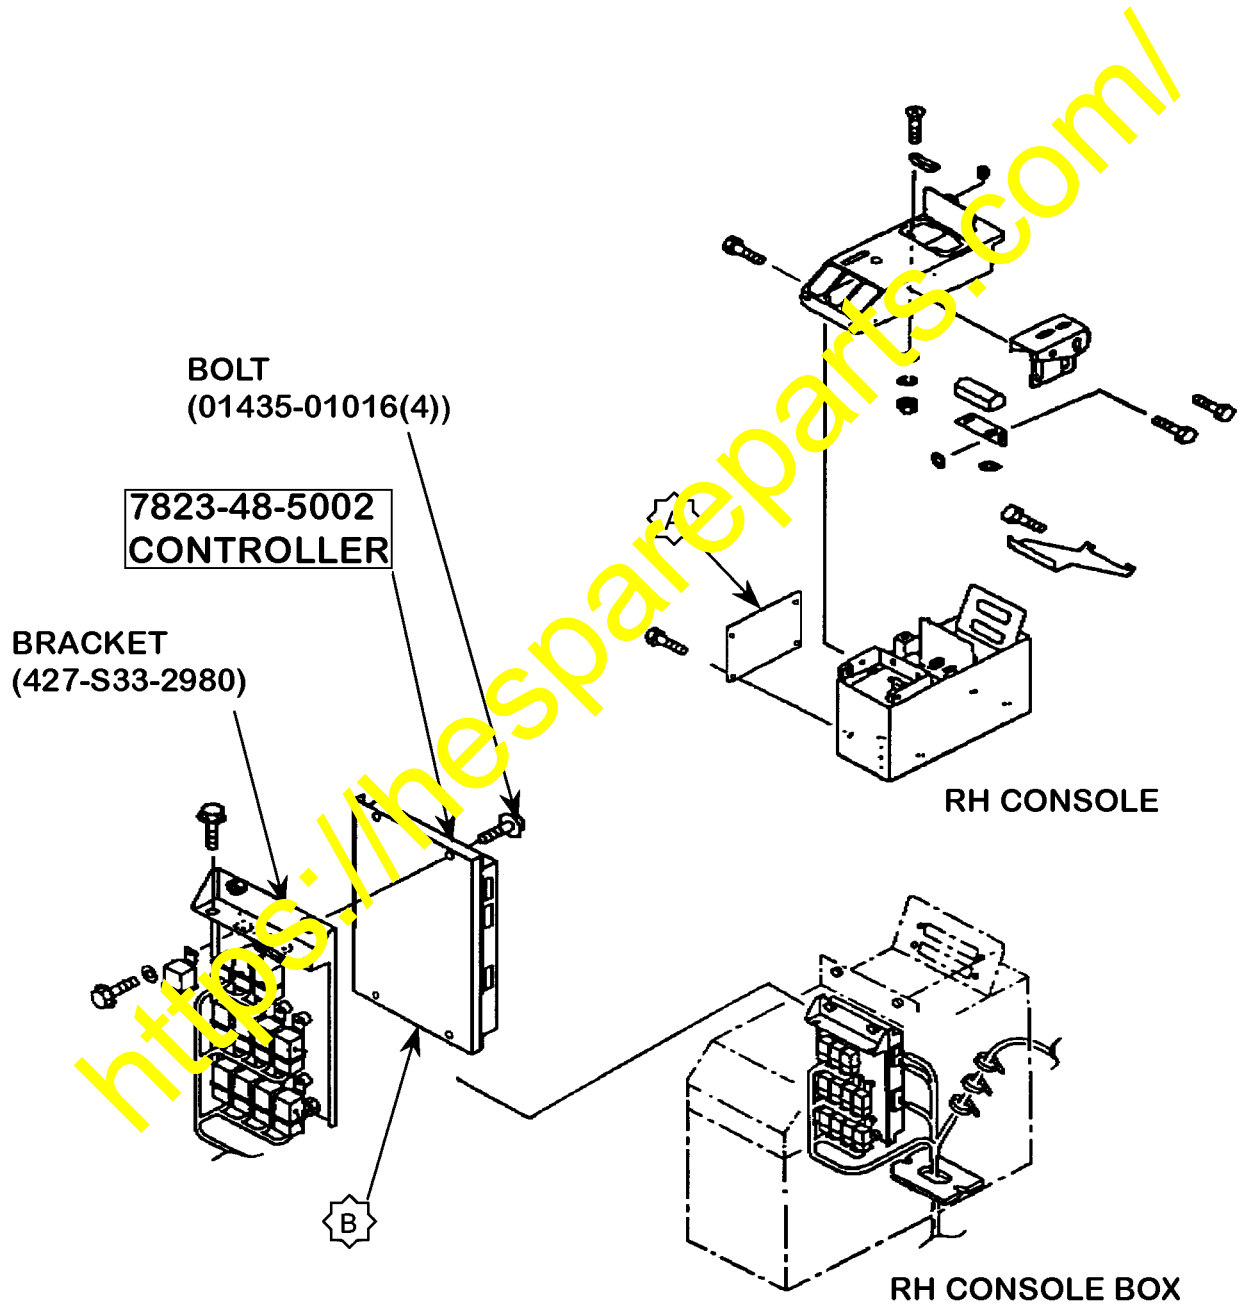
VLPS0093

THE FOLLOWING ILLUSTRATION IS FOR THE WA800-2, WA800-2L, WA800-2LC, WA900-1, WA900-1L, and WA900-1LC.

- a. Remove cover A from right console box in cab.
- b. Remove the existing controller (7823-18-1002) from bracket B in the right console box.
- c. Install the new controller (7823-18-1003). Use existing hardware.
- d. Install cover A to the right console box.

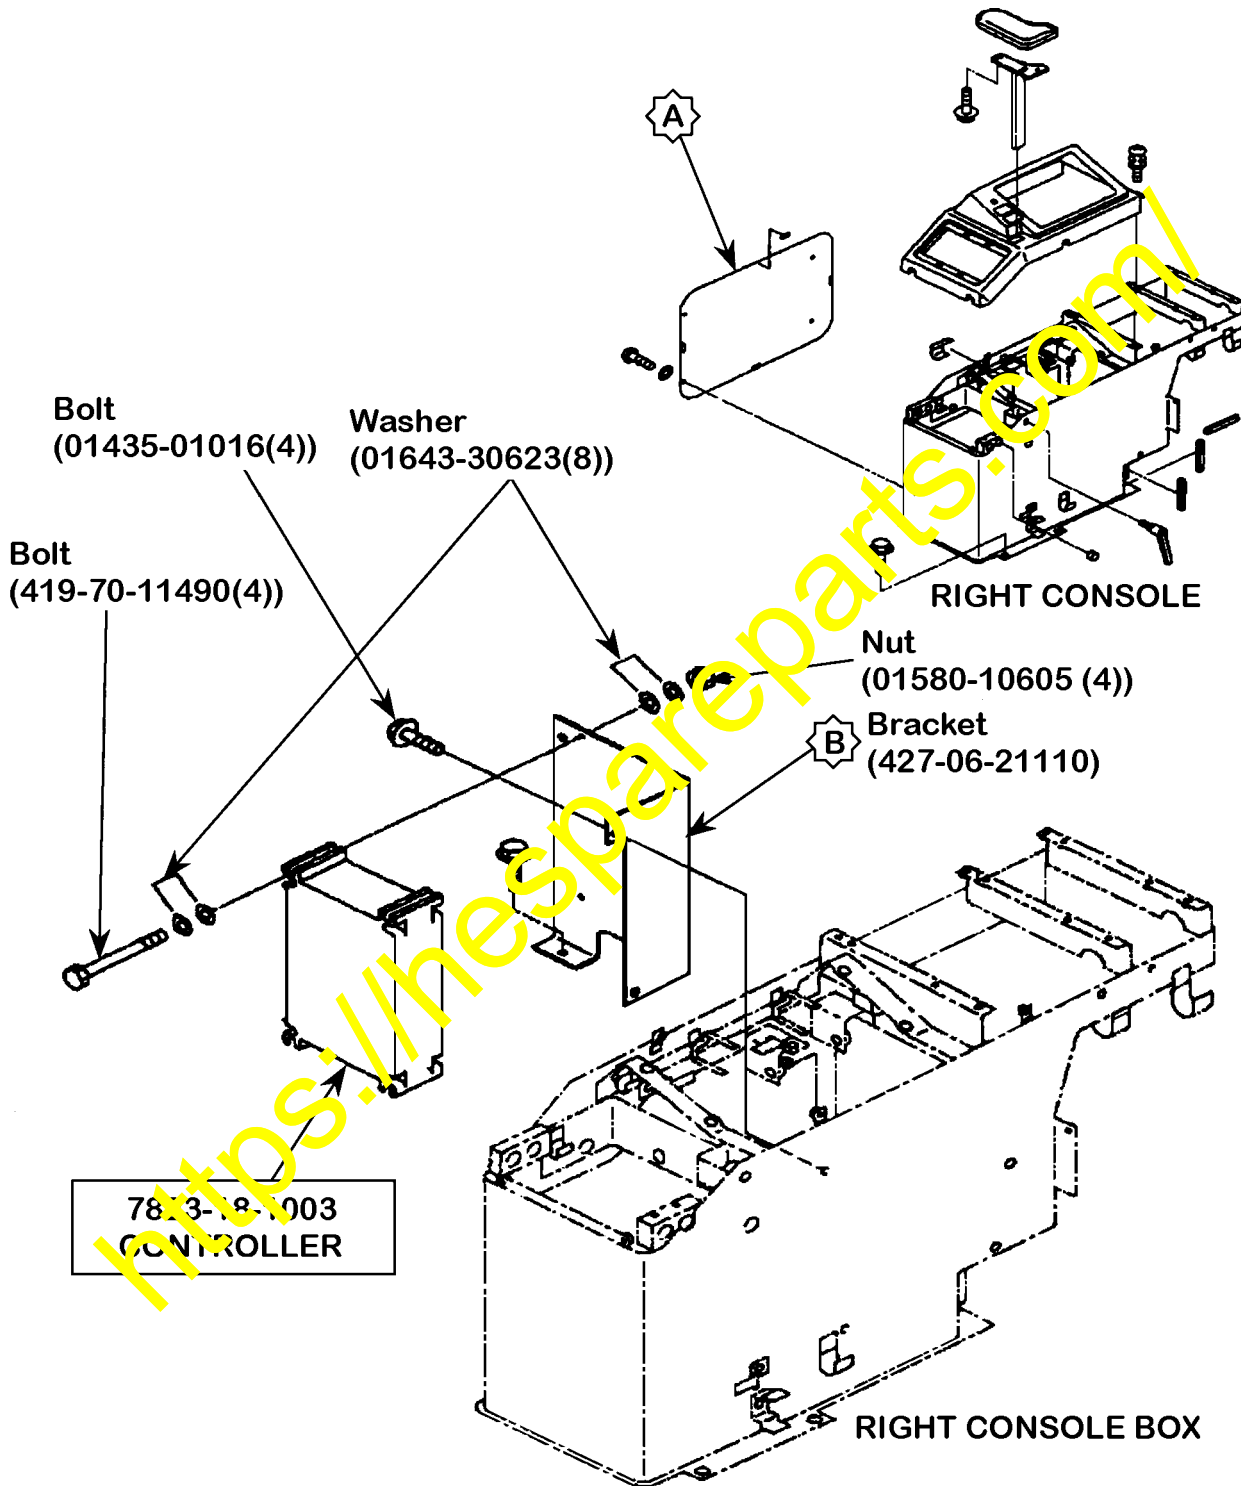
VLPS0068

THE FOLLOWING ILLUSTRATION IS FOR THE WA800-3, WA800-3LC, WA900-3, and WA900-3LC.
