# PARTS & SERVICE NEWS

REF NO. AA01016A

**SUBJECT:** INSPECTION OF SUN PINION GEARS

**APPLICATION:** Komatsu Mechanical Drive Dump Trucks:  
530M: A30001 thru A30038, 32628;  
HD1500-5: A30039 thru A30047

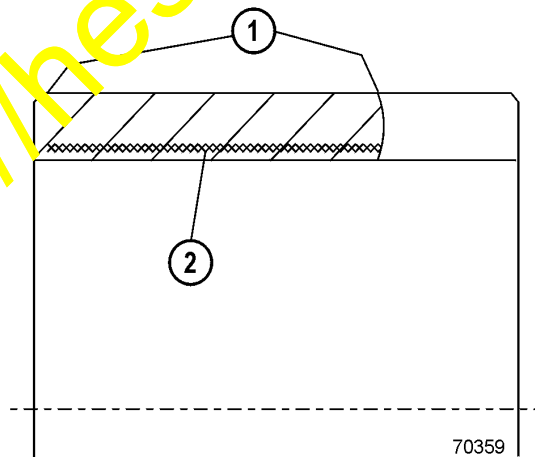
FIGURE 1. TOOTH PATTERNS

1. A wear pattern that extends less than 90% of the face width or is off center. See Item 1, Figure 1.
2. A line of hard contact near the root of the tooth with evidence of pitting or brinelling. See Item 2, Figure 1.

Gear part numbers 562-22-12420 and 562-22-12421 may have a tooth profile that could develop this undesirable wear pattern. A shortened life span and possible tooth breakage may result. The sun gear part number is normally stamped on the end of the gear. Other marks may be present.

1. Wear Pattern extends less than 90% of gear tooth width.
2. Pitting or brinelling near the base of the tooth.

If these wear patterns appear on the teeth of the sun pinion gear, it is recommended that the gear be replaced with sun pinion gear 562-22-12422. The mating planet gears and the internal ring gears from the planetary assemblies should also be inspected for unusual wear.
