PARTS & SERVICE NEWS

REF NO.	AA01053
DATE	February, 09, 2001

SUBJECT: BODY PIVOT CASTING

APPLICATION: Komatsu 930E Dump Trucks AFE48- A & up, A30019 & up

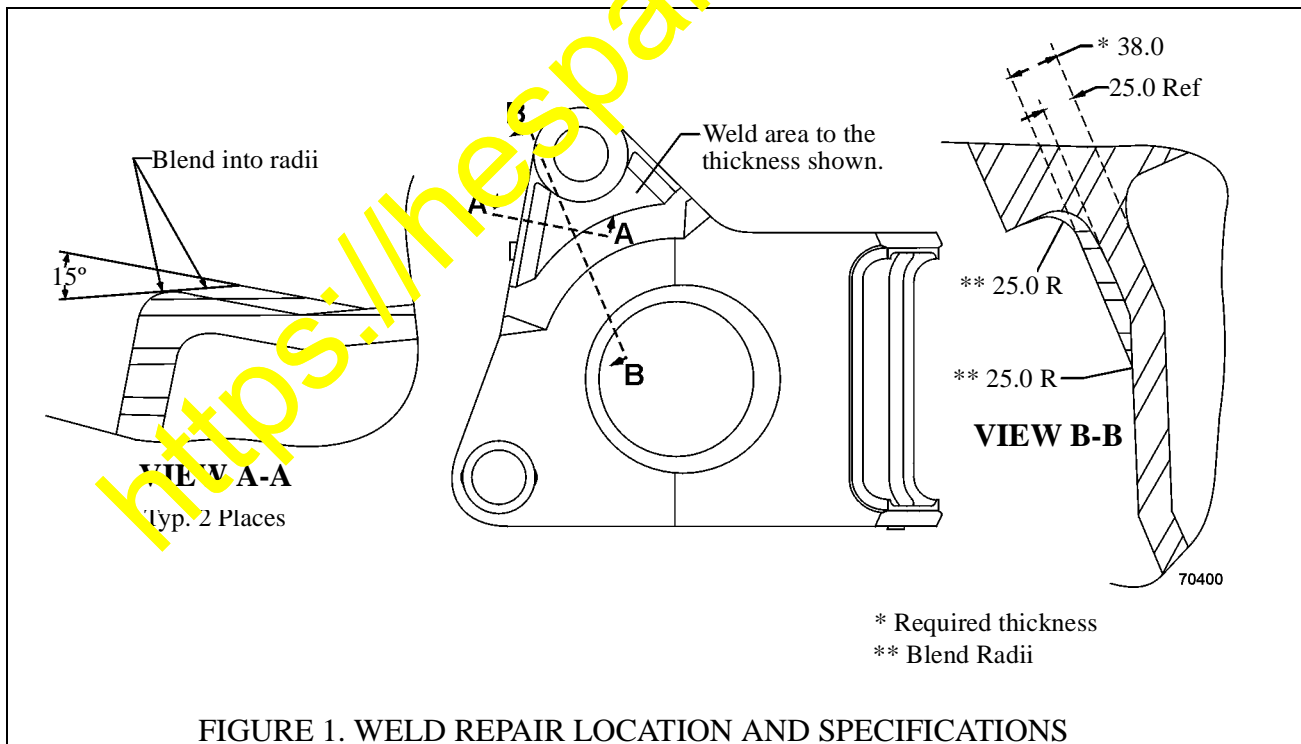
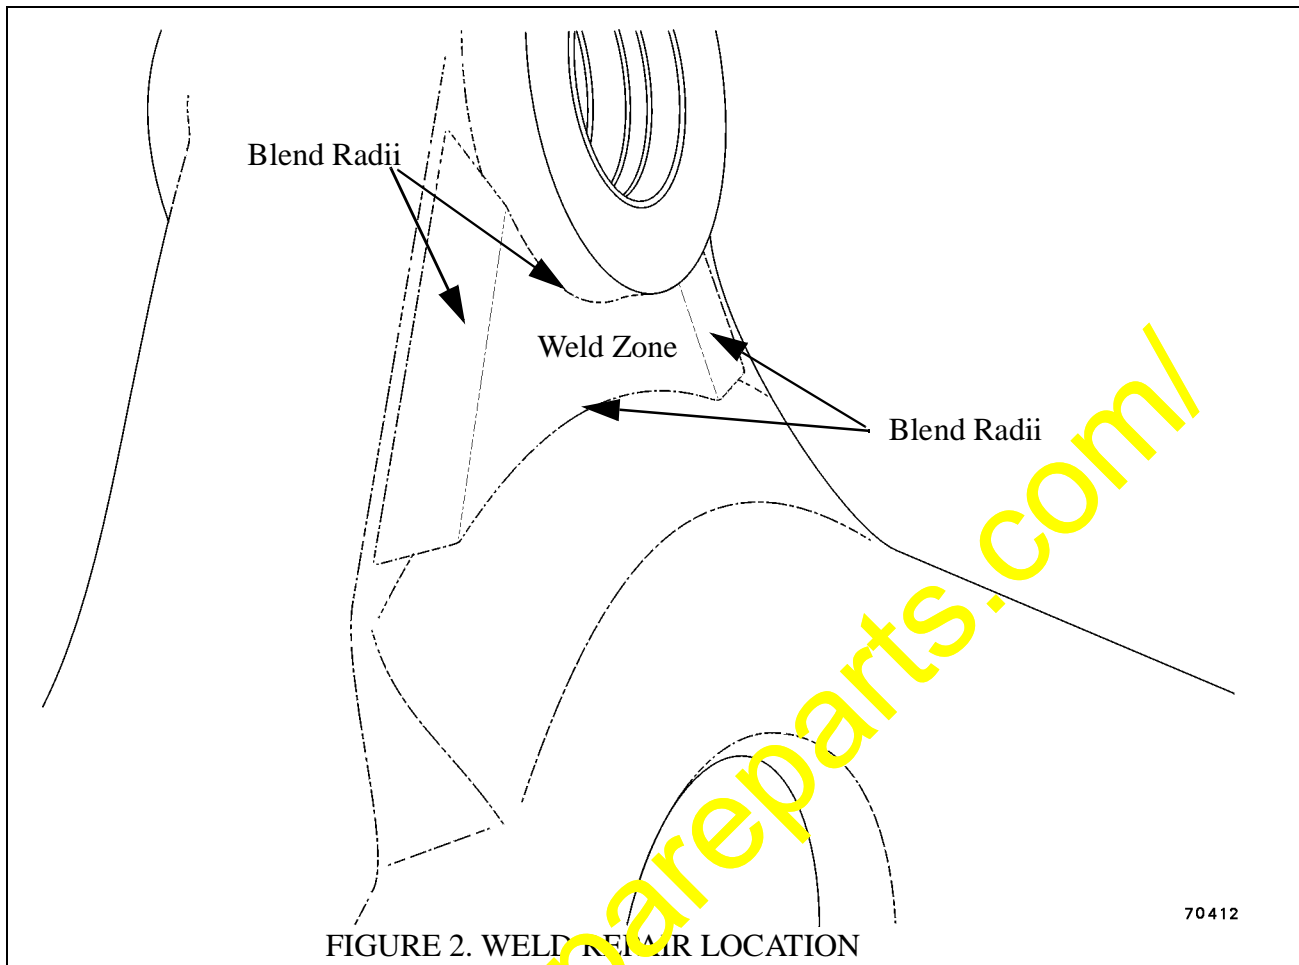
FIGURE 1. WELD REPAIR LOCATION AND SPECIFICATIONS

Some trucks in the field have experienced cracking near the rear body pivot castings due to thin casting walls. This approved procedure is intended to pad weld the walls of the castings in order to prevent further cracking in this area. Follow the proceeding instructions and specifications in order to repair the castings.

1. Inspect the entire welding area and remove any grease, paint, and foreign objects.

NOTE: Do not remove the pivot bushing from the bushing bore until the welding and inspection procedure is complete.

2. Pre-heat the welding area to 250° F (121° C).
3. Use E7018, 5/32 in. weld wire.
4. Weld the casting using small beads.
5. Hammer peen the weld with a 0.25 in. radius tool after each pass.
6. Post heat the weld area plus an additional 3in. (76.2 mm) to 1000° F (538° C).
7. Grind the toe of the weld in order to form a smooth transition with the casting.
8. Perform a magnetic particle inspection (MPI) on the welded area plus an additional 0.25 in. (6.35 mm). Repair any defects if necessary.
9. Replace the bushing in the body pivot bore.
