# PARTS & SERVICE NEWS

REF NO. AA01073

DATE April 9, 2001

- SUBJECT:** CRACKS IN 930E-1 FRONT WHEEL HUBS (EG7682) FOR 57 INCH TIRES AND RIMS
- PURPOSE:** To inform the field of possible modifications or replacements needed in the 930E-1 wheel hubs.
- APPLICATION:** Komatsu 930E Dump Trucks A30002 - A30097, A30099, A30101 - A30120
- FAILURE CODE:** 2A80HA
- DESCRIPTION:** Modification or replacement of cracked front wheel hubs (EG7682).

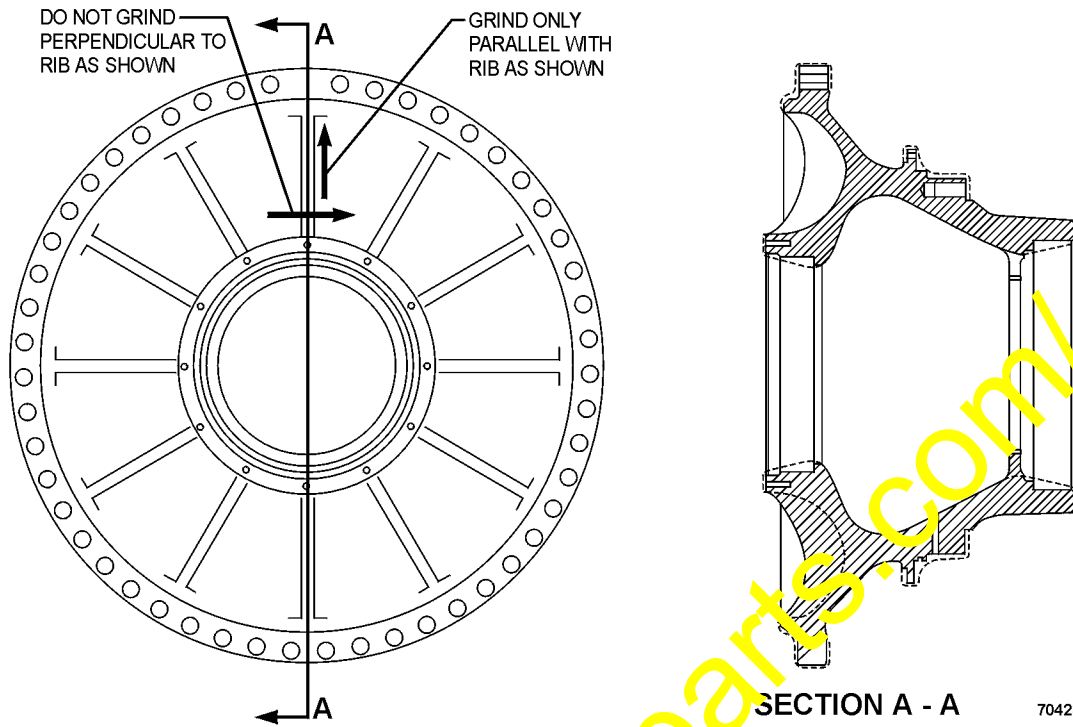
FIGURE 1. FRONT WHEEL HUB

Cracks have been reported in the ribs of some front wheel hubs (EG7682). This problem has not occurred on 930E-2 wheel hubs which uses a ribless design. Depending on the number of ribs that are cracked and on the depth of the cracks, it may be possible to repair a front wheel hub.

1. A crack in a rib is more than 1.0 inch (25.4 mm) deep.
2. Cracks are found in four or more ribs.
3. A crack is found in a location other than a rib.

Cracks that are deeper than 0.5 inch (12.7 mm) may not be repaired. If a crack increases to 1.0 inch (25.4 mm) in depth, the hub must be replaced. For further grinding instructions, refer to Figure 1.

If cracks are found in fewer than four ribs, it may be possible to remove the cracks by grinding or by other mechanical means. No thermal process such as arc welding or torch cutting is permissible. It is permissible to remove a crack up to, but not exceeding 0.5 inch (12.7 mm) in depth by mechanical means. The crack may be ground out of the rib, thereby removing up to 0.5 inch (12.7 mm) of the rib.

*If cracks are removed by grinding, the direction of grinding should be radial, along the length of the rib, and must not be transverse, across the rib.*
