PARTS & SERVICE NEWS

REF NO.	AA01104
DATE	May 21, 2001

SUBJECT: 730E FRAME REPAIR AND INSPECTION

APPLICATION: Komatsu 730E Dump Trucks AFE47 & Up, A30079 & Up

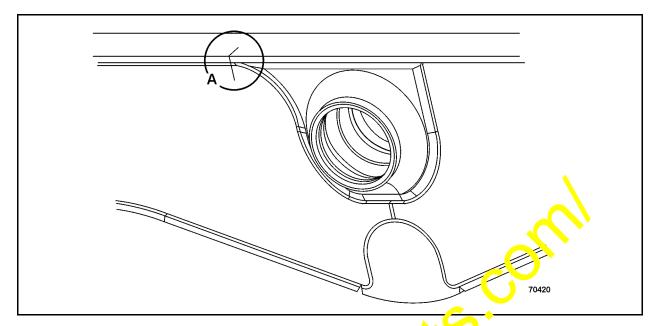
FIGURE 1. DRIVE TUBE CASTING

An evaluation of 730E dump trucks in service has revealed cracks in the area of the frame that is in front of the drive tube casting. Inspect the area in front of the drive tube casting for cracks in the frame.

Due to the location of the cracks (A, Figure 1), field repairs in this area (27.0) difficult to complete. A typical crack is found on the inside of the frame where corner joint backer bar (1, Figure 2) connects with top bar (2) and casting (3).

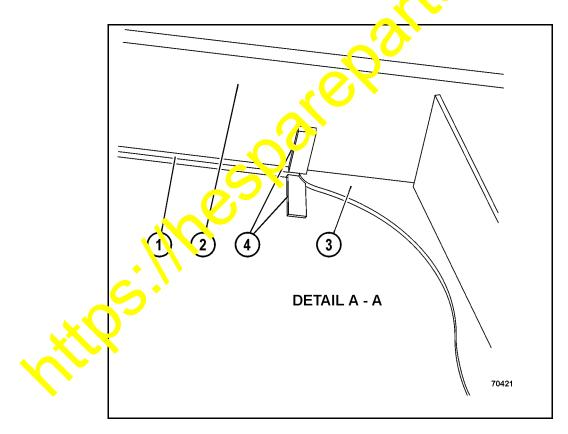
FIGURE 2. INSIDE VIEW OF THE FRAME RAIL

- 1. Corner joint backer bar (.5 x .5 inch)
- 2. Top Bar

- 3. Casting
- 4. Backer bar (1.25 x 1.25 inch)

If required, backing bars may be welded to the drive tube casting in order to provide greater strength. The (1.25 x 1.25 inch) ASTM A36 / UNS K02600 backer bars (4) need to be beveled and welded 100% to casting (3). The backer bars (4) should be used to backer bars in the parent metal, and to connect existing corner joint backer bar (1) up to casting (3)

Use caution when welding a crack or when yelding the backer bars. It is important that the welder is aware that a crack may be adjacent to the casting internally.
