PARTS & SERVICE NEWS

REF NO.	AA01164
DATE	August 29, 2001

SUBJECT: CAB WINDSHIELD REPLACEMENT

PURPOSE: Add brackets to cab that reinforce window mounting to cab

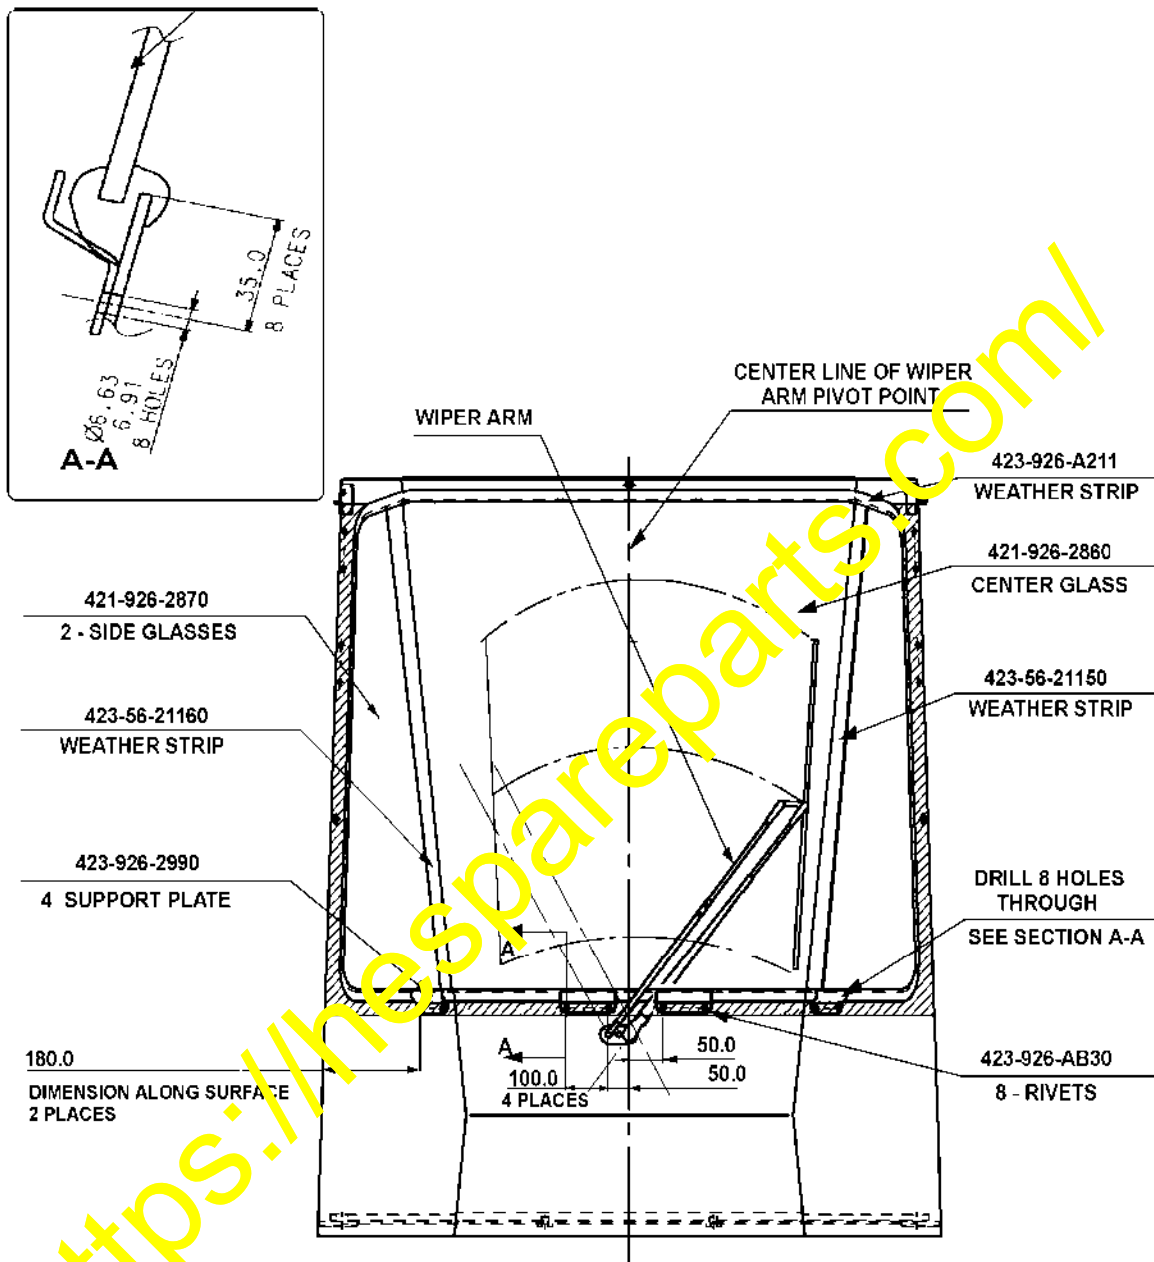
Front Glass Supports

Some of the units listed above have been found to have the windshield fall out. The cause has been determined that the cab metal thickness is insufficient for the groove of the rubber seal. This Parts and Service News Letter provides instructions to correct this problem by adding (4) brackets to the cab that support the windshield.

The following instructions show the procedure for reworking the front of the cab.

Reinstall the glass and weather strips using Threebond 5211 or equivalent
