PARTS & SERVICE NEWS

REF NO.	AA01169A	
DATE	October 2, 2001	
(C)	Page 1 of 5

SUBJECT: BRAKE CHAMBER OVER-STROKING DURING INITIAL BRAKE

APPLICATION AFTER A COLD START

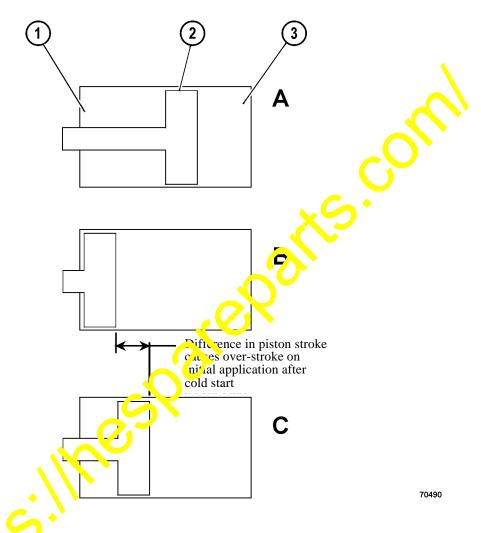
FIGURE 1. BRAKE PISTON POSITIONING

During dormant periods, air pressure in the tarks will gradually be depleted. When the air pressure drops to approximately 3 kg/cm² (45 psi), the rear brakes will apply automatically. This function is a normal safety feature of the truck. After this has coursed the positioning of the brake piston should be similar to that in view (A, Figure 1).

When the truck is started, the traile cooling oil is pressurized, and the oil pressure in the rear brake housing will return the brake piston to its normal brake "OFF" piston position. Refer to view (C).

- 1. Slack Augusta/Brake Chamber Side
- 2. Brale Piston
- 3. Br. ke Disc Side

- A. After 48 hours truck not in operation / Piston in normal "APPLY" position
- B. Cold start position
- C. Normal brake "RELEASE" position

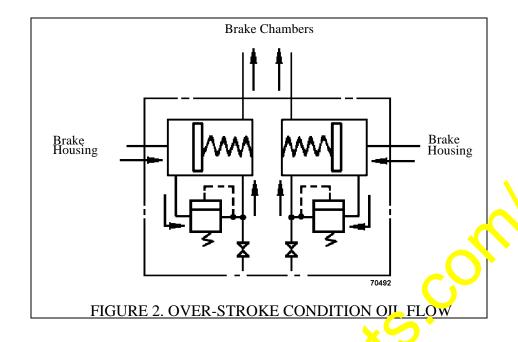
At lower temperatures, the cooling oil's increased viscosity will cause higher pressures in the rear axle until the oil has been reacted during circulation. During cold start-up, the increased cooling oil pressure will unseat the check valve in the slack adjuster. Refer to Figure 2. This creates a path for oil flow, and enables the brace pictor to be pushed away from the friction discs to a position further than its normal position. Perfect to view (B, Figure 1). Only at low temperatures does the cooling oil have the viscosity to cause pressures that are able to unseat the check valve.
