# PARTS & SERVICE NEWS

REF NO. AA01180

**SUBJECT:** HEAD GASKET UPDATE

**APPLICATION:** WA500-1LE Wheel Loader Serial Number A61001 and up  
WA500-3L Wheel Loader Serial Number A71001 and up

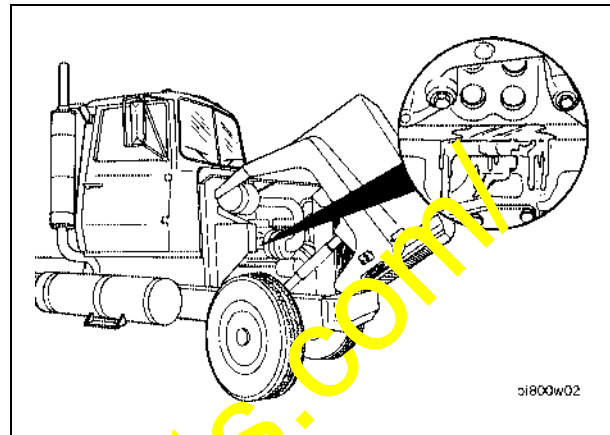
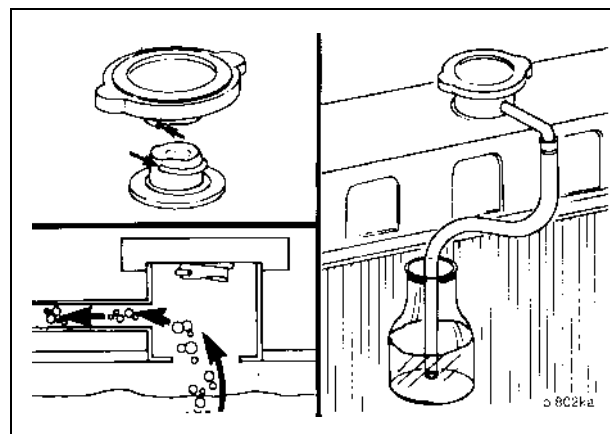
- Initial Check, Procedure 008-019
- Leak Test. Procedure 008-019, complete the following test in accordance with the manual:
  - Fan shutter or heater air control valve
  - Air compressor
  - Aftercooler core
  - Cylinder head and cylinder liner.

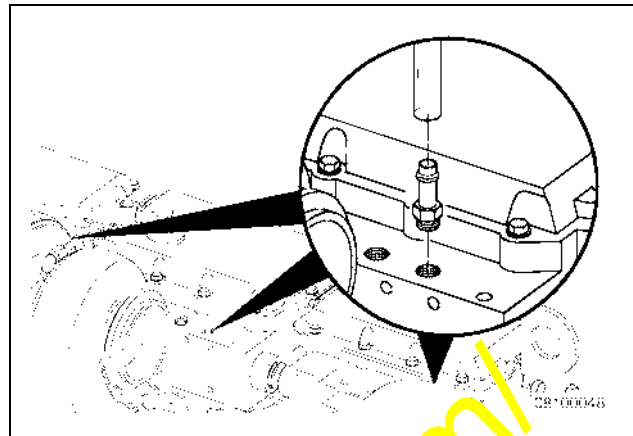
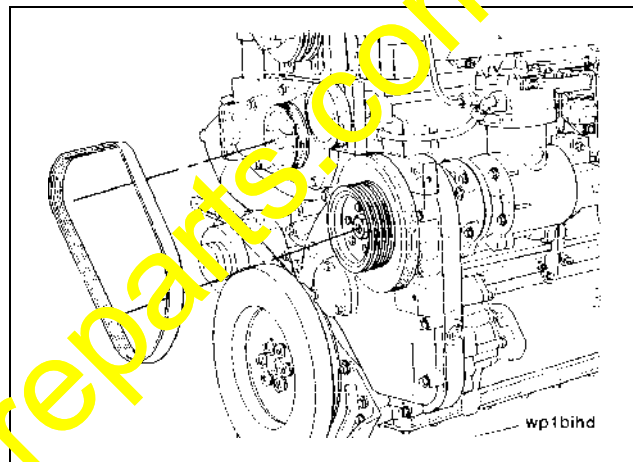
Run the engine, and inspect for the presence of bubbles "percolating" from the pipe nipples or in the clear tubing if used.

The presence of bubbles indicates a combustion leak. Repair the combustion leak in accordance with Combustion Leak Repair Procedure in the document.

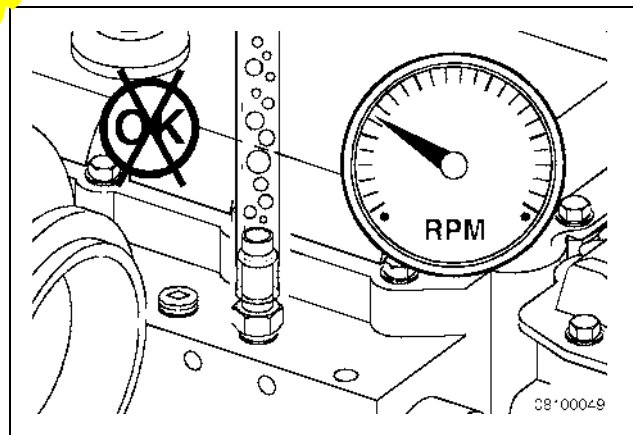
NOTE: Combustion leaks occur almost exclusively between adjacent cylinders under a shared head (i.e, directly between cylinders 5 and 6).

- Grommets for bolt holes, one and/or two will be burnt. The grommets will either be completely missing or will be partially missing, with the remainder being brittle or crumbly.
- A darkened area that appears to be burnt across the top surface of the gasket between bolt holes.

Remove the cylinder head(s) with the leaking gasket. Refer to procedure in the Troubleshooting and Repair manual, N14 Series Engine. Bulletin 3666142.

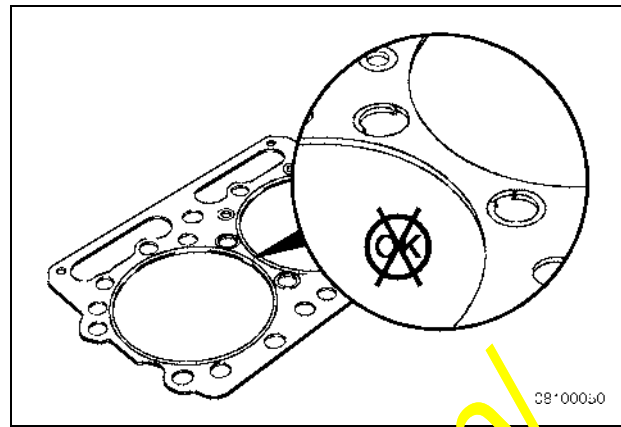
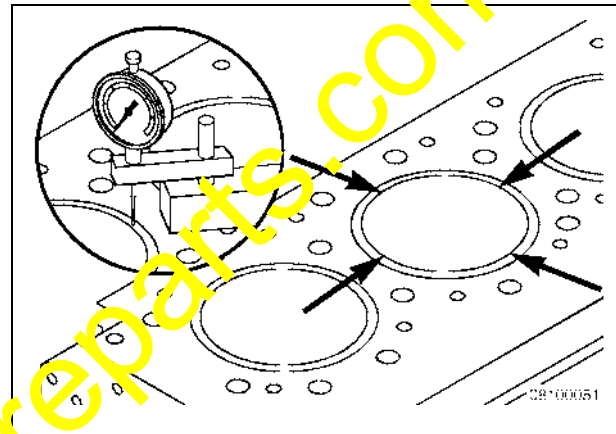
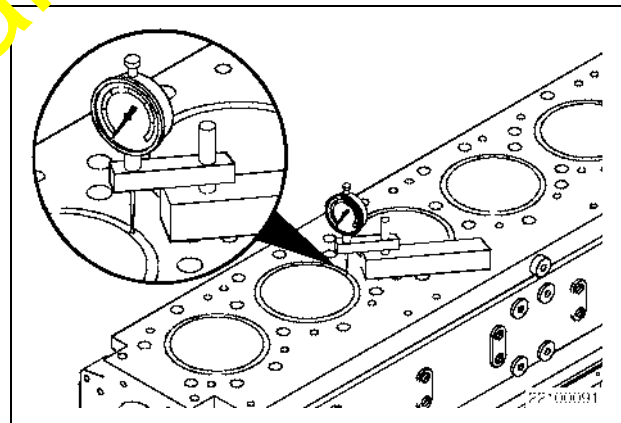
It is necessary to examine the liner protrusion for both liners under a gasket with a chamber leak. Liner inspection/repair is the key to reducing the probability of repeat combustion leak. Accurately measure the liner protrusion. The liner protrusion will be measured for all the liners exposed after the cylinder head has been removed.

- Overall protrusion to be within 0.102 to 0.178 mm [0.004 to 0.007 in]
- No more than 0.025-mm [0.001-in] protrusion variation around a liner
- No more than 0.025-mm[0.001-in] protrusion variation between adjacent liners under a shared cylinder head (1-2, 3-4, 5-6).

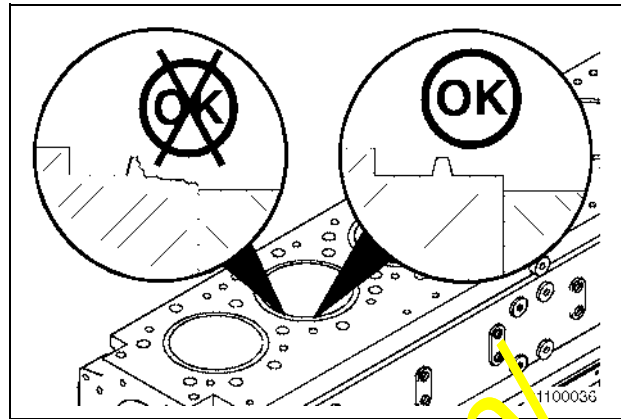
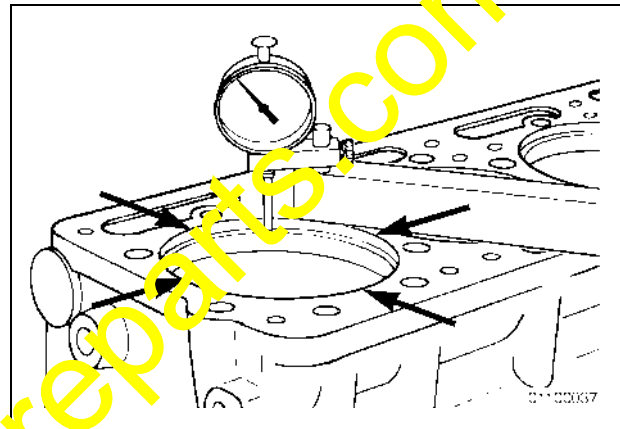
Examine the top surface of the liner flange for evidence of erosion damage to the fire bead. Inspect the polishing or erosion on the liner flange and/or damage or wear to the fire bead. NOTE: If any protrusion measures out of specification or if either liner is eroded, worn or damaged, then both liners under a shared cylinder head will have to be removed to perform an effective repair.

Liner protrusion measurements that are out of specification can indicate a problem with the block counterbores. Inspect the block counterbores. Refer to Procedure in the Troubleshooting and Repair Manual, N14 Series Engines, Bulletin 3666142. Most counterbores do not need to be machined. A good repair can be completed by appropriately shimming the liners.

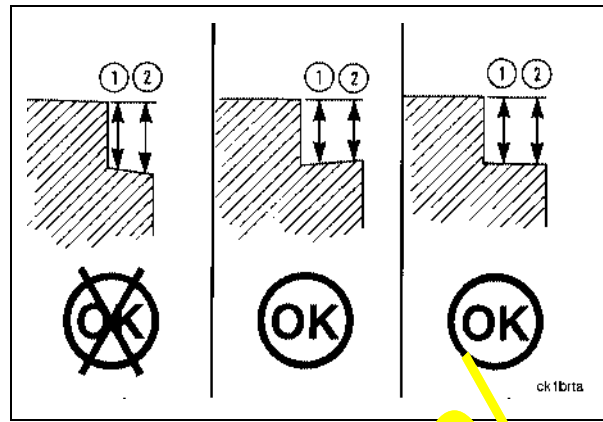
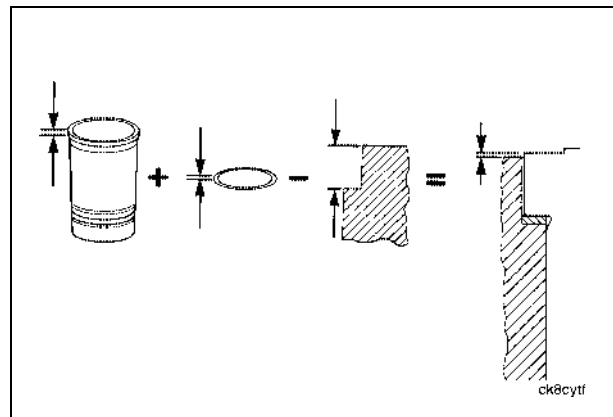
- Overall counterbore depth **must** be 9.398mm[0.370] in.
- Depth variation around any counterbore **must not** be greater than 0.0254 mm [0.001 in].
- Depth variation between counterbore pairs under a shared cylinder head (for example, one and two, three and four, or five and six) **must not** be than 0.0254 mm [0.001 in].
- The outer diameter depth **must never** be less than the inner diameter depth. The outer diameter depth must not be over 0.0254 mm [0.001 in] greater than the inner diameter depth.

Replace both liners under the head gasket that failed. Make certain that the new liners meet the following protrusion specifications (shims as required):

- Overall protrusion will be within 0.102 to 0.178 mm [0.004 to 0.007 in]
- No more than 0.025-mm [0.001-in] protrusion variation around a liner
- No more than 0.025-mm [0.001-in] protrusion variation between adjacent liners under a shared cylinder head.
