PARTS & SERVICE NEWS

REF NO. |AA01247

SUBJECT: RUBBER COMPENSATOR AT THE OIL SUCTION RESERVOIR

APPLICATION: H285S Hydraulic Shovel, S/N 78076, 78083, 78097, 78104, 78110, 78111, 78113, 78120, 78124, 78134, 78139

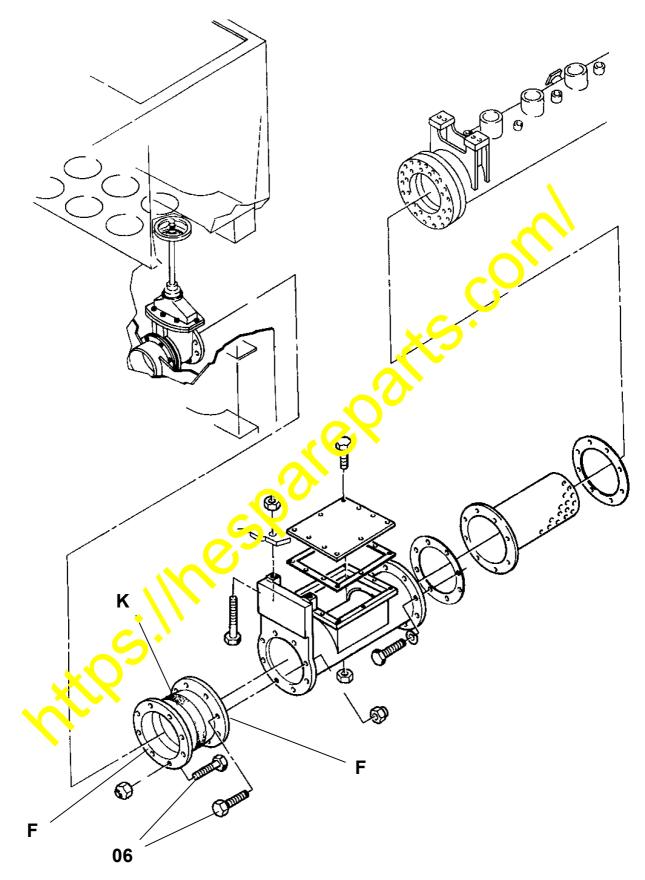
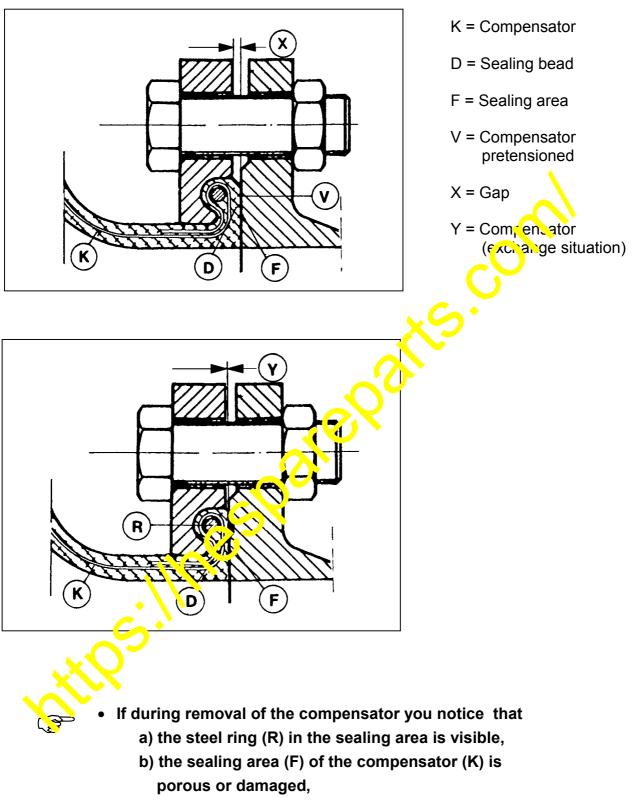
Drawing as example

- Carefully clean sealing area ("F") of the compensator ("K") and he opposite flanges.
- Tightening torque of bolts (06)
- When mounting a new compensator or rubber below, 50×90 Nm.
- Do not tighten the flange connection too much, so the metal-to-metal contact would result. This would damage the rubber bead.
- Assure equal "X" dimension at the circumference of flanges.
- While tightening the bolt (06), illustration "A", to not damage the rubber below with the spanner.
- Tighten the screw connection always on the opposite side of the compensator. *The bolt/nut on the compensator side must not be turned.*

• During repairs or maintenance (without exchange of the compensator and rubber below respectfully), depending on the age hardening of the rubber material, tighten the bolts with at least 90 Nm. After putting the machine in service, check compensator for leaks and, if necessary, retighten the bolts (06) a little bit.
