PARTS & SERVICE NEWS

REF NO.	AA01250		
DATE	Dec. 13, 2001

SUBJECT: REPAIR PROCEDURE OF CAB DOOR

APPLICATION: GD555-3C Motor Graders, S/N 50002 thru 50008, 50010 thru 50029

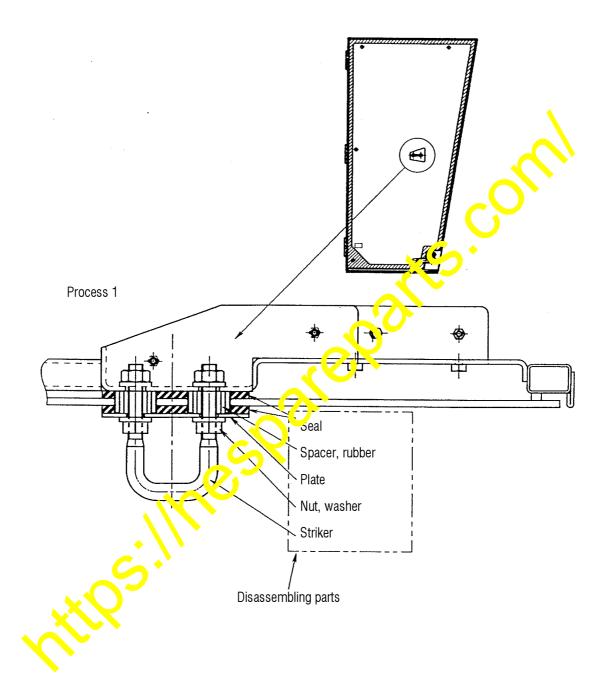
- 3. Modification procedure
- 3-1. Modification procedure of the door frame (1/3)
 - (1) Referring to the Process 1, disassemble the parts of the striker section of the LH and RH doors.

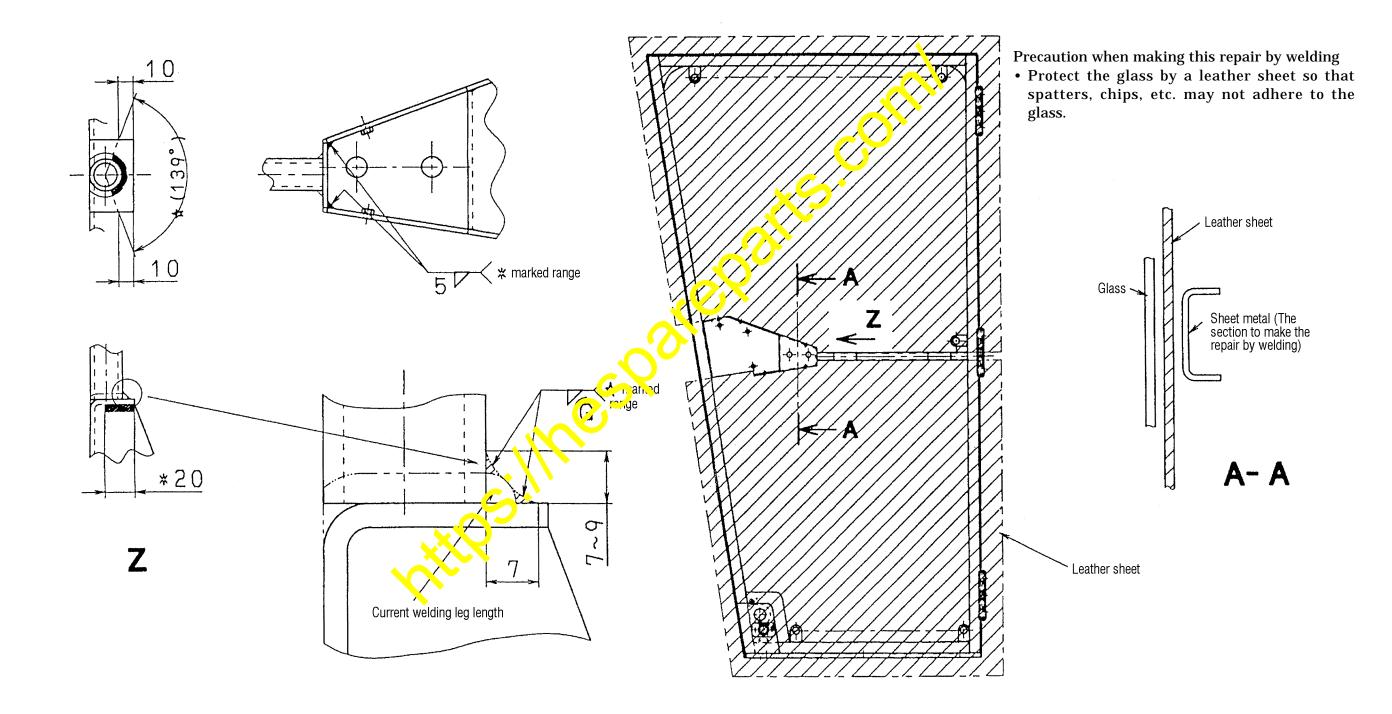
Process 2: Repair procedure of the door frame by welding
This drawing shows the repair procedure of the LH door frame by welding.
Make repair of the RH door frame in the similar way.

- 3-1. Modification procedure of the door frame (2/3)
- (2) Referring to the Process 2, make repair of the LH and RH door frame by welding.

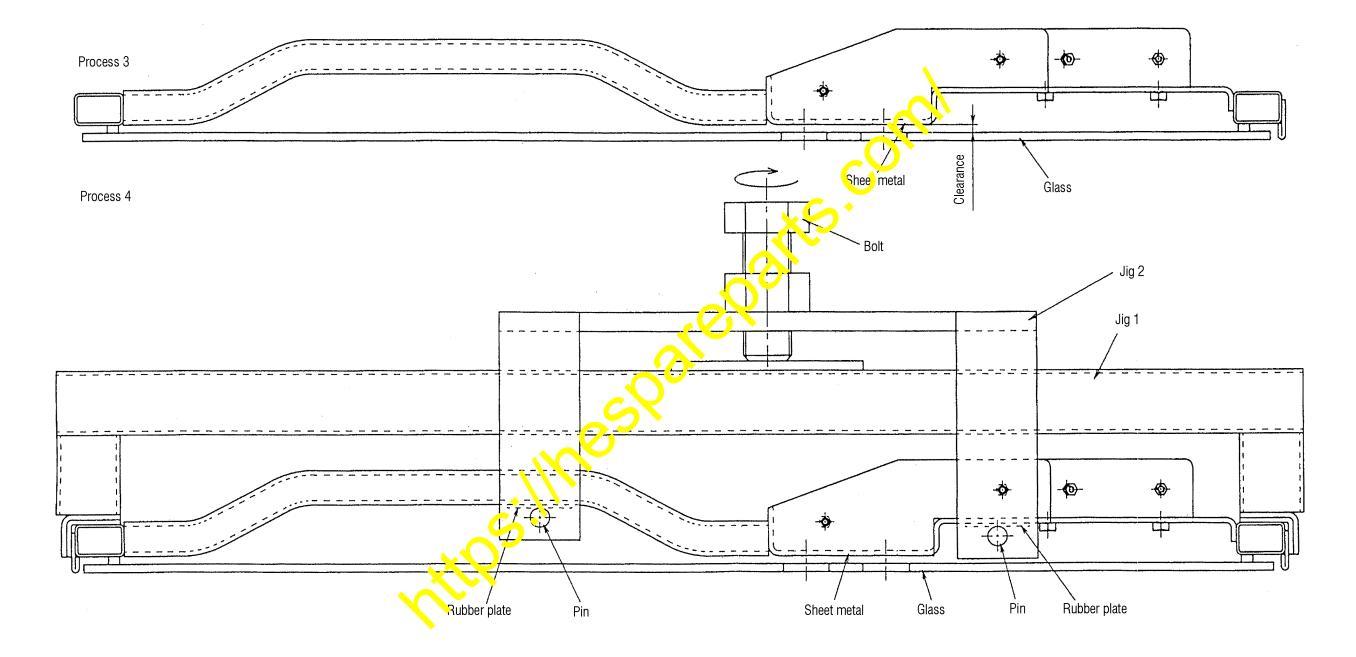
- 3-1. Modification procedure of the door frame (3/3)
 - (3) Referring to the Process 3, check the clearance between the glass and the sheet metal.
 - It is OK if the clearance between the glass and the sheet metal is 5-6 mm.
 - If the clearance between the glass and the sheet metal is less than 5mm, correct the clearance to 5-6 mm referring to the Process 4

- Set the jig 1 and the jig 2 according to the position indicated in the above drawing.
- Turning the bolt clockwise, increase the clearance between the glass and the sheet metal. Standard when increasing the clearance: Increase the clearance by about 6 mm more from the present clearance between the glass and the sheet metal and return the bolt. Then, the final clearance shall increase by about 1 mm.
- (4) Carry out correction painting of the section where the repair by welding was made.

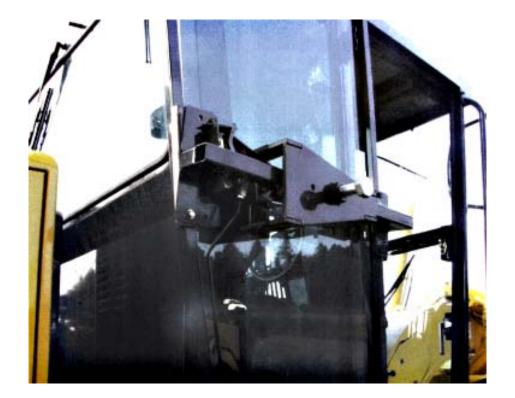
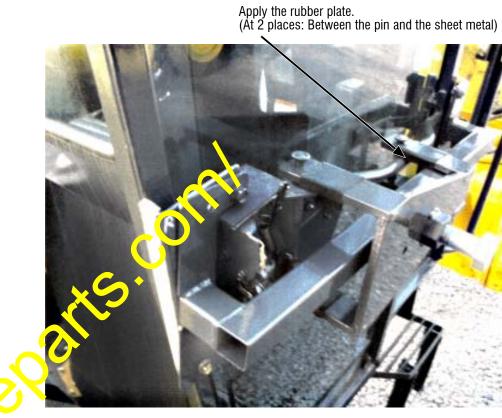
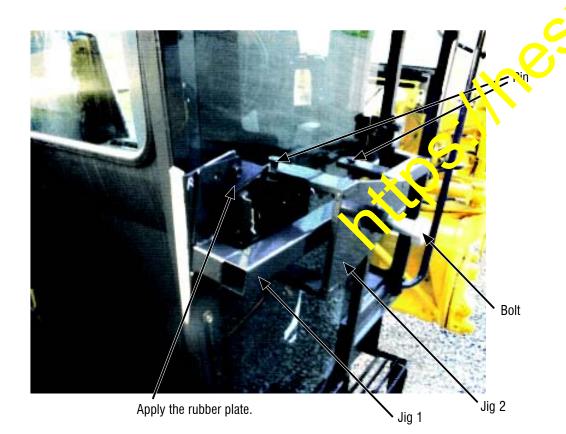
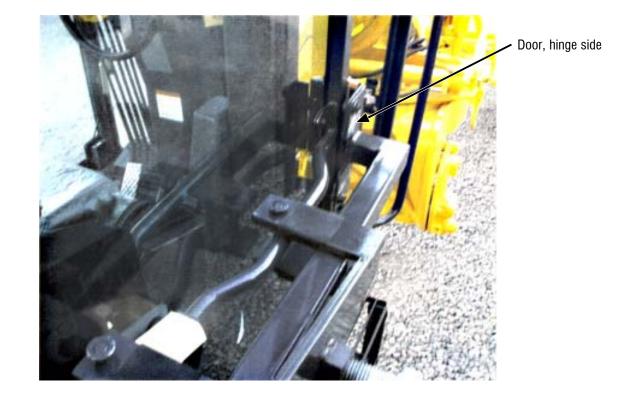
Photograph of the installed status of the jig to correct the clearance between the glass and the frame (sheet metal)

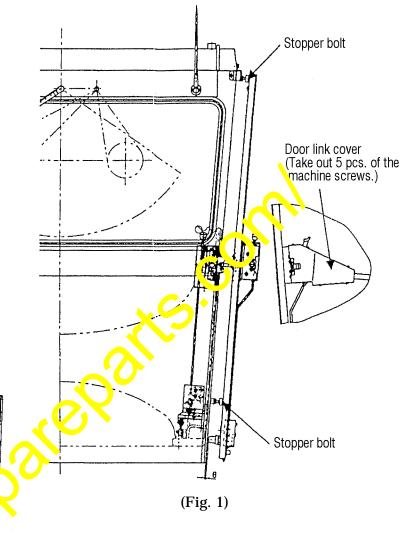
- Mount the striker without inclination to the LH side or to the RH side. (Refer to Fig. 4.)
- Confirm if the striker and the case of the lock are not rubbing. (Refer to Fig. 4.)

- 3-3. Modification procedure of the stopper bolt
- (1) Disassemble the stopper bolt. (4pcs. on the LH, RH, upper and lower sides)
- (2) Set the door strike section to the lock section of the cab body.
- (3) Confirm if the striker and the lock are concentric. (Refer to Fig. 3.)

- (5) If the striker is not being set concentrically to the lock, disassemble the door link cover and shift the striker up and down to set it concentrically to the lock. (Refer to Fig. 1 and Fig. 3.)
