# PARTS & SERVICE NEWS

REF NO.	AA02091
DATE	March 26, 2002

**SUBJECT:** BACKUP ALARM AND REAR LIGHT FAILURES

**APPLICATION:** Komatsu Wheel Loaders  
WA800-3LC A50001 & Up;  
WA900-3LC A50001 & Up

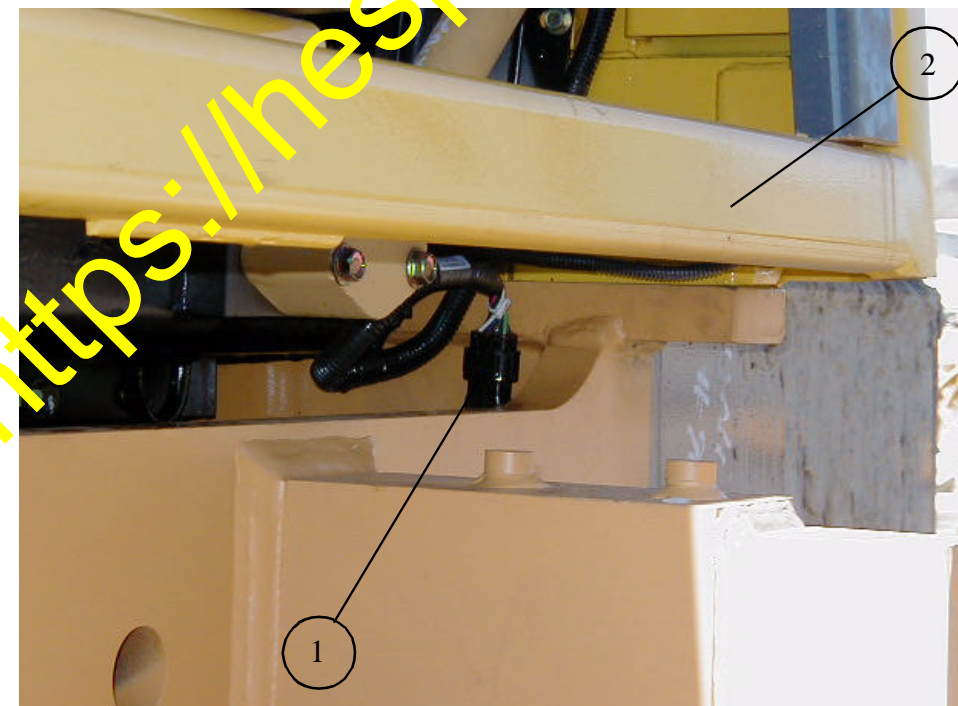
FIGURE 1. GR1 CONNECTOR LOCATION

Some wheel loaders in the field may develop a corrosion problem with the GR1 connector in the rear frame wiring harness. The corrosion can be attributed to water intrusion due to the location and orientation of the mounting clip for the harness. Common symptoms of this problem include failure of the backup alarm and rear lights.

1. Remove GR1 connector (1, Figure 1) from the existing wire clip and position the harnesses and connectors out of the way. The connector is located on the RH side of the machine near the front of the engine, below the radiator guard.
2. Inspect the GR1 connector terminals for corrosion. Clean or repair the terminals as necessary.
3. Remove clip (2, Figure 2) from the frame.
