PARTS & SERVICE NEWS

REF NO. | AA02116

SUBJECT: IMPROVED FRONT WHEEL HUB

APPLICATION: Komatsu Mechanical Drive Dump Trucks: 530M: AFP49-A thru Y, A30001 thru A30038; HD1500-5: A30039 thru A30059

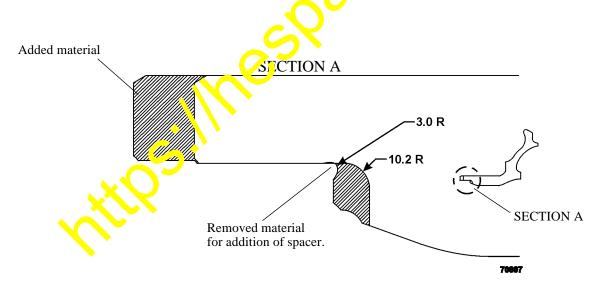
FIGURE 1. CHANGES TO WHEEL HUB

Some trucks in the field that operate under extreme conditions and heavy loads may experience front hub damage near the outer race of the inner bearing. Damage may come in the form of inner bearing failures or hub cracking. Oil leakage in the inner hub and front brake assembly an indicate such problems have occurred.

New hub (EJ9605) has been developed to replace previous hubs (EJ9580 & EJ9612). The new hub is manufactured from stronger material and visible changer to the shape of the hub have been made. The hub contains more material near the inner bearing housing a well as a machined groove for the installation of bearing spacer (884-06-38144). These modifications contribute to a stronger, more reliable wheel hub.
