PARTS & SERVICE NEWS

REF NO.	AA02169
DATE	July 16, 2002

SUBJECT: WELD JOINT CRACKING AT REAR ENGINE MOUNTS

APPLICATION: Komatsu 930E Dump Trucks AFE48-A & Up, A30019, A30026 thru A30120

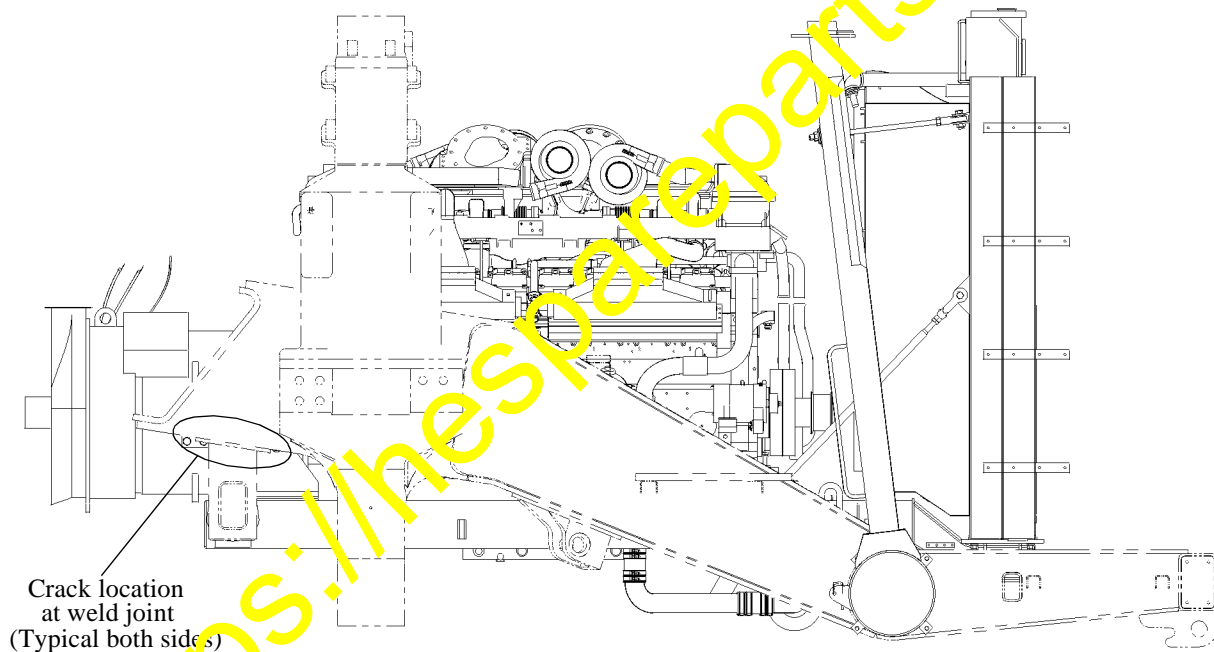
Some trucks in the field may experience cracking at the rear engine mount to frame rail weld joints. Refer to Figure 1. Carefully inspect each mount for cracking at the weld joint. Ensure a thorough inspection of these areas are performed during normal frame inspections at regular intervals.

FIGURE 1. ENGINE MOUNT CRACK LOCATION

If cracks are found in the specified area, the frame must be repaired, accordingly. Follow the guidelines that are outlined in Parts and Service News, "FIELD WELDING FOR ASSEMBLY OR REPAIR" (AA00046B). For additional welding guidelines, refer to Welding I (SEBF40001) and Welding II (SEBF15002).

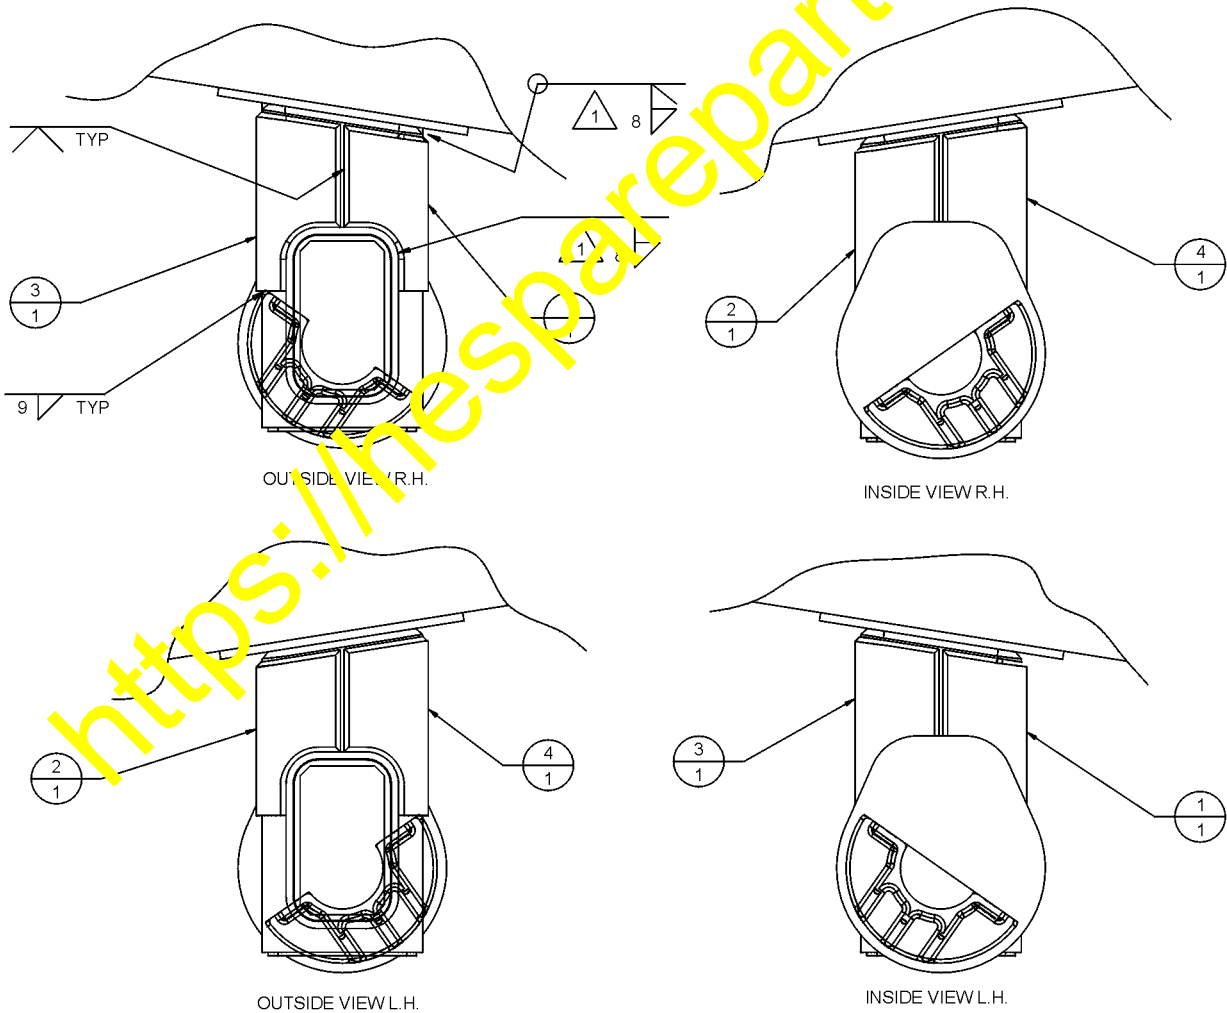
FIGURE 2. REAR ENGINE MOUNT REINFORCEMENT

Engine Mount Reinforcement Kit (MK4027) has been developed to reinforce the rear engine mounts. Contents of the kit are listed in Table 1. Welding specifications and component locations are shown in Figure 2, and on drawing (EH5509) included in the kit. Each kit contains the necessary parts to reinforce both rear engine mounts.
