PARTS & SERVICE NEWS

REF NO.	AA02227
DATE	Mar. 4, 2003

SUBJECT: REPAIR PROCEDURE FOR DAMAGED ENGINE AND TRANSMISSION MOUNT CUSHIONS

APPLICATION: WR11-3 Reach Loader, S/n 53001 thru 53127
 WA100-3 Wheel Loader, S/N 53001 thru 55285 and 63001 thru 64099
 WA120-3 Wheel Loader, S/N 53001 thru 54036
 WA120-3L Wheel Loader, S/N A30001 and up
 WA120-3MC Wheel Loader, S/N A31001 thru A31061

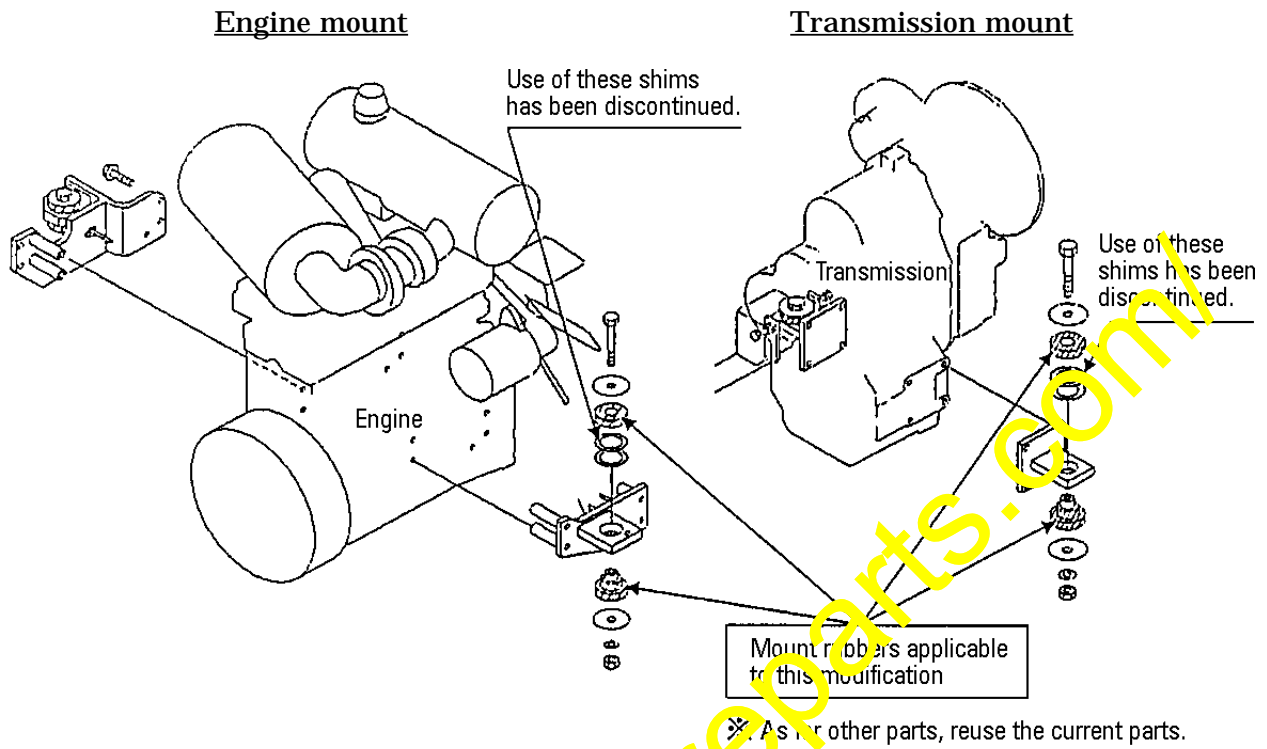
3.1 The shape and the hardness of the mount rubbers have been modified to improve their durability. Also, use of shims has been discontinued pursuant to this modification.

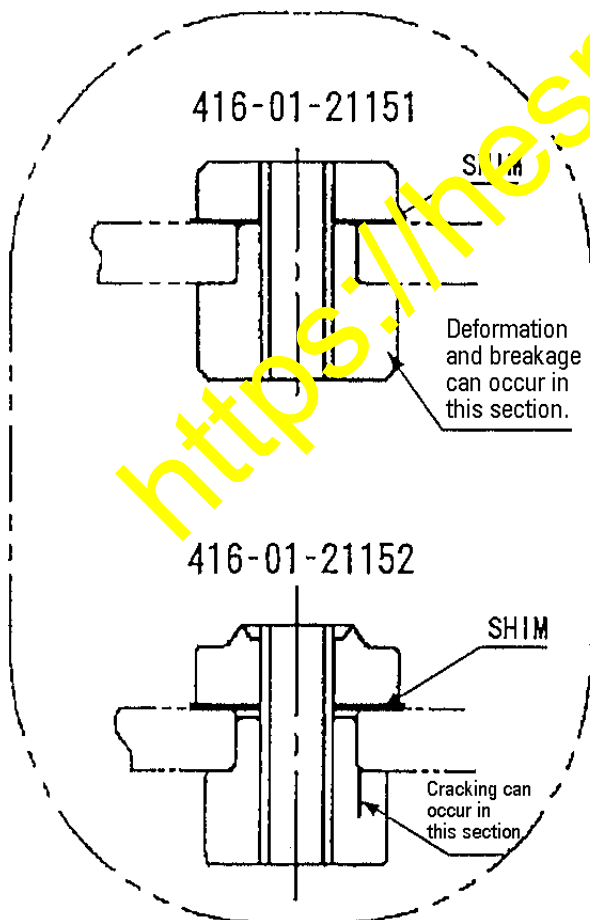
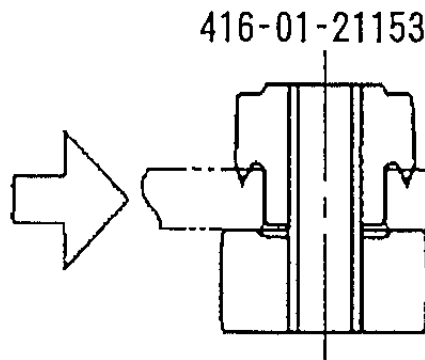
Detail drawings for the mount rubber

The shape of the rubber mount has been so modified that the projecting section has been shifted to the upper rubber and the hardness of the material has been changed.

* Pay attention to the direction when installing them.
