## PARTS & SERVICE NEWS

REF NO.	AA02234
DATE	October 29, 2002

**SUBJECT:** HOIST CYLINDER CABLE BRACKET MODIFICATION

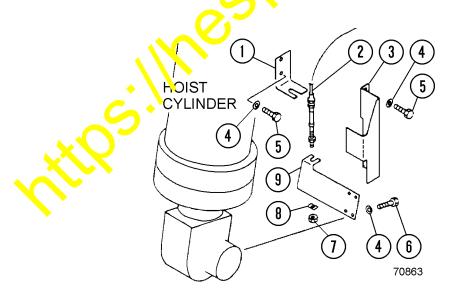
FIGURE 1. DUMP CONTROL LINKAGE

Some trucks have experienced problems with the hoist cylinder cable sligging out of place. Bracket (9, Figure 1) is attached to the rear of left hand hoist cylinder. The bracket has a slotted hole which holds the hoist cylinder cable (2) in place.

To secure the hoist cylinder cable, weld flat washer (2, Figure 2) over the slotted hole. The flat washer has an inner diameter of 20 mm. Position flat washer (2) or existing bracket (1) so that inside radii of flat washer and bracket are flush. Weld as shown in Figure 1.

In addition, a new bracket (EK3361) has been designed to replace bracket (1 Figure 2). Instead of a slotted hole, the new bracket will have a 20 mm diameter hole to hold the heist cylinder cable in place.
