# PARTS & SERVICE NEWS

REF NO.	AA02241
DATE	Nov. 11, 2002

**SUBJECT:** IMPROVED NEEDLE BEARING AND PLANETARY GEAR SHAFT IN 2ND CLUTCH PACK IN TRANSMISSION

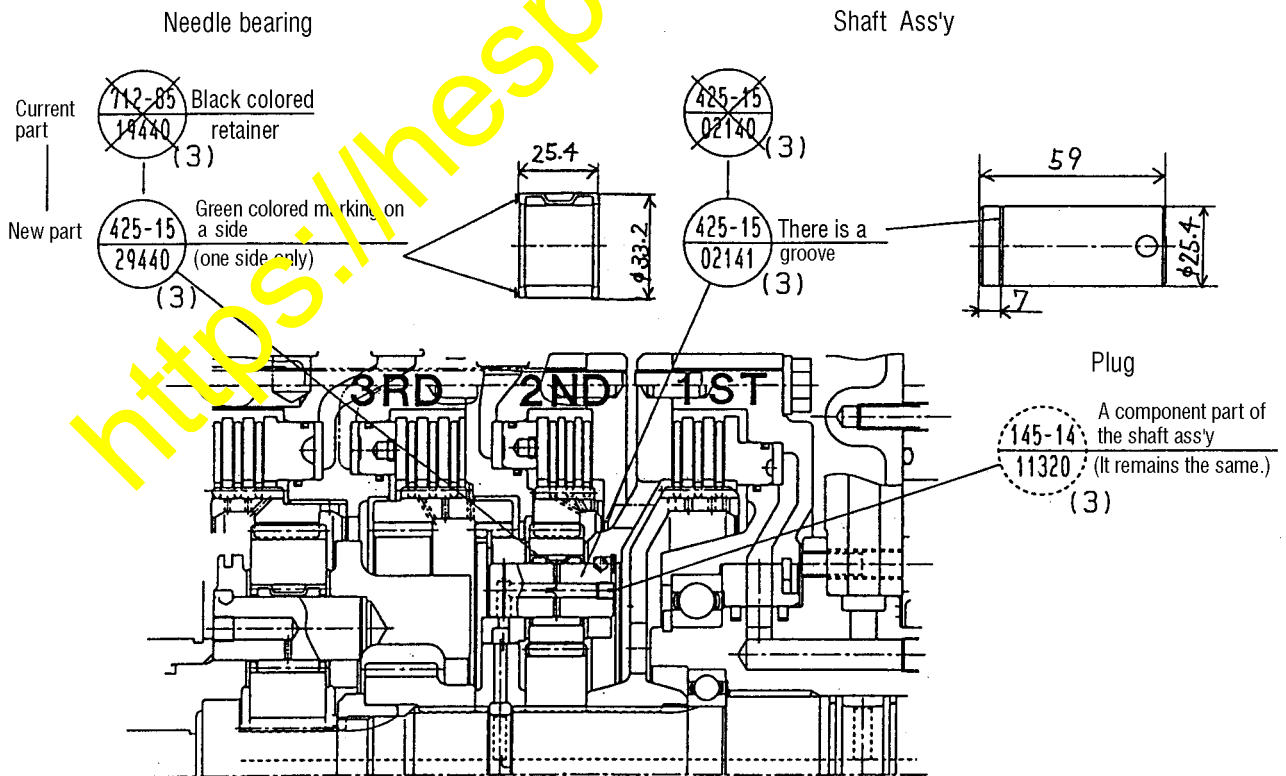
4. Discrimination between the improved and current parts (Refer to the figure shown below.)

① Discrimination between the improved and current needle bearings

(Current needle bearing) Color of the retainer surface is black.

(Improved needle bearing) Color of the retainer surface is silver + a mark with green color on a side (one side only).

② Discrimination between the improved and current planetary gear shaft

(Current planetary gear shaft) There is no groove

(New planetary shaft) There is a groove (One groove only)

Note) Longer life of the planetary gear assembly cannot be obtained unless both the needle bearing and the planetary gear shaft are replaced together. (If either one of them is replaced independently, the life of the planetary gear assembly would be even shortened.)

5. Replacement procedures

Replace those parts consulting the section "Disassembly and assembly of transmission" in the Shop Manual.
