PARTS & SERVICE NEWS

REF NO.	AA03009
DATE	January 14, 2003

SUBJECT: LEAKAGE FROM TRANSMISSION REAR COUPLING, SLIDING TYPE

PURPOSE: Introduce a repair procedure for transmission rear coupling leakage.

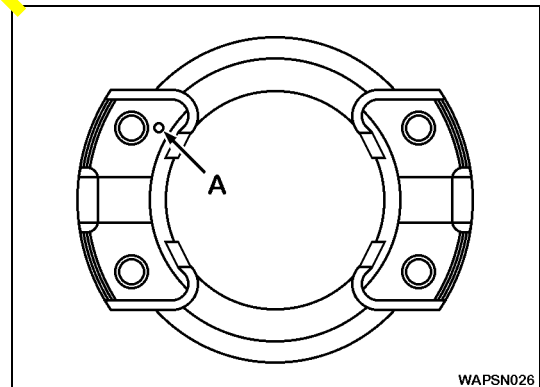
There is a possibility of oil leaking between the coupling and the inside cover. It has been improved by changing the clearance tolerance from a loose fit ① to a tight fit ②. Sealant ③ is now applied on each side of the inside cover. In order to clarify the improved coupling, an identifying mark **A** is punched as shown. Make sure it is indicated on the new part before replacement.

DESCRIPTION: When oil leakage is found from the rear coupling area, replace the old coupling with the new one.

New Part	Description	Old Part
714-13-14121	Rear Coupling	714-13-14120
