PARTS & SERVICE NEWS

REF NO.	AA03032A
DATE	November 22, 2004

REPAIR PROCEDURE FOR BRACKET ON RETURN HYDRAULIC PIPING SUBJECT:

return pipe fastening bracket on WA800-3 and WA900-3 wheel loaders

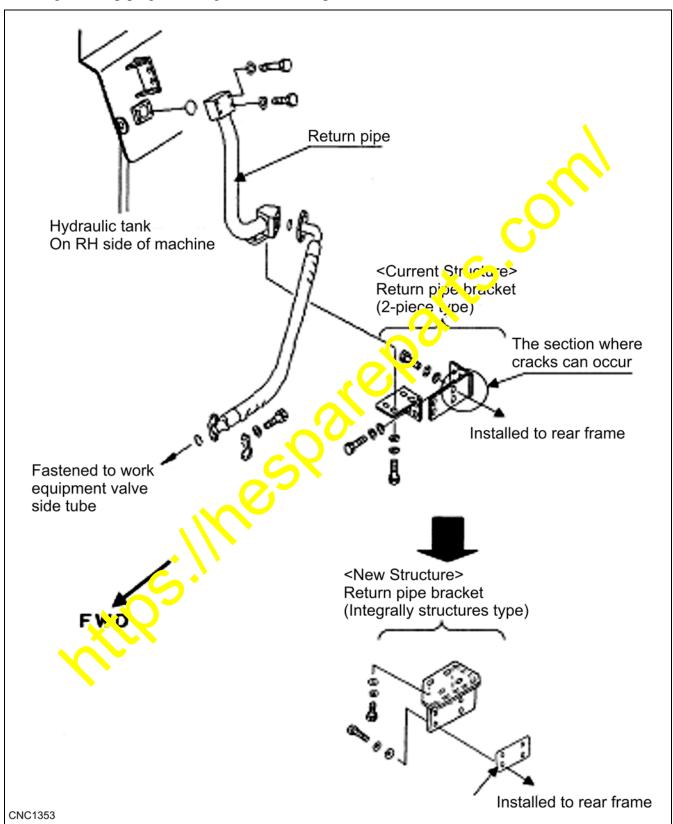
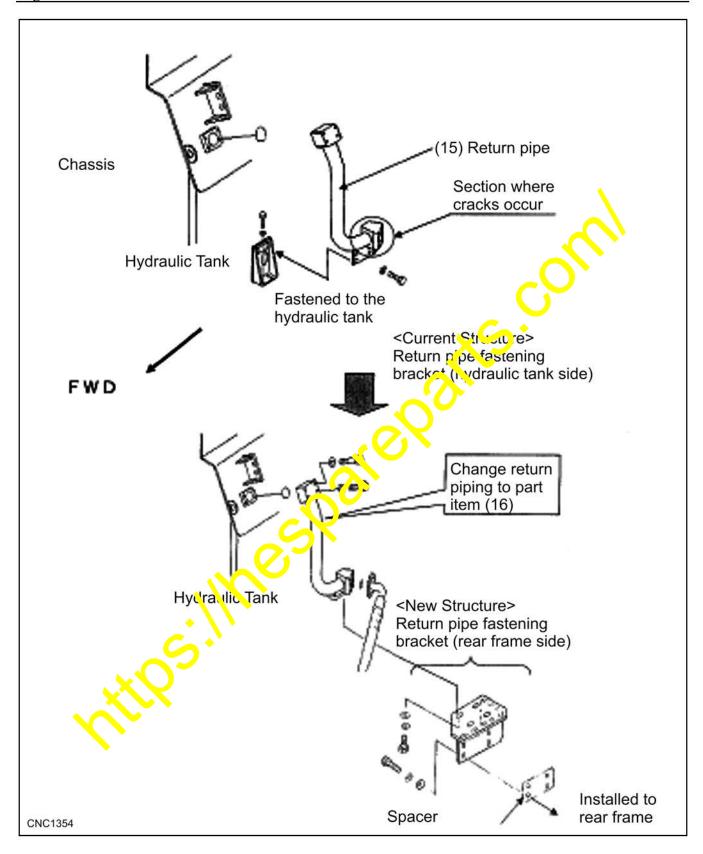
DESCRIPTION: There is a possibility of occurring cracks in the return pipe mounting bracket

> installed to the hydraulic tank on the WASOL 3 and WA900-3 wheel loaders, starting from the welded end. When cracks occur, make the modification to change the return pipe fastening bracket to the reinforced new part following the modification procedure being out in this Service News. On WA800 (#50030 and after) and WA900 (#50027 and after), insufficient rigidity in the hydraulic tank mount bracket may cause check to grow in return piping welded joints. If the above failure is found, make the modification to repair it following this Service

To change return piping mounting bracket to new part
