## PARTS & SERVICE NEWS

REF NO.	AA03035A
DATE	August 14, 2003

**SUBJECT:** 730E FRAME RAIL CASTING REWORK PROCEDURE

**APPLICATION:** Komatsu 730E Dump Trucks A30079 - A30145

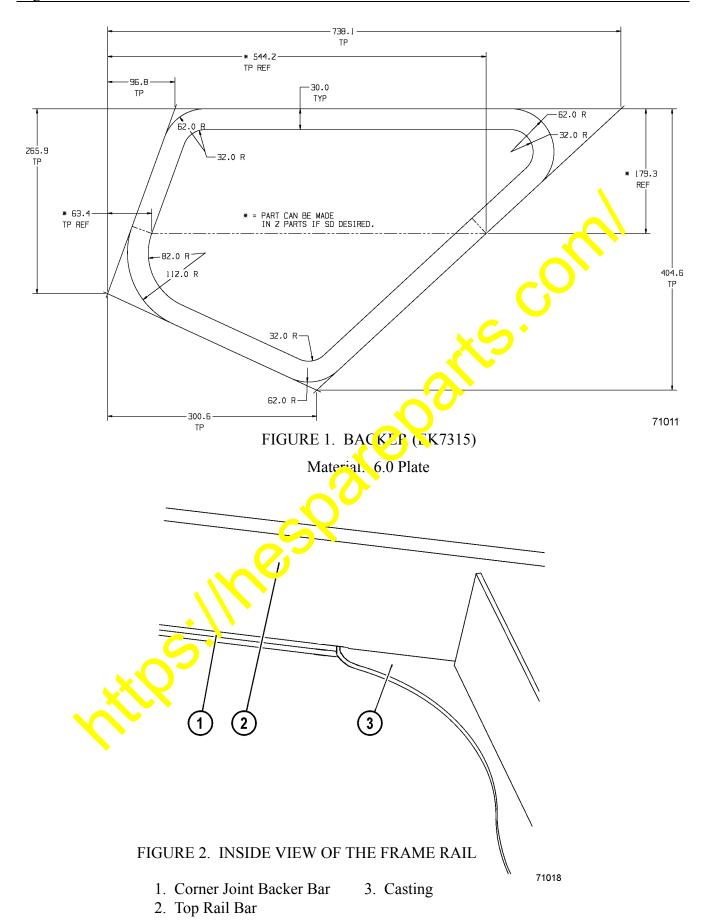
Some trucks in the field may experience cracking at the weld joint of the inner cide sheet to top rail bar joint. The typical crack location is found near the front finger of the drive tube casting approximately 1 foot forward of the drive tube center. Carefully inspect the weld joint, at the front of the drive tube casting for cracks. Refer to Figure 2.
