PARTS & SERVICE NEWS

REF NO. | AA03059

SUBJECT: REAR AXLE WELD CRACKS AT SUSPENSION MOUNTS & REINFORCEMENT PLATE

APPLICATION: Komatsu Electric Drive Dump Trucks: 930E: 32604 - 32816, A30019, A30026 and up; 930E-2: A30012, A30098, A30100, A30121 and up

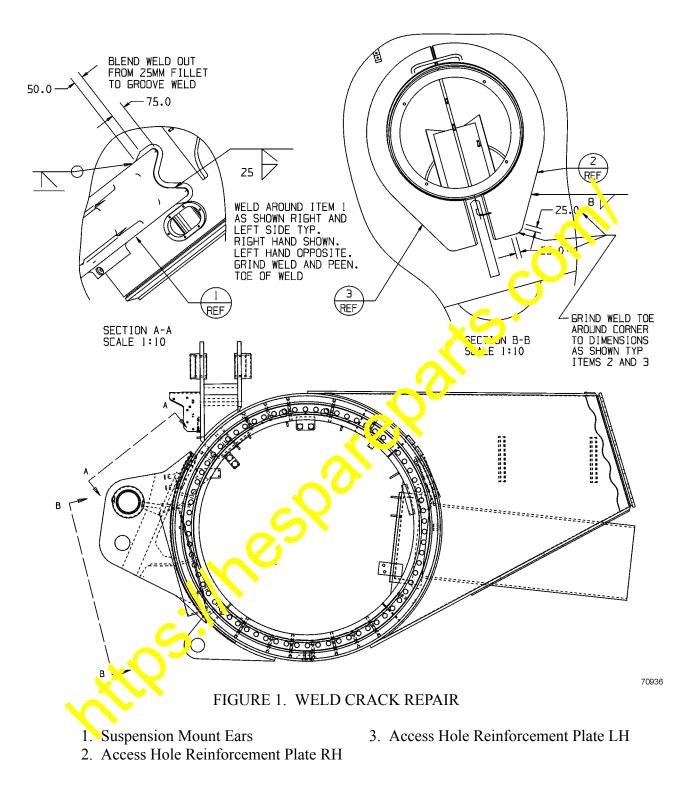
Some trucks in the field may experience weld cracks in the upper cre. of suspension mounts and around the bottom of axle housing access hole reinforcement plate. Caleful y inspect each area for cracking at the welded joints. If cracks are found, follow the procedure out ined below to properly repair the cracks.

- 2. Suspension Mounts Add 25 minufallet weld around upper part of suspension mount as shown in Figure 1, Section A-A. The vere must have a smooth profile and the toe must have a good transition to the parent material before peening is performed. Grinding the weld face and toe area is permitted to correct unacceptable conditions.

- 3. Visually inspect the well before peening.
- 4. Peen the type of the 25 mm fillet weld per Parts & Service News (AA00046B, Annex B 1.0).
- 5. Visual ispection / acceptance is to be completed after peening per Parts & Service News (AA00040B, Annex B 1.0).

- 6. **Reinforcement Plates** Grind the toe of the weld in the area shown in Figure 1, Section B-B per Parts & Service News (AA00046B, Annex B 2.0).
- 7. Visual inspection / acceptance is to be completed after grinding per Parts & Service News (AA00046B, Annex B 2.0).
