PARTS	&	SER	VICE
NEWS

REF NO. AA03143

SUBJECT: **REINFORCING A/C CONDENSER OUTLET PIPING PURPOSE:** To inform the field of a reliability improvement for air conditioner systems.

APPLICATION: Komatsu Electric Drive Dump Trucks: 445E: 32210-32972, 31202-31736, A511001-A511037; 510E: 31222-32259, 31682-32865; 630E: (170 ton): 31670-32866, A31435 & Up; 630E: (190 ton): 31678-32848, A31431 & Up; 685E: 31402 & Up; 730E: 32530-32845, A30079 & Up; 830E: 31320-32825, A30544 & Up; 930E: 32604-32816, A30019, A30026-A30120 930E-2: A30012, A30098, A30100, A30121 & Up; 930E-3: A30294, A30304 & Up; equipped with A/C condenser (PB9520) Komatsu Mechanical Drive Dump Tucks: 530M: A30001 thru A30038, 22523 HD1500-5: A30039 and up; equipped with A/C cordenser (PB9510)

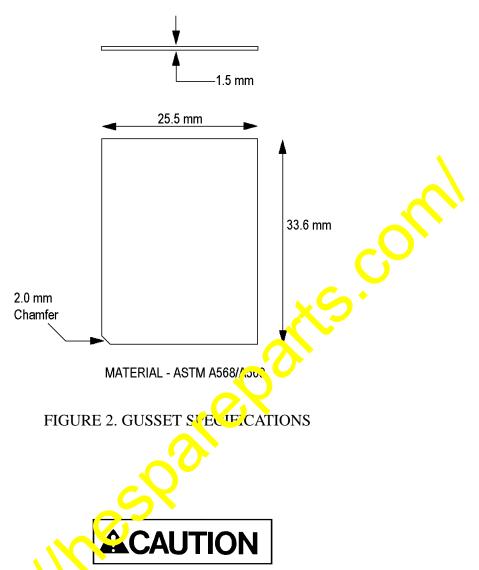
FIGURE 1. OUTLET TUBE

Some trucks in operation may experience damage to the outlet tube on air conditioning system condensers (PB9510). Normal truck operation and vibration can sometimes cause damage to this tube due to lack of support. Figure 1 illustrates the current outlet tube arrangement.

Inspect the condenser for cracking near the fitting. If any cracking is evident, repair or replace the condenser.

A field improvement has seen developed that entails welding a locally foricated support gusset to the existing support. The addition of the gusset reduces the possibility of this damage occurring and increases the life of the condense, resulting in less downtime.
