PARTS & SERVICE NEWS

REF NO. AA03144

SUBJECT: RADIATOR REINFORCEMENT KIT (XK0305)

APPLICATION: Komatsu Wheel Loaders:
WA800-3LC: A50001 and up;
WA900-3LC: A50001 and up

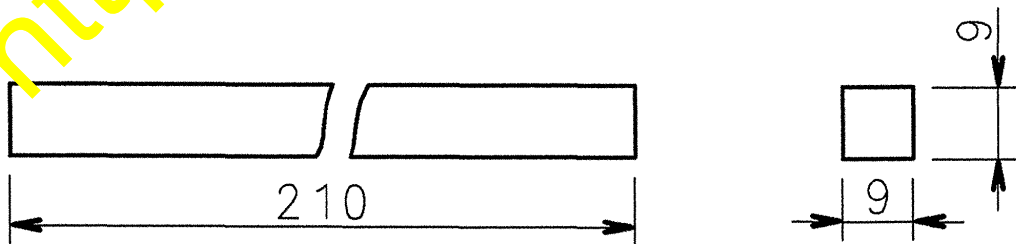
FIGURE 1. BAR (EF8225)

Material Spec: SS400, ASTM A36

1. Heat the solder and remove the fill neck (2, Figure 2) and seat extension assembly (1) from tank. Clean and flush around the fill hole.
2. Remove the paint from the top tank plate in the area where the bars are to be welded. Weld the two reinforcement bars (5). Refer to Figure 1 for reinforcement bar specifications.

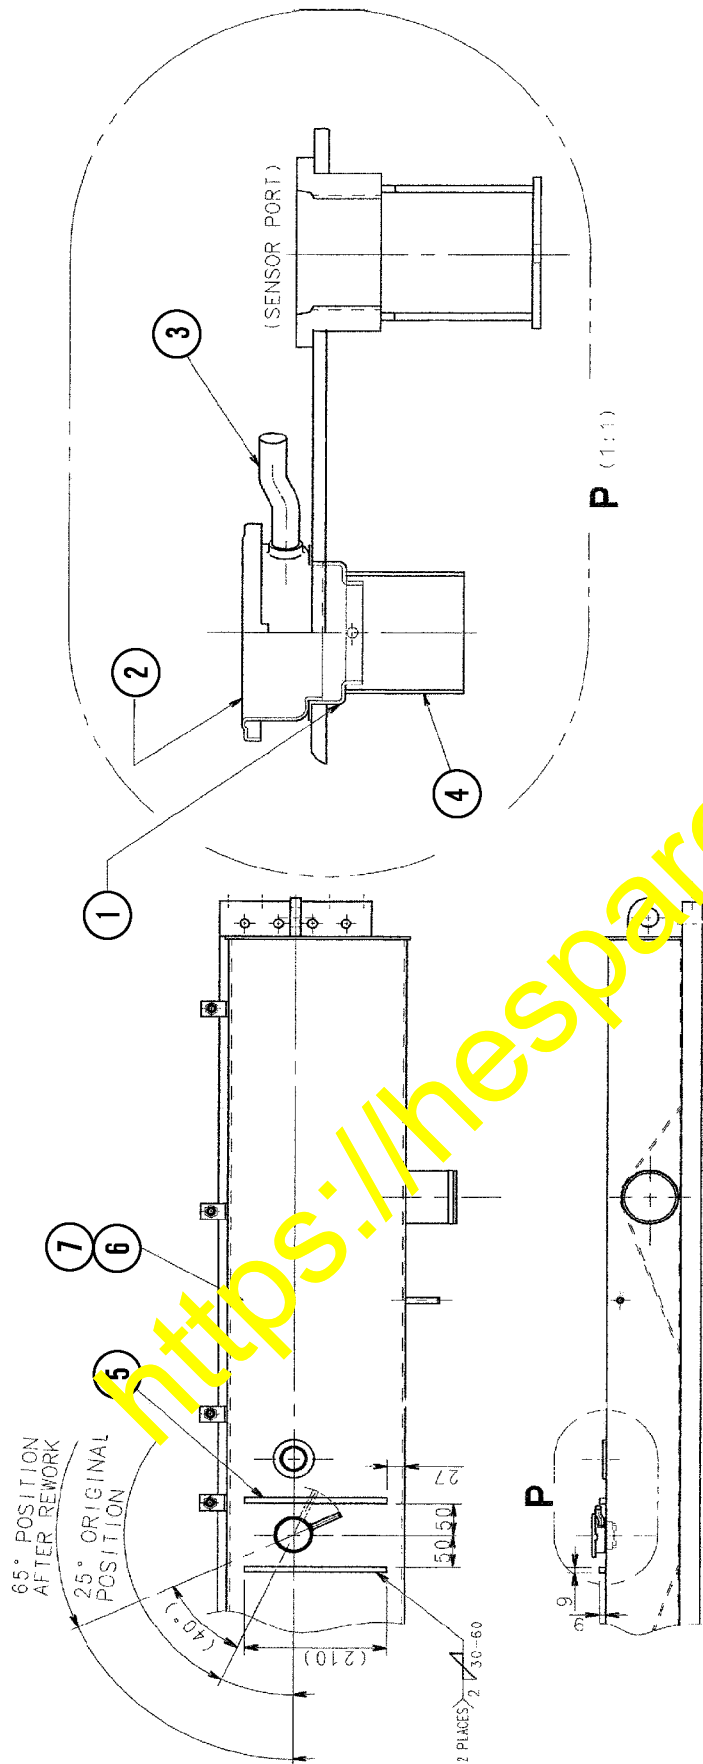
FIGURE 2. RADIATOR REWORK

Some wheel loaders may form a crack or pin-hole leak at the radiator fill neck joint to the top tank plate. A new kit (XK0305) welds two external bars to the top tank. The tank is stiffened and stress is reduced at the soldered joint of the fill neck area, thus preventing cracks.

3. Refer to Figure 3. Apply a small amount of solder to seat and to tank and to fill neck surfaces.
4. Refer to Figure 2. Set seat on tank correctly. Set fill neck on seat, using care to set the angle of the overflow tube.

1. Heat the solder and remove the fill neck and seat extension assemblies from tank.
2. Weld the two reinforcement bars (EF8225) as shown above.
