# PARTS & SERVICE NEWS

REF NO. AA03165

DATE November 24, 2003

- SUBJECT:** DUAL CRANKING MOTOR MODIFICATION KIT
- PURPOSE:** To introduce a kit for relocating engine cranking motors for increased reliability.
- APPLICATION:** Komatsu HD1500-5 Dump Trucks, A30039 - A30072
- FAILURE CODE:** AB30BK
- DESCRIPTION:** Dual Cranking Motor Modification Kit (XK0221)

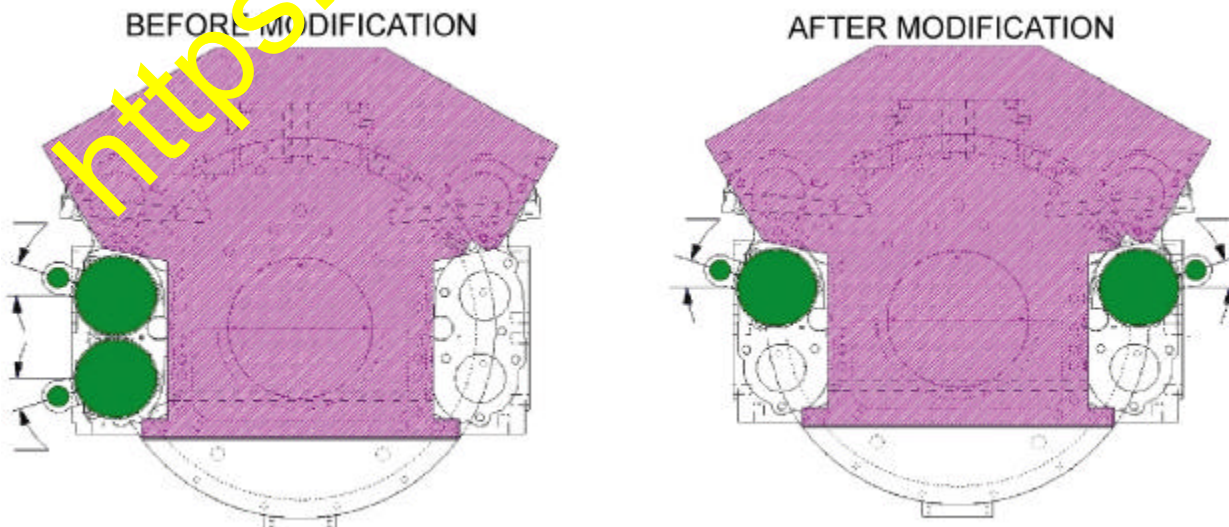
Some trucks in operation may experience premature failures of the lower engine cranking motor. The primary cause of these failures is due to the orientation of the main engagement solenoid with respect to the centerline of the cranking motor. The orientation of the lower cranking motor solenoid is angled approximately nine degrees downward from the horizontal plane through the cranking motor centerline. Refer to Figure 1. This downward angle allows debris and dust to enter and settle inside of the solenoid cavity. As the cavity becomes fully contaminated, the mechanism fails and prevents the cranking motor from engaging. As a result, the upper cranking motor will be used at a higher duty cycle torque, which in turn may lead to premature failure of the upper motor, as well.

FIGURE 1. BEFORE AND AFTER KIT INSTALLATION

A modification kit has been developed to fully relocate the lower cranking motor. The installation of the kit entails removing the lower cranking motor from the RH side of the engine and installing a new and different cranking motor in the upper LH side of the engine. The new cranking motor is a different part number than the previous cranking motor and is necessary for installation on the LH side of the engine. If in good condition, the removed cranking motor may be kept as a replacement part for the existing upper RH cranking motor.
