## PARTS & SERVICE NEWS

REF NO.	AA04070	
DATE	June 1, 2004

**SUBJECT:** REPAIR PROCEDURE FOR ENGINE IDLER SHAFT

**PURPOSE:** To introduce a modification procedure to repair the rear idler shaft

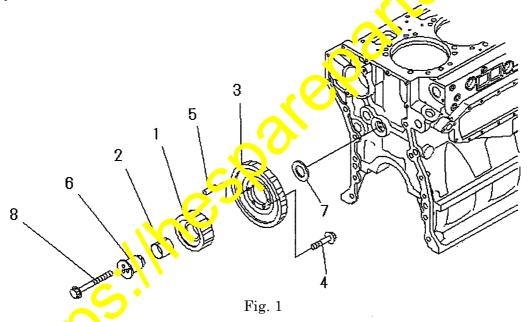
- 3. When the rear idler shaft breaks, carry out the inspections and modification following the procedure described below.
  - 1) Referring to the Shop Manual, remove the flywheel and flywheel housing.
  - 2) Remove the idler gears (1) and (3) of the rear gear train.

In case the idler shaft bolt (8) is broken, completely remove the tip end of the bolt remaining in the cylinder block.
  - 3) Check the contact surface of the idler shaft and the hole for the shaft on the cylinder block.

- Therefore, remove the cylinder head and inspect the moving valve parts and the piston, and replace the malfunctioning parts.
  - 5) After the inspection and repair works, install the improved idler gear to restore the cylinder block.

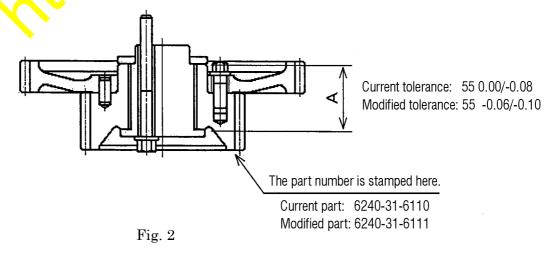
Dimension, of the improved gear - To improve the lubricity, the tolerance of the dimension "A" has been modified as follows:
