PARTS & SERVICE NEWS

REF NO.	AA04109
DATE

SUBJECT: ENGINE SUBFRAME CRACKS**PURPOSE:** To inform the field of a reinforcement procedure for strengthening the engine subframe.**APPLICATION:** Komatsu Electric Drive Dump Trucks:

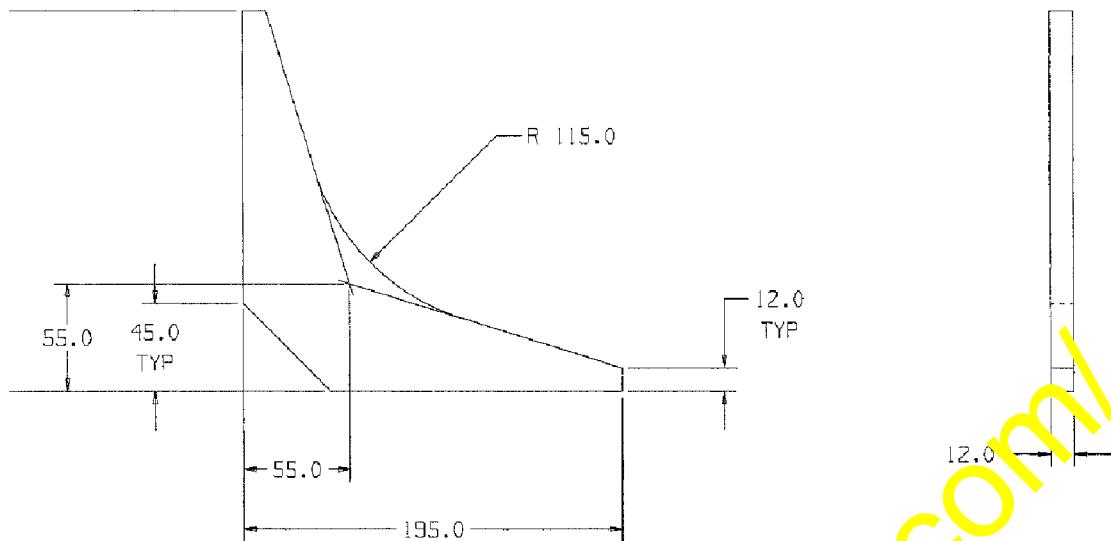
FIGURE 1. GUSSET - EL2575

Some trucks in operation may experience cracks in four locations on the engine subframe. Two crack locations are in the welded joints between the front engine mount and the main side rail. The other crack locations are in the weld joints between the rear cross tube and main side rail. A subframe structure reinforcement procedure has been developed to strengthen those areas to prevent cracking from occurring. Refer to Figure 4 for crack locations and details for installation of reinforcement components. Table 1 lists the necessary parts for completing the reinforcement. These parts are to be fabricated locally from ASTM A572 grade steel. Refer to Figures 1 - 3 for fabrication specifications.

Before installing the reinforcement components, perform a frame inspection in the specified areas, and repair any cracks that are found. Follow the guidelines that are outlined in Parts and Service News, *Field Welding for Assembly or Repair* (AA00046C), Welding Manual I (SEBF14001), and Welding Manual II (SEBF15002). It is important that these instructions are read, fully understood, and followed.
