PARTS & SERVICE NEWS

REF NO.	AA04135
DATE	August 10, 2004

SUBJECT: IMPROVE ROUTING OF BRAKE COOLING SYSTEM TUBE

PURPOSE: To introduce to the field a more reliable routing of brake cooling system tube.

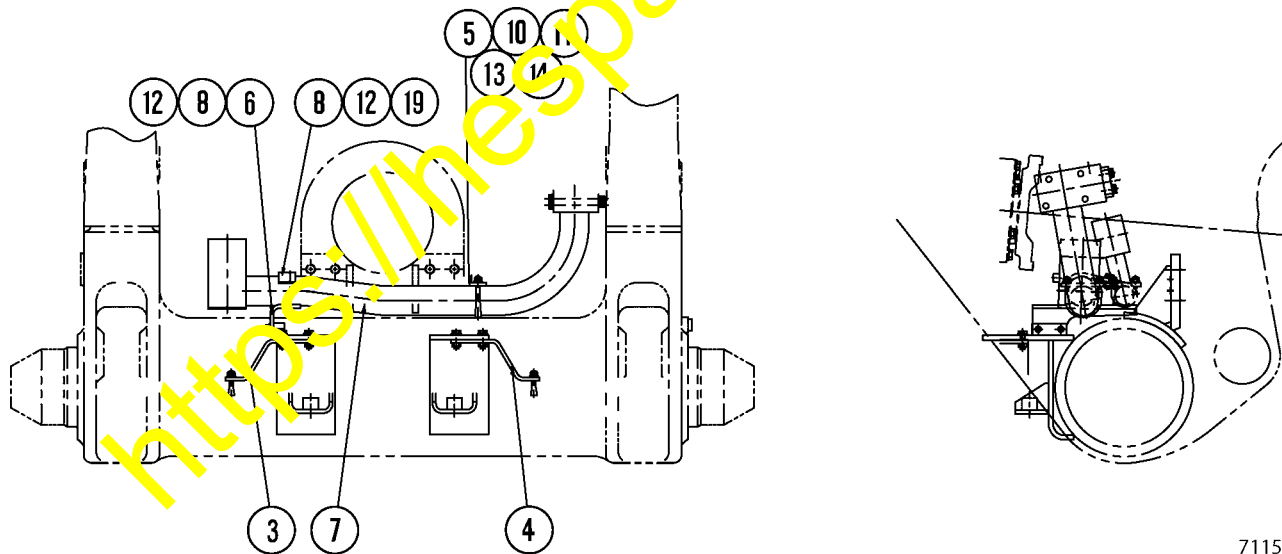
FIGURE 1. CURRENT BRAKE COOLING SYSTEM TUBE ROUTE

Some trucks in the field could experience damage to brake cooling system tube (7, Figure 1). The damage can be caused by a joint failure in the rear drive shaft. After the joint fails, the drive shaft breaks loose and is constrained by the driveshaft guard. The brake cooling system tube is too close and is often hit by the draft shaft. When the brake cooling system tube is damaged, oil leakage may occur. This Parts & Service News introduces a better route for the brake cooling system tube and a rework procedure for the driveshaft guard.

1. Remove existing brake cooling system tube (7, Figure 1).
