PARTS & SERVICE NEWS

REF NO.	AA04179
DATE	November 30, 2004

SUBJECT: THE IMPROVED REAR AXLE DIFF. ASS'Y MOUNTING BOLTS
AGAINST BREAKAGE

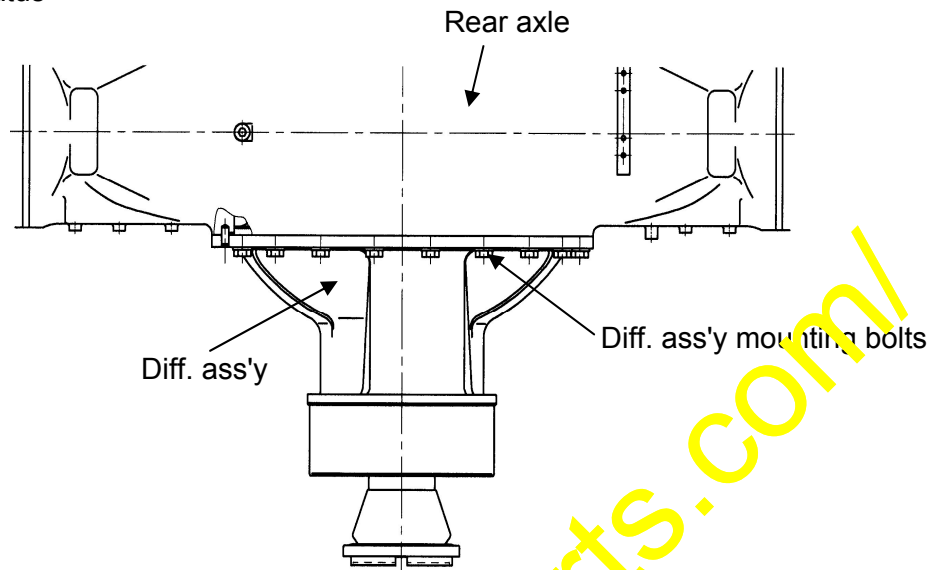
Current status

By addition of a spacer at 10 sections on the upper side bolts (Marked ● in the drawing) among all the rear axle diff. ass'y mounting bolts, stress to the bolts can be decreased.
