PARTS & SERVICE NEWS

SUBJECT: CENTER DRIVE SHAFT

PURPOSE: To provide the proper parts list for the center drive shaft

APPLICATION: WA180-3 Wheel Loader S/N A80001 and up

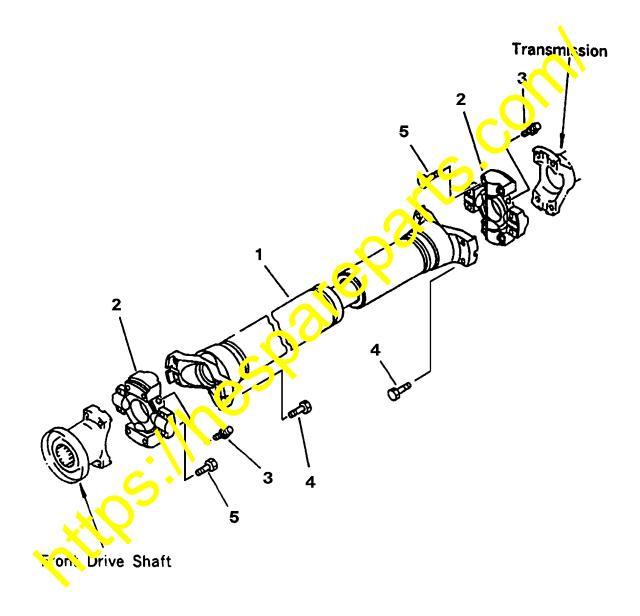
F4200W01.30P

CENTER DRIVE SHAFT
