# PARTS & SERVICE

REF NO.	AA99002	
DATE	Dec. 28, 1998	
	Page 1 of 2

**SUBJECT:** IMPROVED BELL CRANK PIN

**PURPOSE:** To introduce an improved bell crank pin

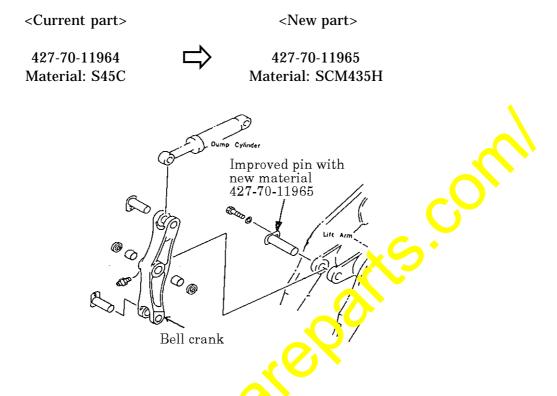
The material of the bell crank center pin has been changed from S45C to SCM435H to increase the durability of the part.

When replacing the bell crank center pin, always apply "LM-P" to the pin and the bushing before installing them, in order to prevent galling or early wear. For details, refer to the previously issued Service News No. A796202 "PRECAUTION ATTACHMENT ASSEMBLY AT SITE ON WA700, WA800, "A920".
