PARTS & SERVICE NEWS

REF NO. AA99096

SUBJECT: HYDRAULIC TUBE BRACKET MODIFICATION OR REPLACEMENT

APPLICATION: WA800-2L WHEEL LOADER WITH S/N A20001 THRU A20019
WA800-2LC WHEEL LOADER WITH S/N A20020 THRU A20023
WA900-1L WHEEL LOADER WITH S/N A20001 THRU A20007
WA900-1LC WHEEL LOADER WITH S/N A20008 THRU A20014

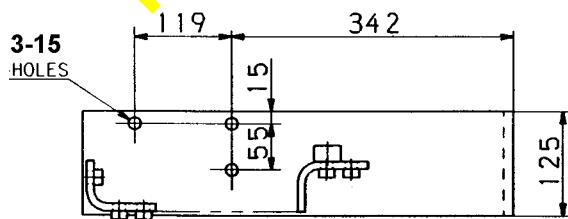
OLD BRACKET

DESCRIPTION: Misaligned hydraulic oil piping may cause cracks in the oil piping tubes.

You will have a choice of using the new bracket or modifying the existing bracket.
