PARTS & SERVICE NEWS

Ref.no.	AH04007
Date.	05.07.2004

Subject: Modification procedure of muffler bracket on WA470-5H and WA480-5H.

Purpose: To introduce modification procedure to repair cracks on the muffler bracket for the

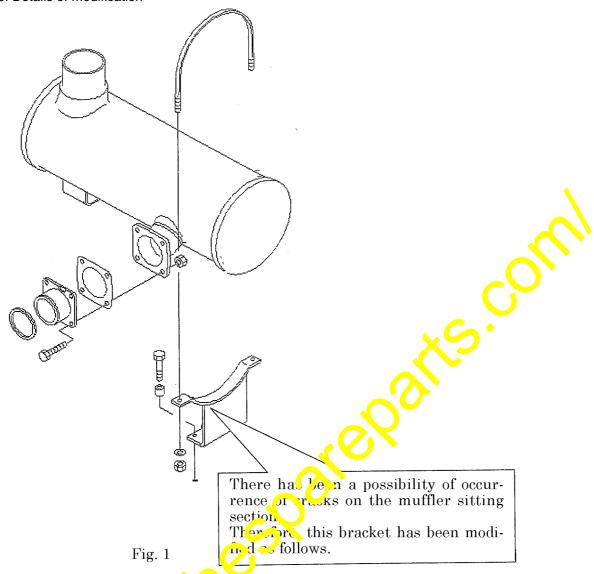
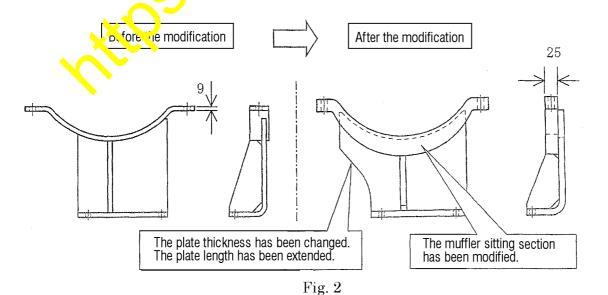
Details of the modification of the brocket

When cracks occur on the muffler bracket for the SAA6D125 engines being used for the WA470-5H and WA480-5H wheel loaders, repair the cracks following the modification procedure described in this Service News.

- (1) The muffler sitting section (9 mm thick plate \rightarrow 25 mm machined block)
- (2) The plate thickness has been changed and, moreover, the plate length along the muffler sitting section has been extended.
