PARTS & SERVICE NEWS

REF NO.	AT00016
DATE	Apr. 6, 2000
(C)	Page 1 of 6

SUBJECT: ENGINE UNDERGUARD INSTALLATION ON HD325-6, HD405-6

PURPOSE: To introduce modification procedures to improve the method of installing the engine underguard thereby to eliminate chattering.

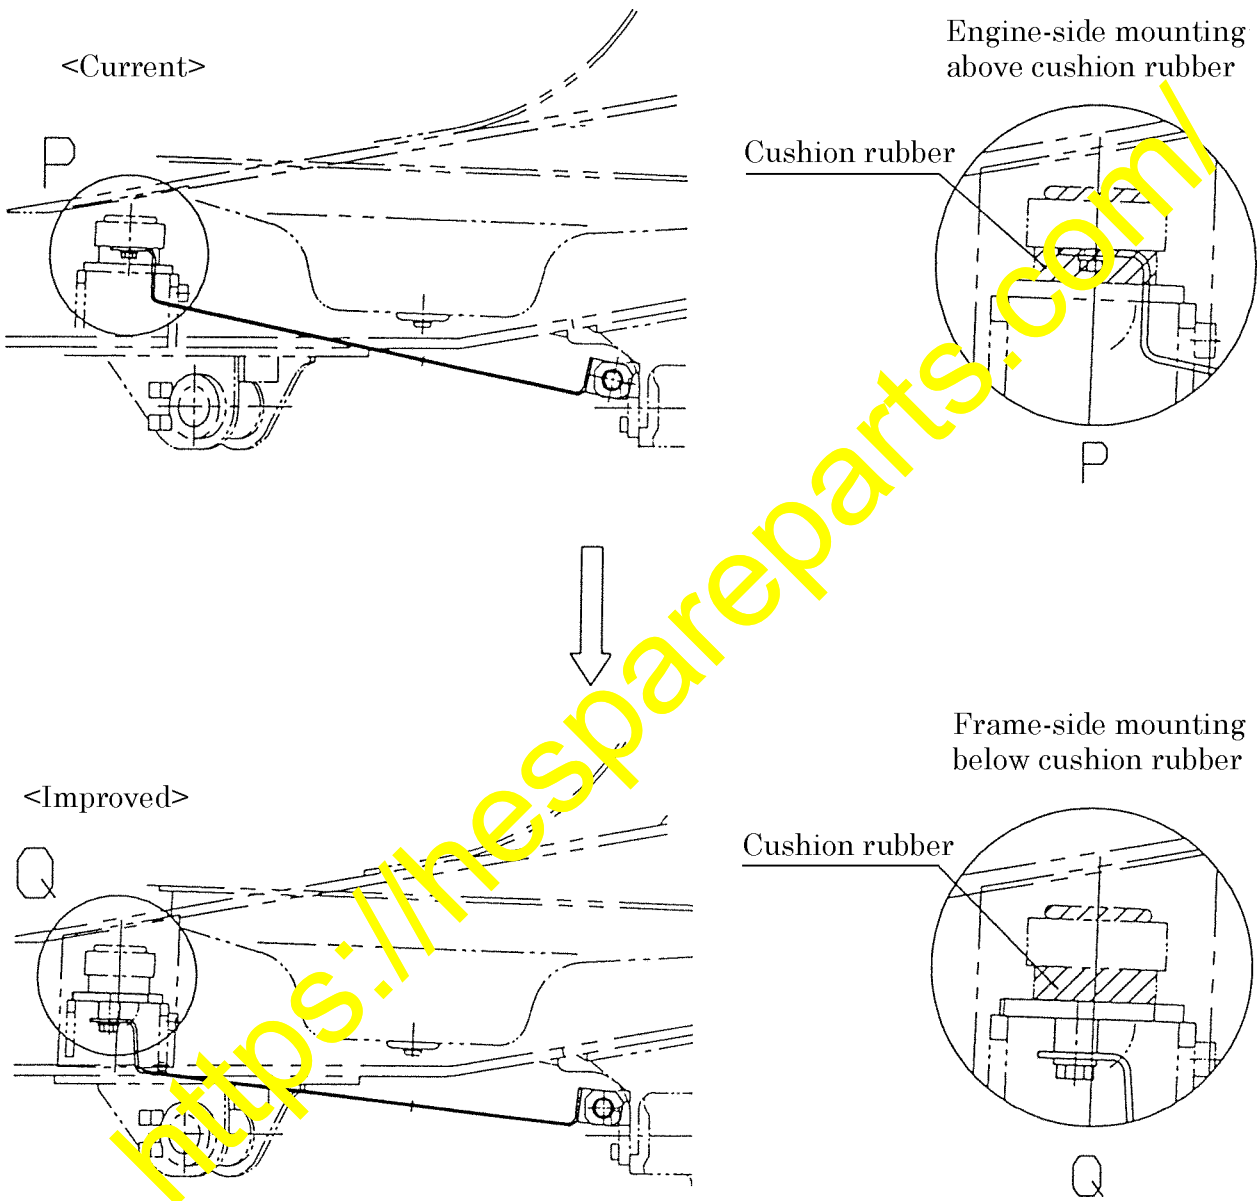
Since the engine underguard is vibrated by engine vibration and makes chattering (abnormal noise) if its front section mounts on the engine mounting rubber (cushion rubber), the mounting position of the underguard front section is to be changed to a frame side position below the mounting rubber, as shown in the diagram below.
