PARTS & SERVICE NEWS

REF NO.	AT00204
DATE	Oct. 16, 2000

SUBJECT: REPAIR PROCEDURE OF ECMV FILL SWITCH ON WA1200-3

APPLICATION: WA1200-3 Wheel Loaders, Serial Nos. 50001 thru 50006
(T/M, Serial Nos. 001001 thru 001010)

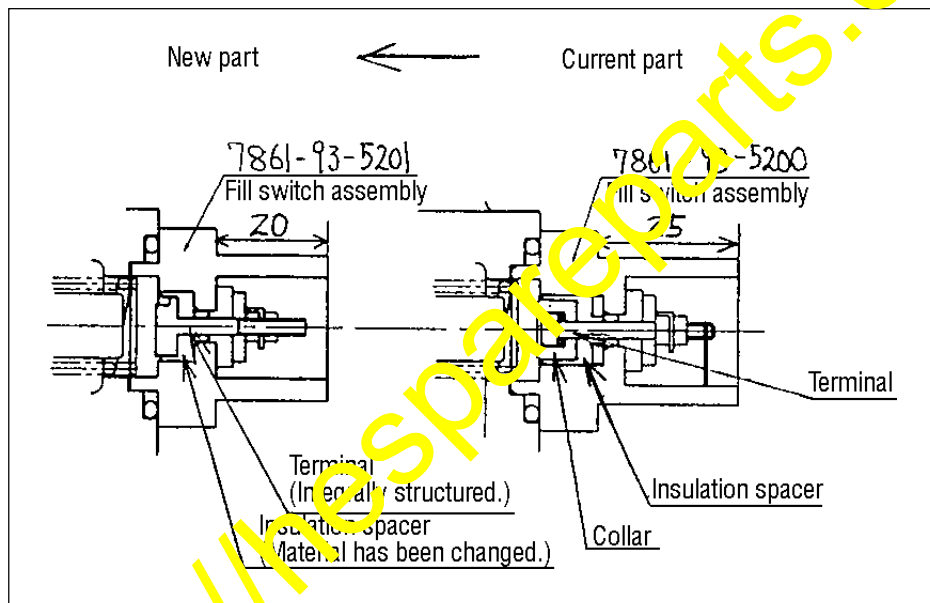
<Fig. 1>

- 1) The structure of the terminal has been changed to an integral structure to improve the conduction reliability of the fill switch.

New structure ←	Current structure
Terminal structure	Integrally structured terminal	Split structure of the collar and the terminal

- 2) The base material of the insulation spacer has been changed to cotton cloth having better joining property for the molded resin material.

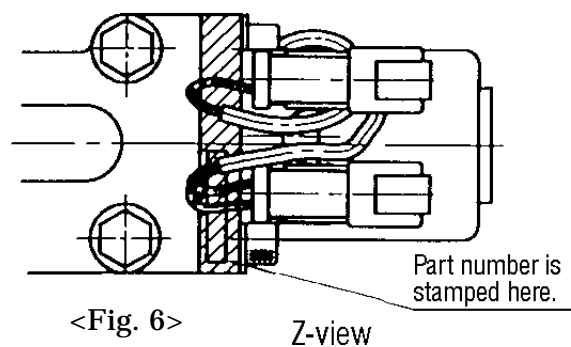
As shown in <Fig. 6> below, the part number (7861-93-5201) is stamped on the surface of the flanged section (hatched section shown in Fig. 6) of the fill switch.
