# PARTS & SERVICE NEWS

REF NO.	AT00205A
DATE	Sep. 6, 2001

**SUBJECT:** REPAIR OF T/C STATOR BUSH ON HD465/605/785/985-5

**PURPOSE:** To introduce modification procedures to repair the torque converter stator bushings on HD465-5, HD605-5, HD785-5 and HD985-5 dump trucks

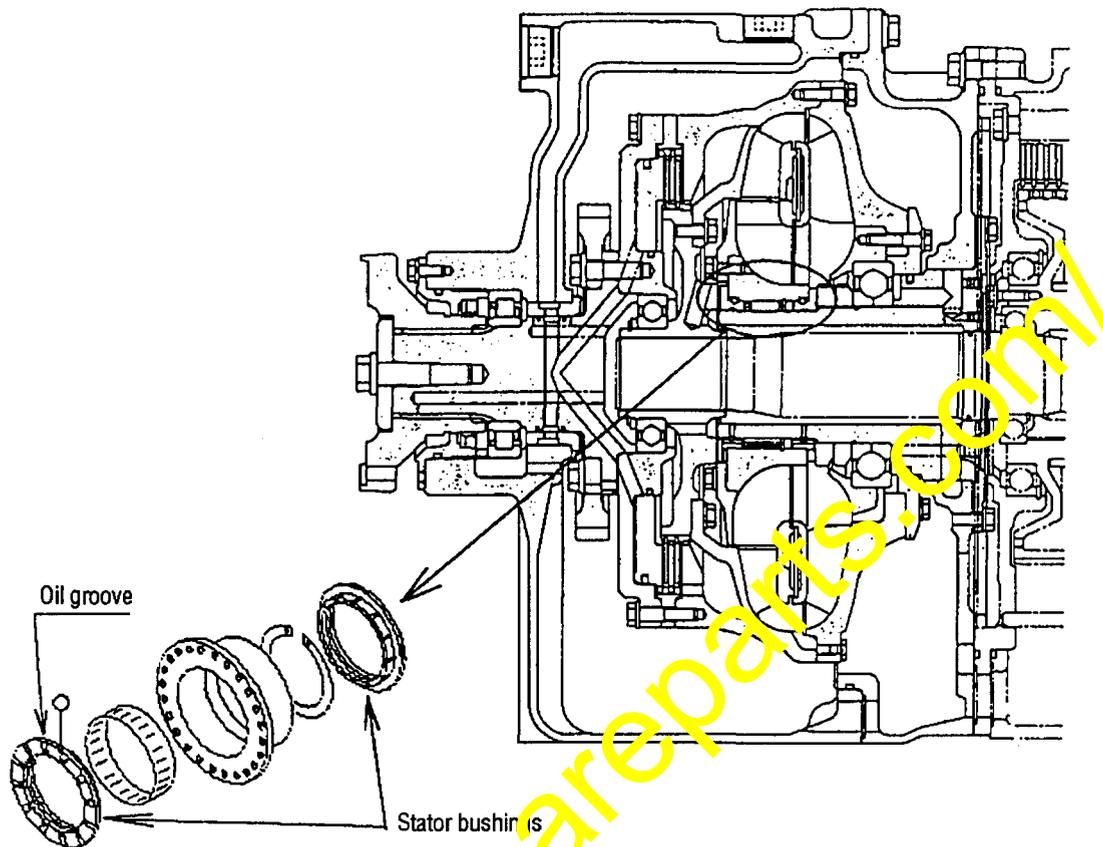
Fig. 1 Cross-sectional view of the torque converter

- (1) Torque converter stator bushings with insufficient chamfering for the side edges of the oil groove were used when some of the aforementioned dump trucks were manufactured and these vehicles have been shipped out already.  
(Refer to page 2 for details.)

- (2) When these vehicles are in operation, the end face of the bushings may wear abnormally by run out of the oil film.  
Although performance of the vehicle will stay normal during initial stage of wears (within 1,000 hours), as the wear progresses, horse power shortage or similar abnormality will occur.

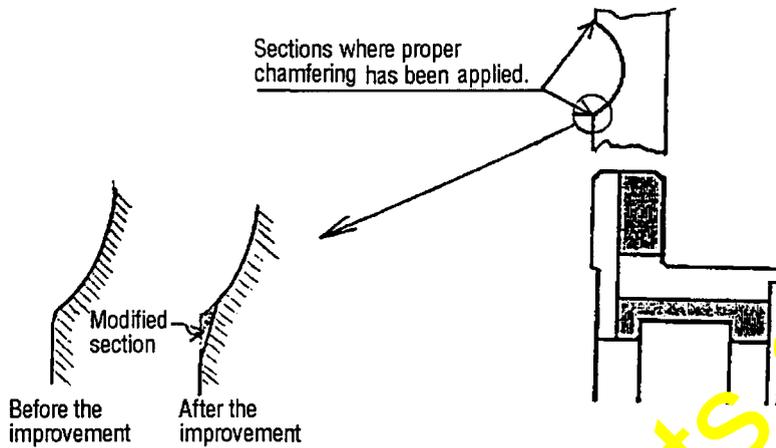
Fig. 2 Torque converter bushing

The side edges of the oil groove of the torque converter stator bushings are now properly chamfered to facilitate oil entry, thus preventing occurrences of running out of film lubrication and eliminating the cases of early stage wears of the bushings.

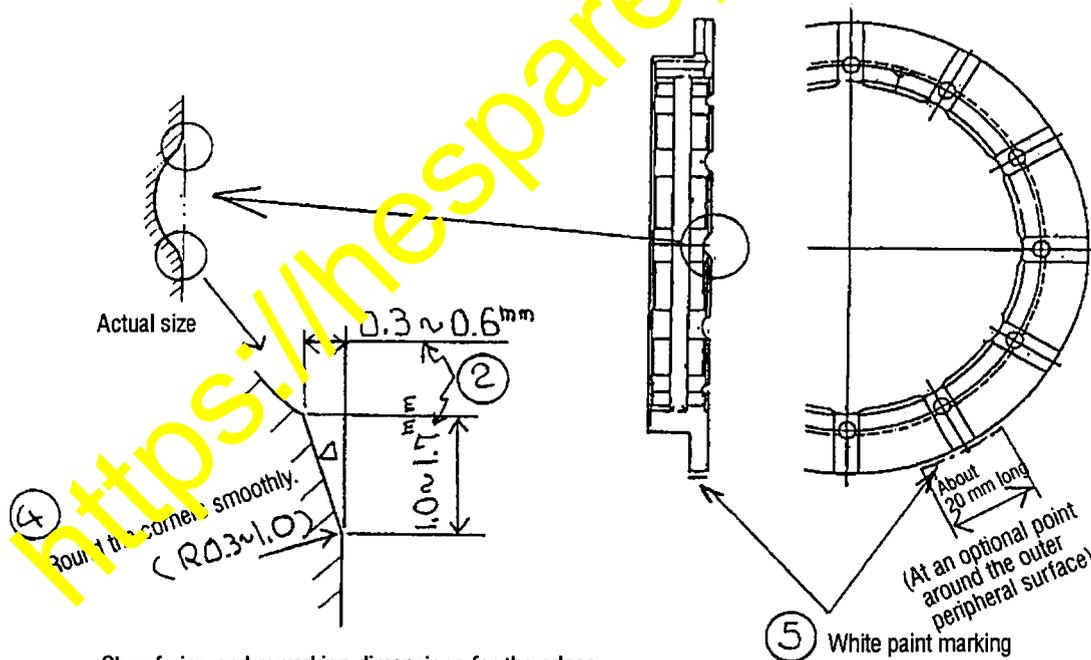
Chamfering and reworking dimensions for the edges of the oil groove (Make the modification using the above dimensions as the reference dimensions.)

- 1 Necessary tools and devices
  - a. Files    b. Emery paper (#200) (Necessary man-hour for this modification: 0.5 hours)
- 2 Grind the edges of the oil groove to the following dimensions using a file.
- 3 Remove burrs and flashes from the corners using a file.
- 4 Finish the corners to smooth surfaces using emery paper.
- 5 After finishing this modification, apply white paint marking of about 20 mm long on the outer peripheral surface of the bushing.
