PARTS & SERVICE NEWS

REF NO.	AT00281
DATE	Feb. 2, 2001

SUBJECT: REPAIR TO IMPROVE WATERPROOF-ABILITY OF T/M CONTROLLER MOUNTING SECTION ON WA200/250-3

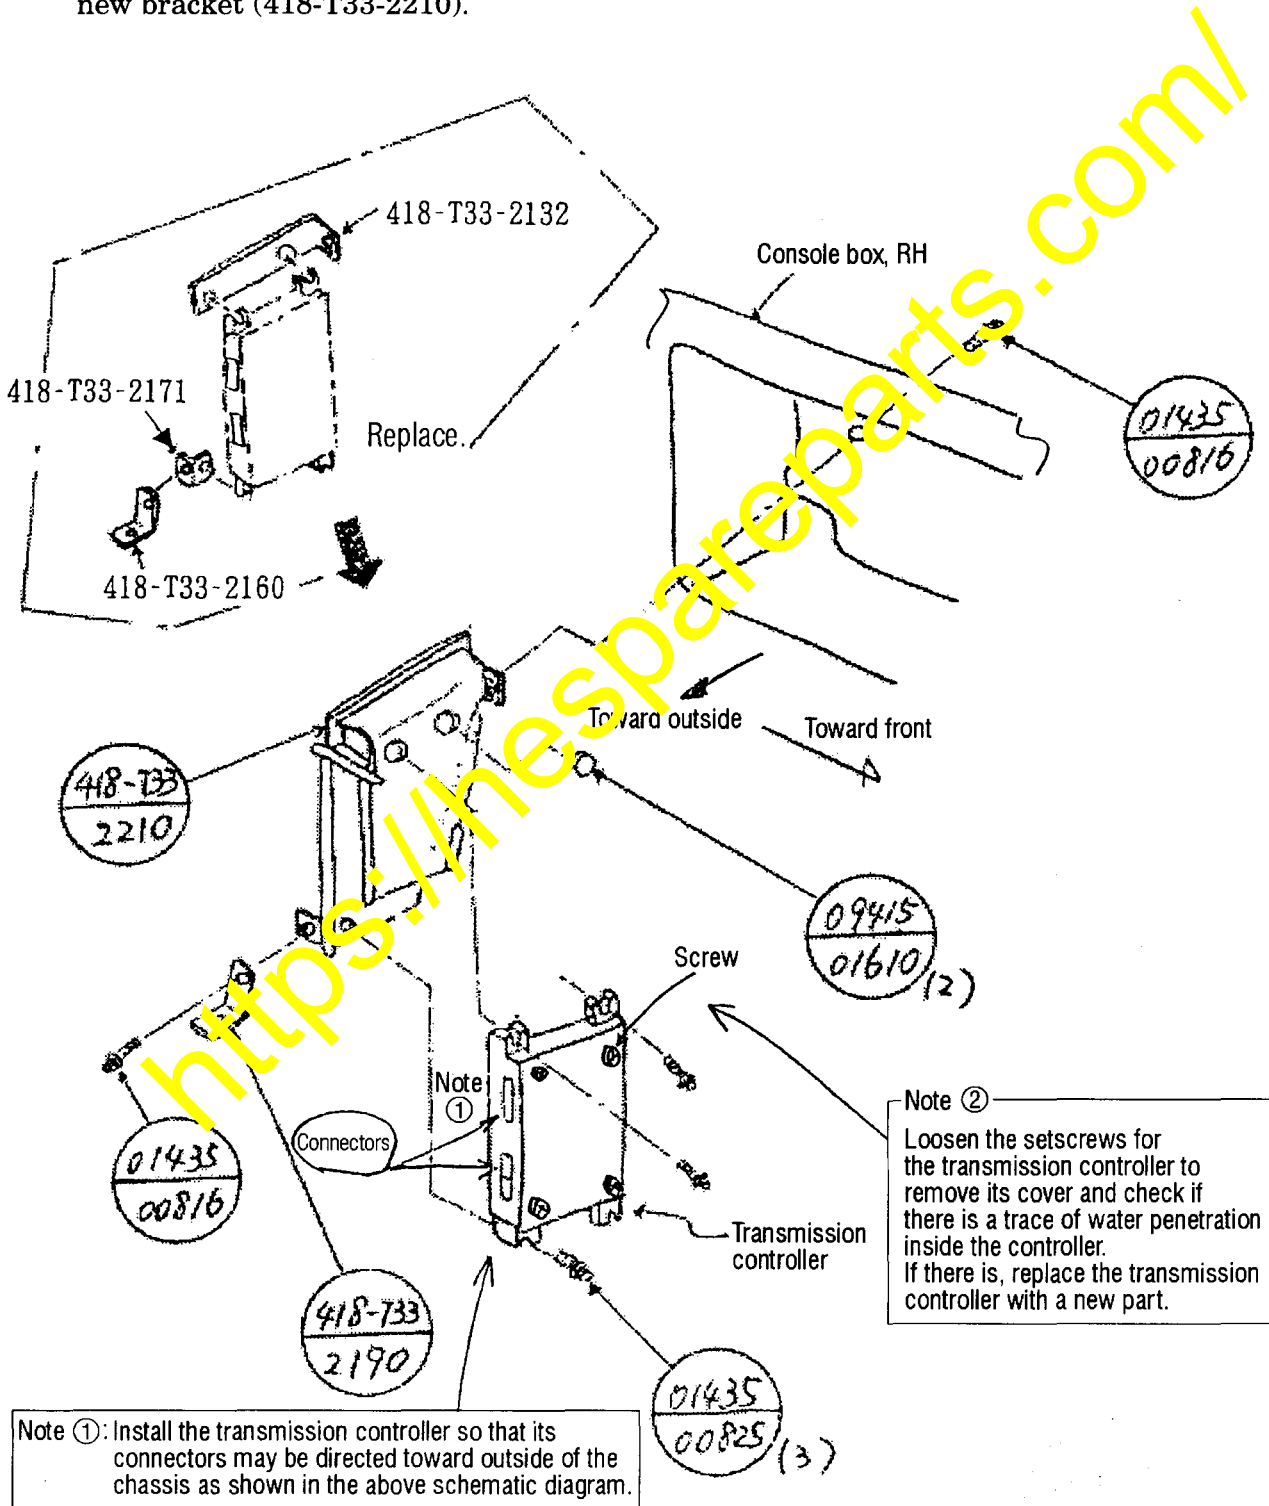
4-1. Replacing the transmission brackets

With the WA200-3 and WA250-3 wheel loaders equipped with the optional CANOPY and automatic-shift transmission, if rain water penetrates into the console box to cause shorting in the transmission controller circuit located inside the console box making it unworkable to have the machine travel forward nor backward, make the modification being introduced in this Service News to repair the failure.

According to the instructions given in the schematic diagrams indicated below, replace the transmission control bracket located inside the RH console box with the prepared new bracket (418-T33-2210).
