PARTS & SERVICE NEWS

REF NO. AT00305

SUBJECT: REPAIR OF PILOT PIPING CRACK IN WORK EQUIPMENT VALVE ON WA1200-3

APPLICATION: WA1200-3 Wheel Loaders, Serial Nos. 50001 thru 50006

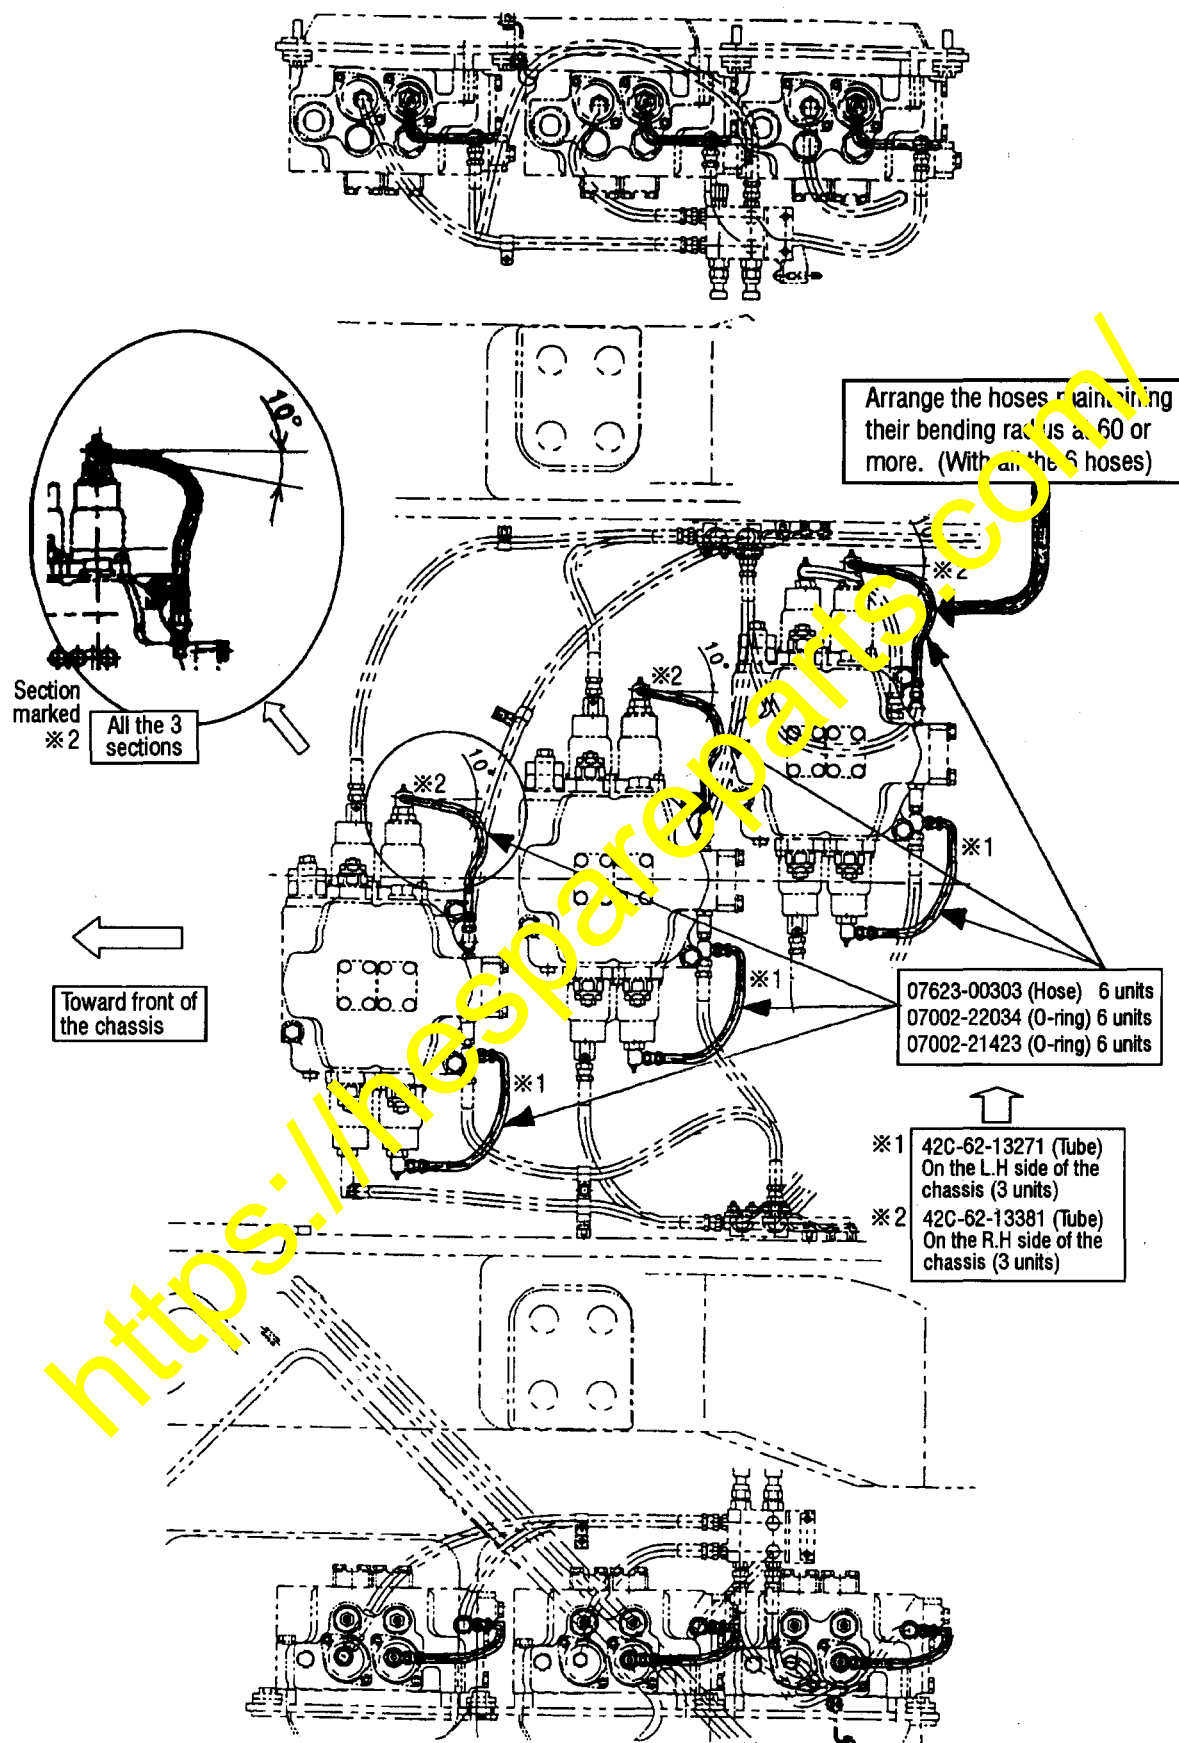
With the WA1200-3 wheel loaders, if the PPC piping (tube) connecting to the work equipment control valve assembly has been installed forcibly, the tube may crack while the machine is being used for a long period of time, resulting in occurrence of oil leakage. Consequently, replace the tube with a hose following the modification procedures outlined in this Service News to prevent occurrence of this failure.

42C-62-13271	3 tubes	Marked ※1 in the schematic diagrams indicated on the next page
42C-62-13381	3 tubes	Marked ※2 in the schematic diagrams indicated on the next page.

Install six hoses 07623-00303 in replacement of the tubes which have been disconnected and removed. Arrange the layout of these hoses paying attention that their bending radius may be maintained at 60 or more.

When replacing these tubes with the hoses, it becomes necessary to change the directions of the elbows and tees on both sides and be sure to replace the O-rings altogether.

(Refer to the schematic diagrams regarding their directions.)

Tightening torque for the flare nuts at 12 places in total:

29.4 – 68.6 Nm (3.0 – 7.0 kgm)
