PARTS & SERVICE NEWS

REF NO.	AT01030
DATE	Apr. 11, 2001
(C)	Page 1 of 3

SUBJECT: INTRODUCTION OF IMPROVED HOSE CLAMP ON HD465-5/HD605-5

APPLICATION: HD465-5 Dump Trucks, Serial Nos. 4407 thru 4886
HD605-5 Dump Trucks, Serial Nos. 1001 thru 1130

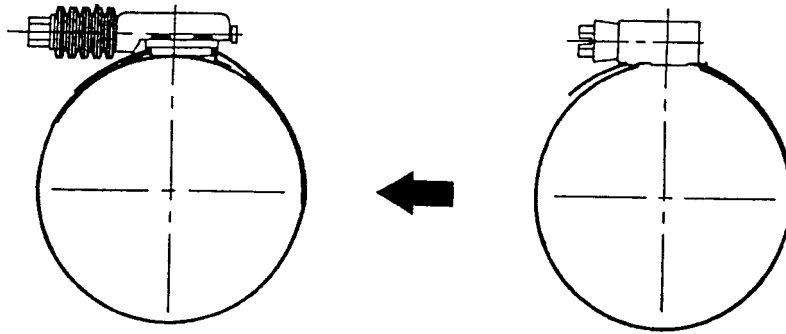
Fig. 1

The current high torque type clamps (KES D07289) made by Breeze are being changed to Breeze's constant torque type clamps (KES D07299) with which the tightening torque level is less apt to change.

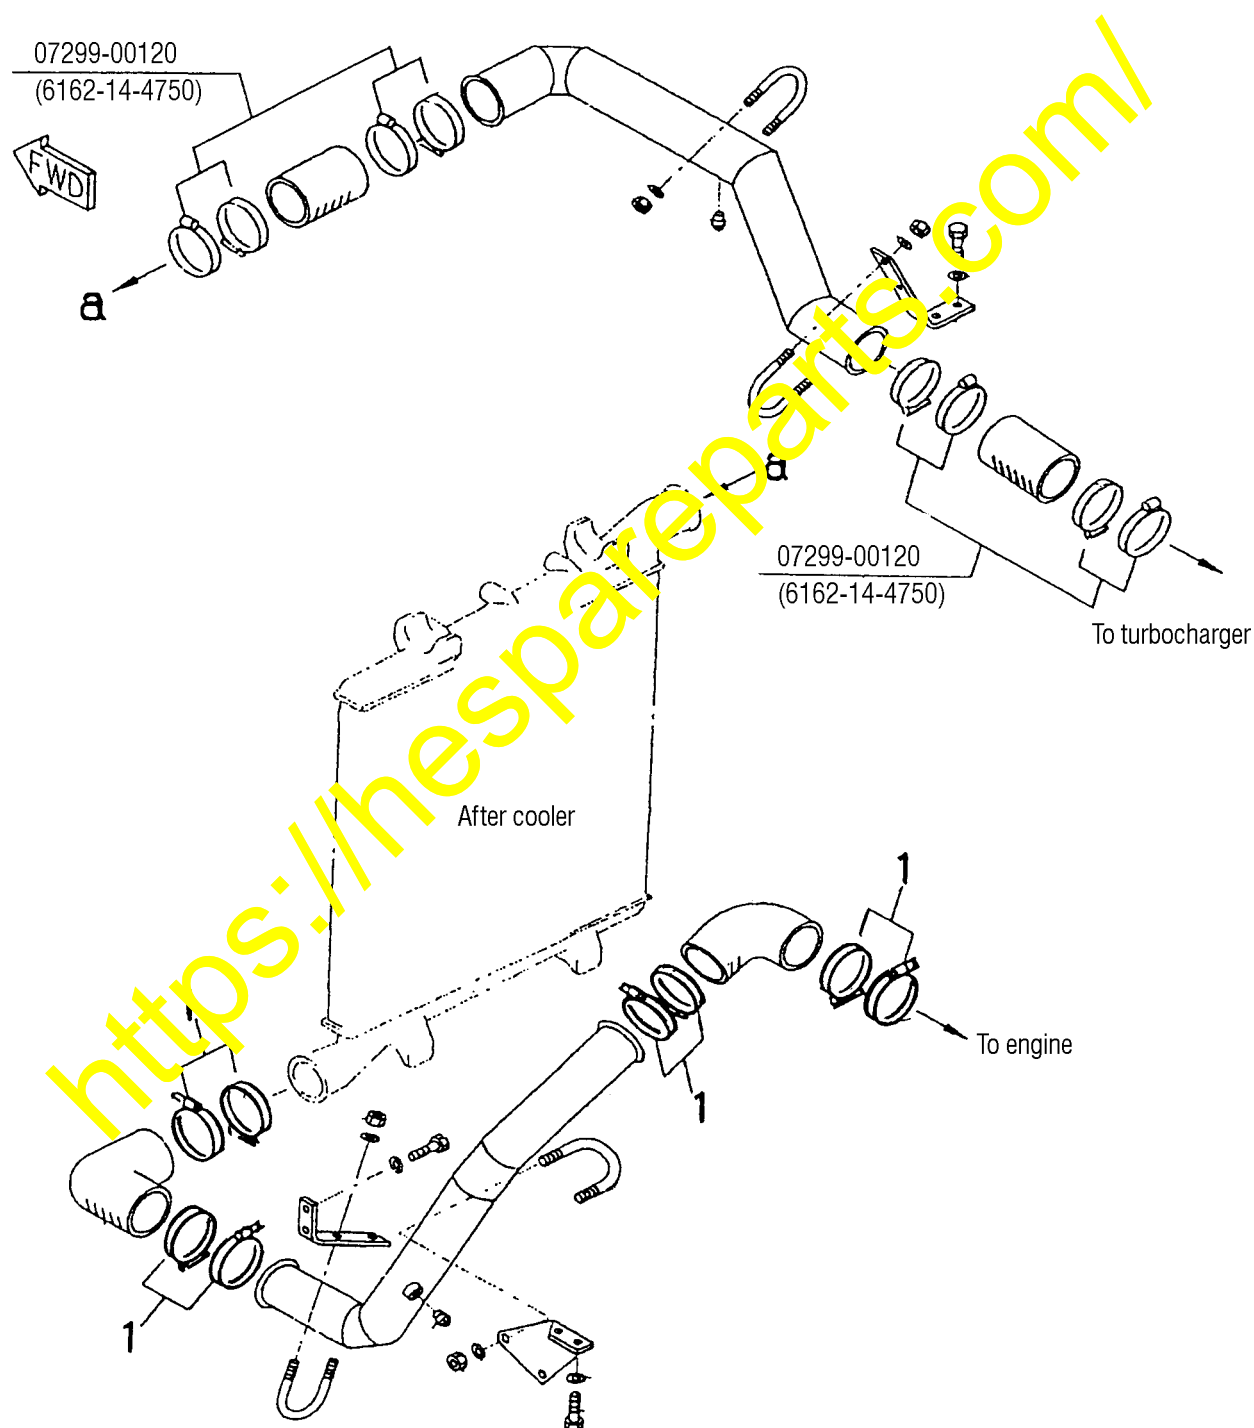
Fig. 4

The number being used in the illustration given below corresponds to the item number in the list of necessary parts for this modification.

The clamps with the Part No. 6162-14-4750 are identical to the clamps with the Part No. 07299-00120.
