# PARTS & SERVICE NEWS

REF NO.	AT01070
DATE	May 18, 2001
(C)	Page 1 of 7

**SUBJECT:** REPAIR METHOD OF T/C TRUNNION BOSS ON HD785-3, 5/  
HD985-3, 5/330M

**PURPOSE:** To introduce a spare part to repair excessive wear of the trunnion boss section of torque converter on HD785-3/5, HD985-3/5 and 330M dump trucks and relevant modification procedures  
[Applicable to the rebuilt torque converter]

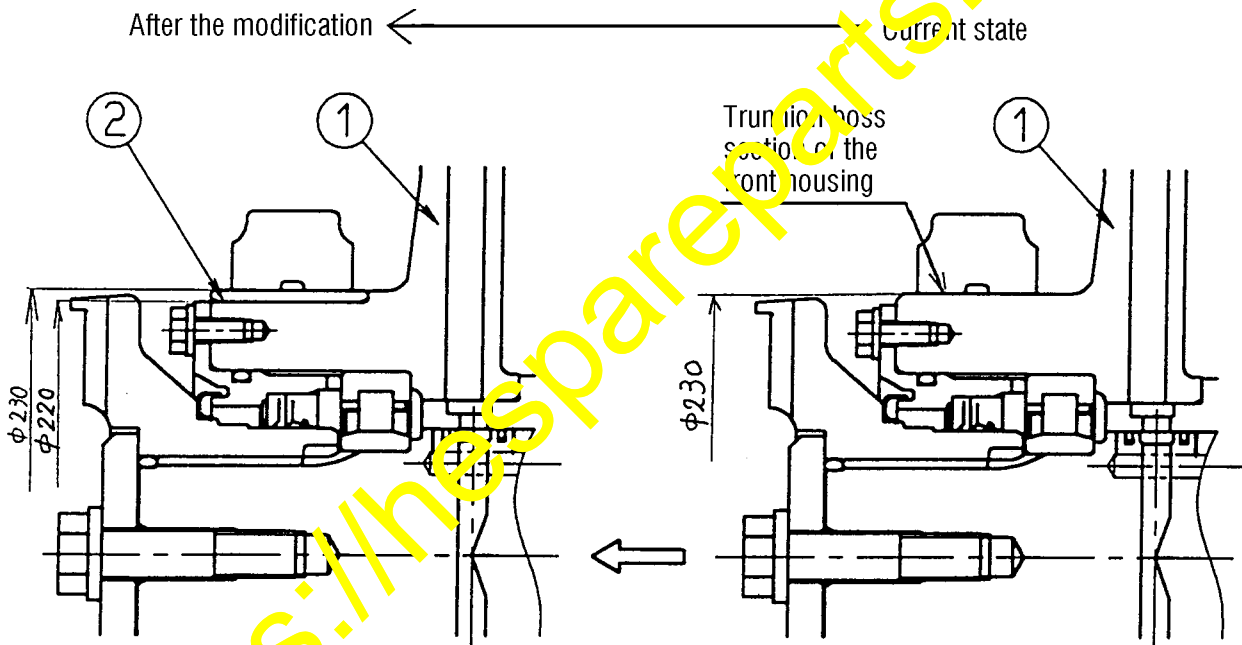
<Fig. 1> Contents of the modification

Rework the worn trunnion boss section of the front housing of the torque converter and press-fit a bushing.

No.	Part names	Part numbers	Contents of the modification
①	Front housing	561-13-43131	Machine the designated section of the trunnion boss from the current dimension of $\phi 230$ to $\phi 220$ .
②	Bushing	561-13-53380	New part (Press-fit it.)

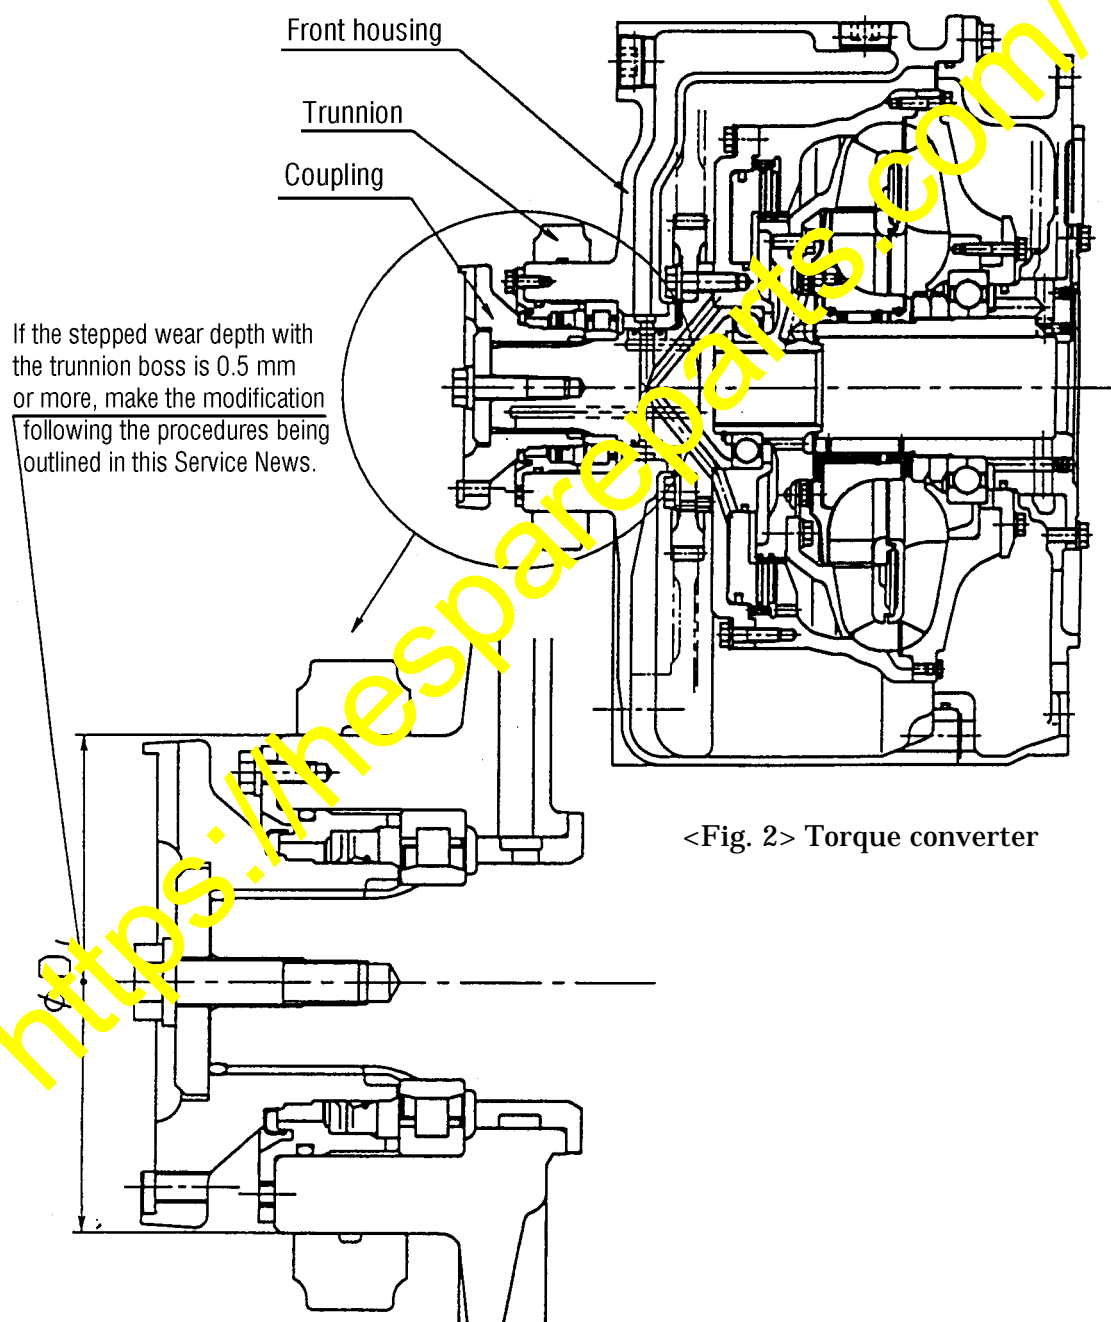
&lt;Fig. 3&gt; Trunnion boss section

For your reference: The cause of excessive wear of the trunnion boss section is considered to be due to insufficient greasing by customers resulting in the drying up of the oil film.

Checking point	Initial dimension	Criteria
Trunnion boss section of the front housing (The section "D1" in Fig. 3.)	$\phi 230 \begin{matrix} -0.100 \\ -0.172 \end{matrix}$	If the stepped wear depth with the trunnion boss is 0.5 mm or more, make the modification following the procedures being outlined in this Service News.
