PARTS & SERVICE	REF NO.	AT01125
NEWS	DATE	Aug. 29, 2001
		Page 1 of 4

SUBJECT: REPAIR OF STEERING CIRCUIT BLOCK ON WA1200-3

- **PURPOSE:** To introduce modification procedures to strengthen the steering circuit block on WA1200-3 wheel loaders
- APPLICATION: WA1200-3 Wheel Loaders, Serial Nos. 50001 thru 50010

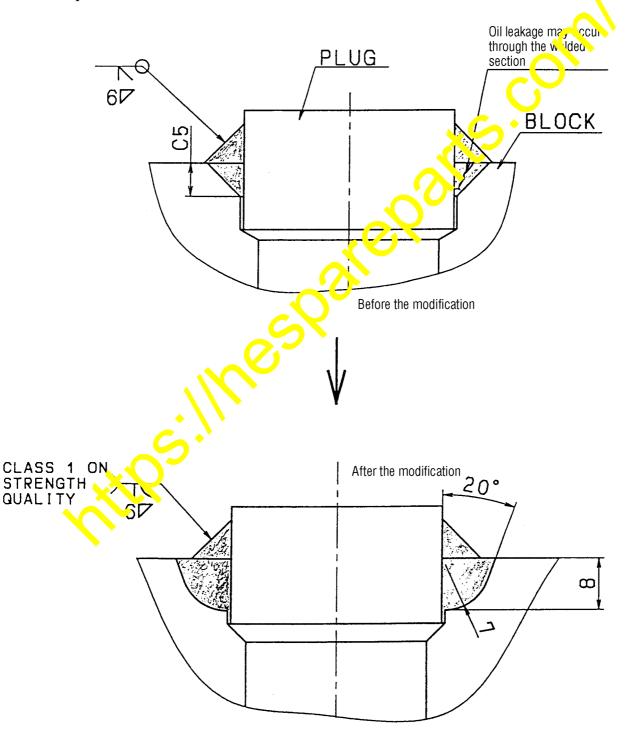
Cracks may occur in the inside structure of the welded section where a plug is welded, of the block contained in the steering circuit on the WA1200-3 wheel loaders because of dispersions of the fusing state of the plug, resulting in oil leading failure.

- 3. Contents of the modification
 - (1) The welding groove shape of the section where the plug is being welded has been changed and the welding quality has been upgraded. (To cope with the imperfect fusing problem)
 - Shape of the welding groove: "V" shape \rightarrow "J" shape
 - Welding quality:

Class 3 (Without designation in the drawing) \rightarrow Class 1 (Fusing: $\triangle 2 \text{ mm} \rightarrow +0.5 \text{ mm}$)

(2) The depth of the welding groove has been changed. 5 mm \rightarrow 8 mm (The throat depth has been increased to reduce stresses.)

When the aforesaid failure is found to be occurring or when preventing occurrence of such failure, make the modification introduced in this Service News to replace the part with the improved part with stronger welding.

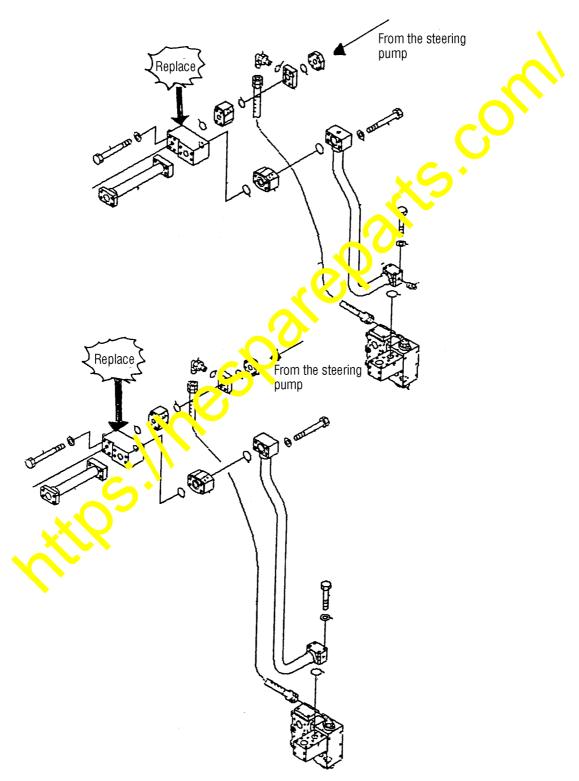
(2) Replacing the junction block for the emergency steering pump circuit and the steering pump circuit inside the rear frame

Replace the blocks 42C-62-16192 with the newly prepared blocks 42C-62-16193. (2 units)

Precaution: This replacement is applicable to the machines with the Serial Nos. of 50001 and 50002 only. These blocks are not being used with machines of other serial numbers.
