PARTS & SERVICE NEWS

REF NO.	AT01222
DATE	Dec. 25, 2001

SUBJECT: REPAIR OF CRACK AND REINFORCEMENT ON EXTERIOR ON WA1200-3

APPLICATION: WA1200-3 Wheel Loaders, Serial Nos. 50001 thru 50006

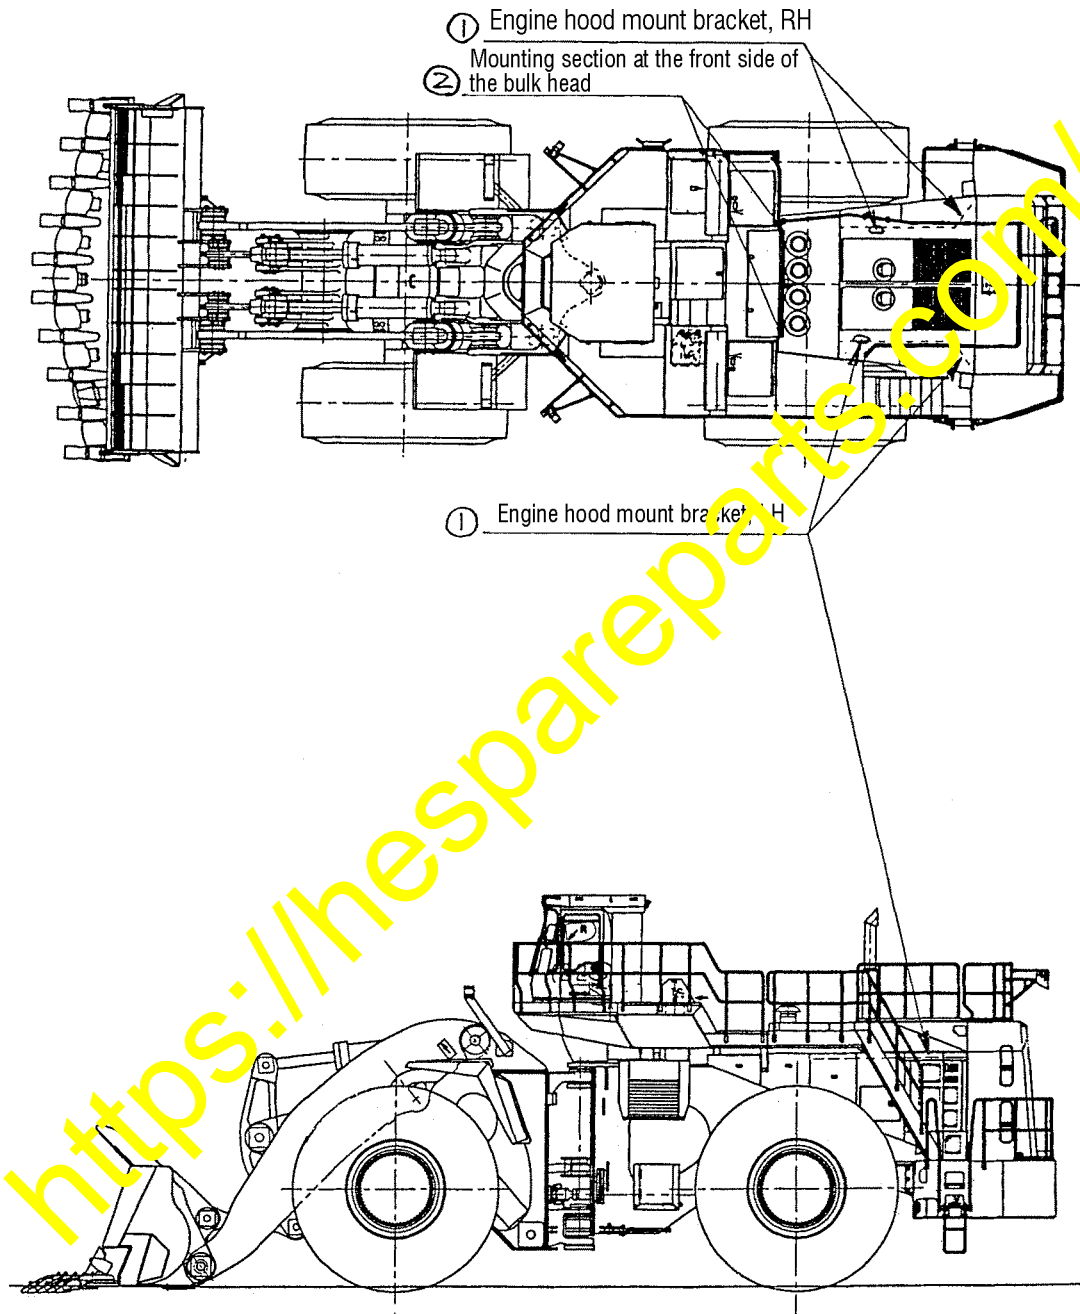
There is a possibility of occurrence of cracks at the ① mounting section of the engine hood mount bracket and ② mounting section at the front side of the bulk head when the WA1200-3 wheel loaders are used for long time.

- (1) Make the modification in the sections indicated in the drawing below.
Be sure to paint after the rework.
