REF NO.	AT01237		
DATE	Jan. 28, 2002		
•	Page 1 of 13

SUBJECT: REPAIR OF FUEL INJECTION PUMP (ELECTRONIC GOVERNOR) ON

SA6D170A ENGINE FOR GENERATOR

PURPOSE: To introduce modification procedure to prevent occurrence of malfunction-

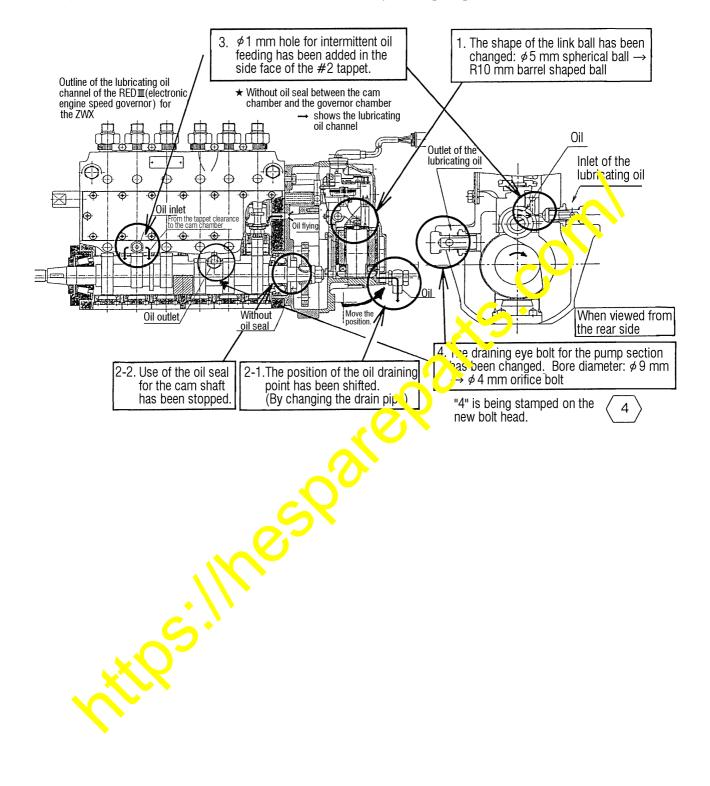
2) Contents of the modifications of the fuel injection pumps

Part number of the fuel injection pumps	6162-74-1310	6162.74-1311	6162-74-1312
	Serial numbers of the applicable engines	-#20718	#20719 – #21567	#21568 –
e modifications	 The shape of the link ball being used inside the governor has been changed: 1) \$\phi 5\$ mm spherical ball → R10 mm barrel shaped ball 		0	0
	 The oil level inside the governor charaber has been raised: Use of the oil seal for the came shatch has been stopped. The position of the oil draping port has been shifted. 		0	0
Contents of the	3. The oil feeding quantity has been increased: 1) \$\phi\$1 mm hole has been added in the #2 tappet.	_	_	0
Cor	 4. The oil flow out quantity from the cam chamber has been decreased: 1) The hale of the draining bolt has been changed. hale diameter: \$\phi 9\$ mm → \$\phi 4\$ mm 	_	_	0

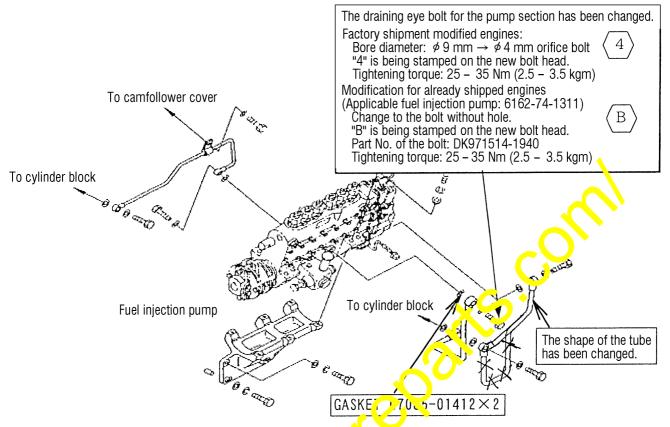
3) Contents of the modifications of the oil draining circuit

As the exclusive part for modification of already shipped engines (to modify the fuel injection pump from 6162-74-1310 to 6162-74-1311), the joint bolt "without hole" to use for the oil draining circuit of the cam chamber side of the fuel injection pump has been developed.

By this modification, oil drainage from the cam chamber side will be stopped and, since oil drain will then be male from the governor side only, the oil level inside the fuel injection pump will be raised thus making it possible to improve the lubrication status inside the fuel injection pump.

"B" has been stamped on the bolt head of the above joint bolt without hole for the identification purpose.

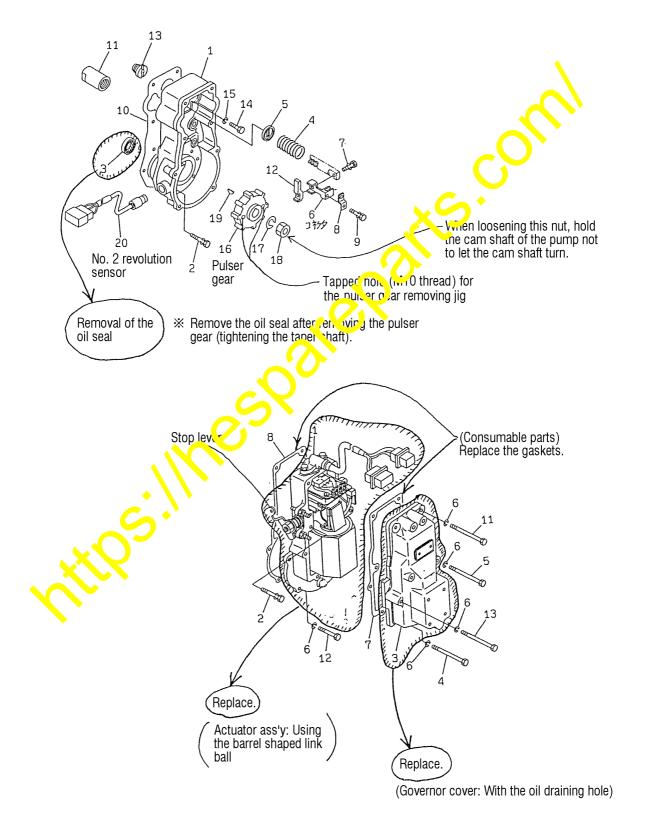
The contents of the modification are as follows:

(1) Modify the governor.

When modifying the governor, request the agent of Bosch Automotive Systems Corporation to make this modification.

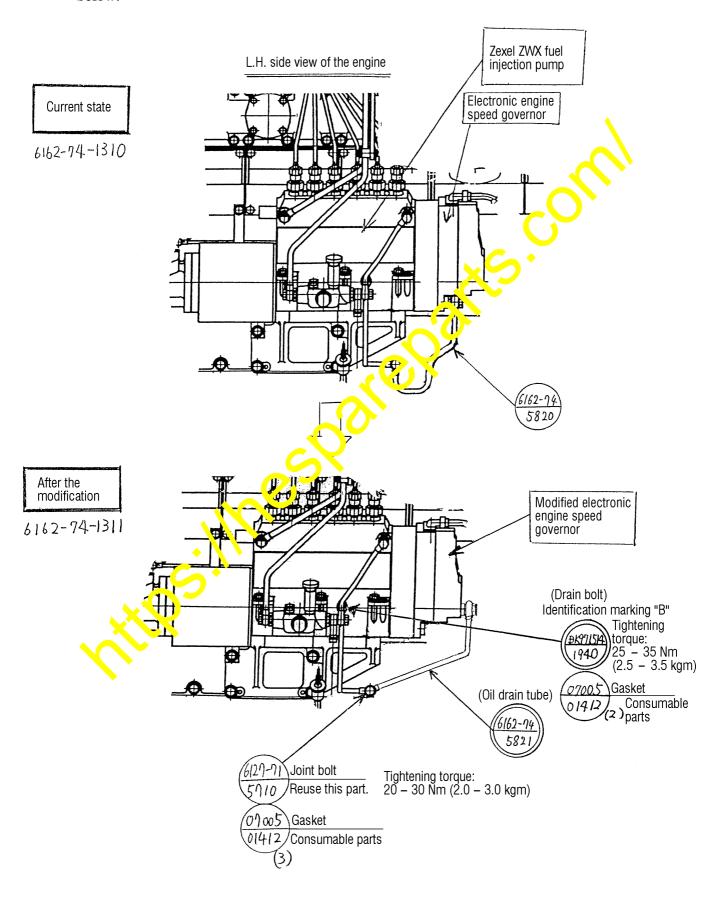
Since the position of the oil draining port of the modified governor is shifted to a different point, replace the oil drain tube as per the instructions given in the drawing below.

(2) Replace the oil draining tube.
