PARTS & SERVICE

REF NO.	AT01253	
DATE	Feb. 12, 2002	
	Page 1 of 7

SUBJECT: MODIFICATION PROCEDURE OF RIGHT PLATFORM CRACK ON

HD785, HD985

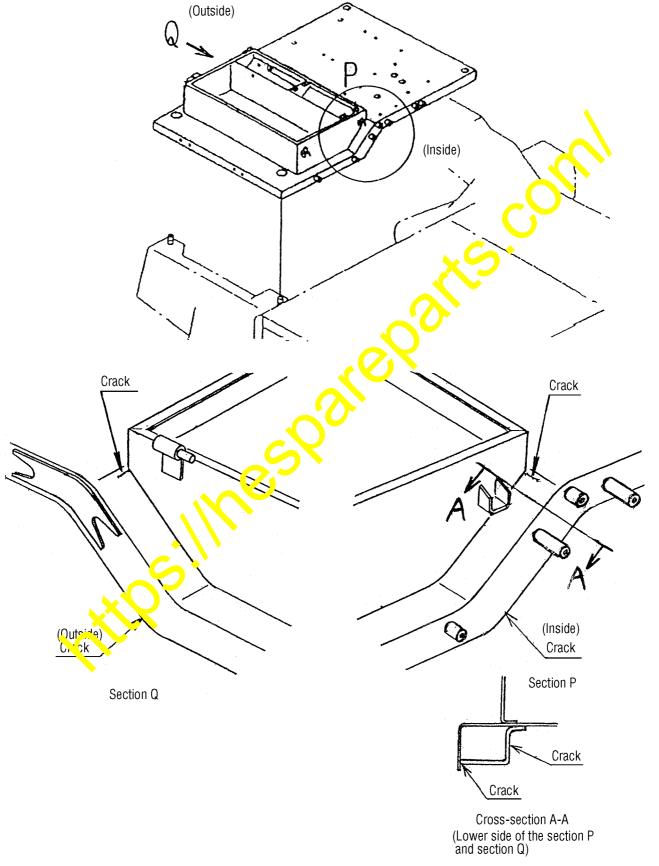
When the stepped sections (section P or section Q) become cracked on the upper side or on the lower side, repair the cracks following the repair procedure being introduced in this Service News.

Fig. 1: Positions where the cracks may occur
