PARTS & SERVICE NEWS

REF NO.	AT02029
DATE	Mar. 8, 2002

SUBJECT: MODIFICATION PROCEDURE OF TORQUE CONVERTER PUMP HOSE FAILURE ON WA800/900-3.

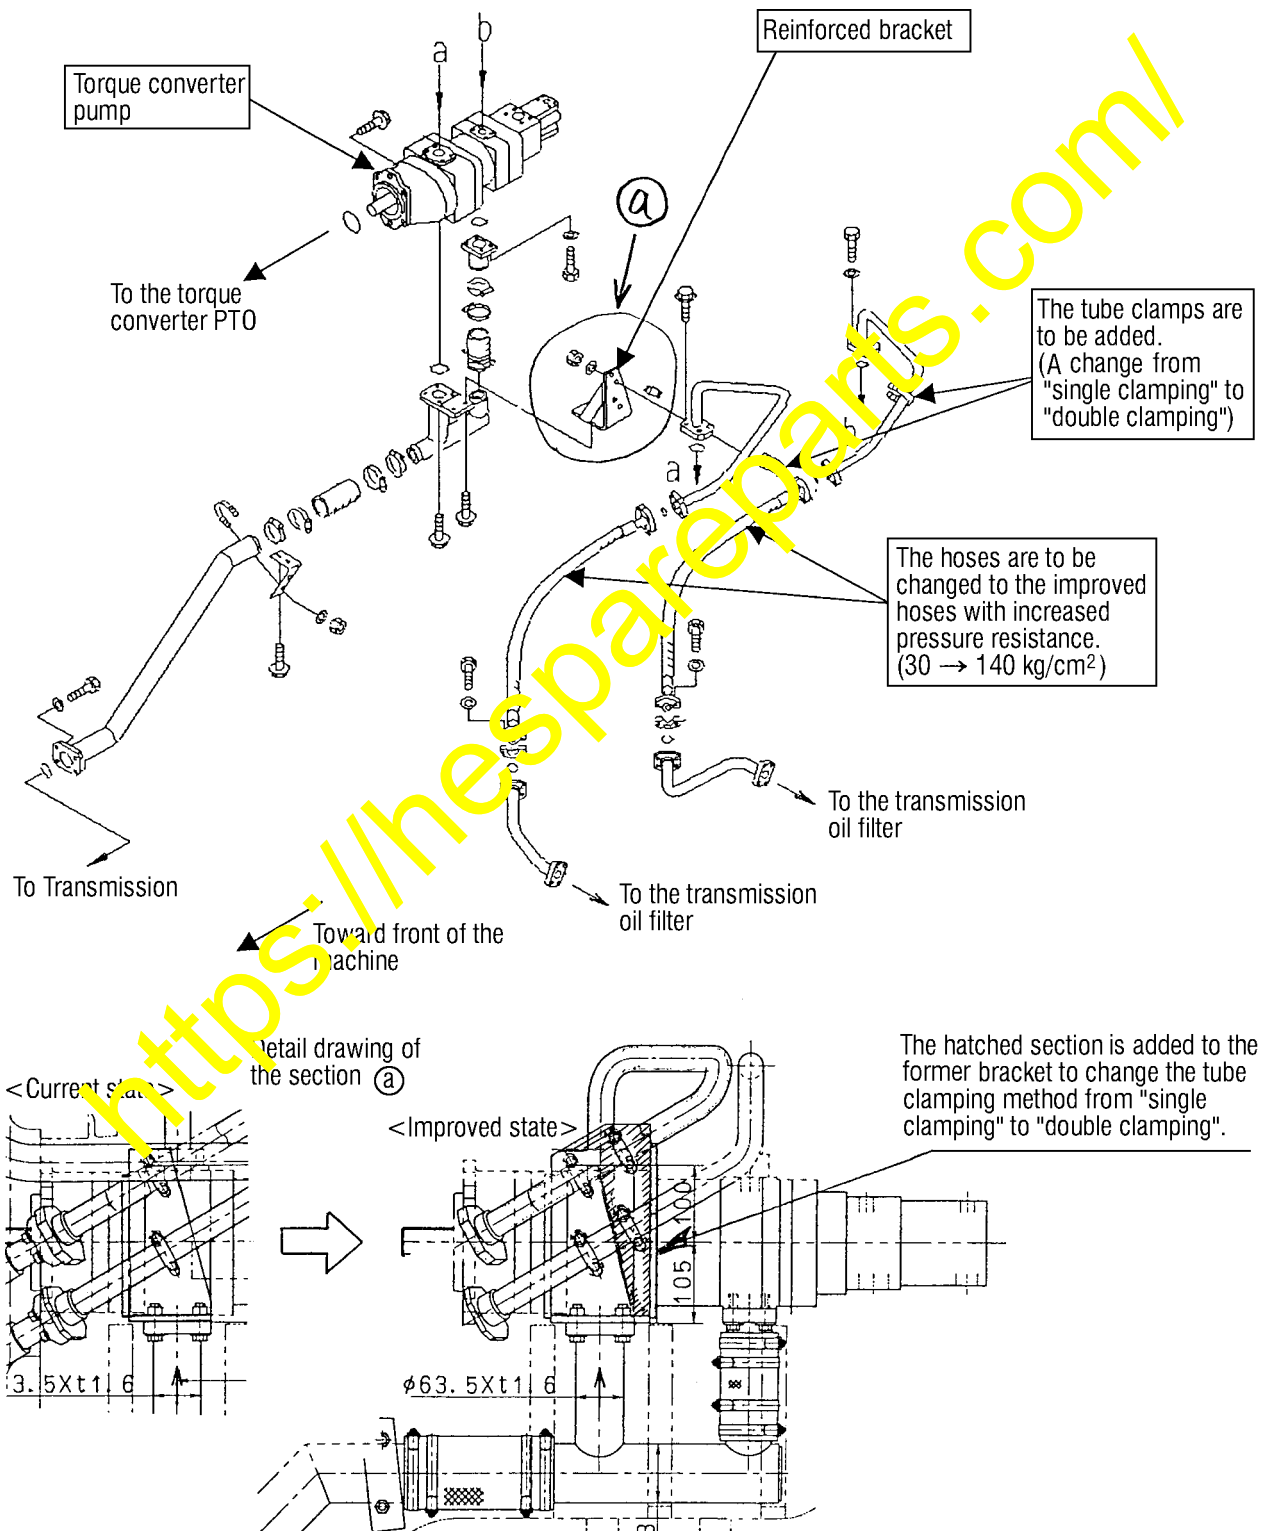
By pulsations, etc. of the discharge pressure from the torque converter pump on the WA800-3, WA900-3 and WD900 wheel loaders while the oil temperature is still low, breakage failure may occur with the outlet circuit tubes and hoses. Therefore, implement the modification following the procedures being outlined in this Service News to prevent occurrence of the above failure.

- 1) To prevent breakage failure of the tube:
 - The bracket is to be changed to the reinforced new bracket.
 - A tube clamp is to be added.
(A change from "single clamping" to "double clamping")
- 2) To prevent breakage failure of the hose:
 - The hoses are to be changed to the improved ones with increased pressure resistance. (30 → 140 kg/cm²)
